# KKBE Coming Street Cemetery • Charleston, SC

*Report by Clemson University/ College of Charleston  
Masters in Historic Preservation Program  
Advanced Conservation Spring 2015*

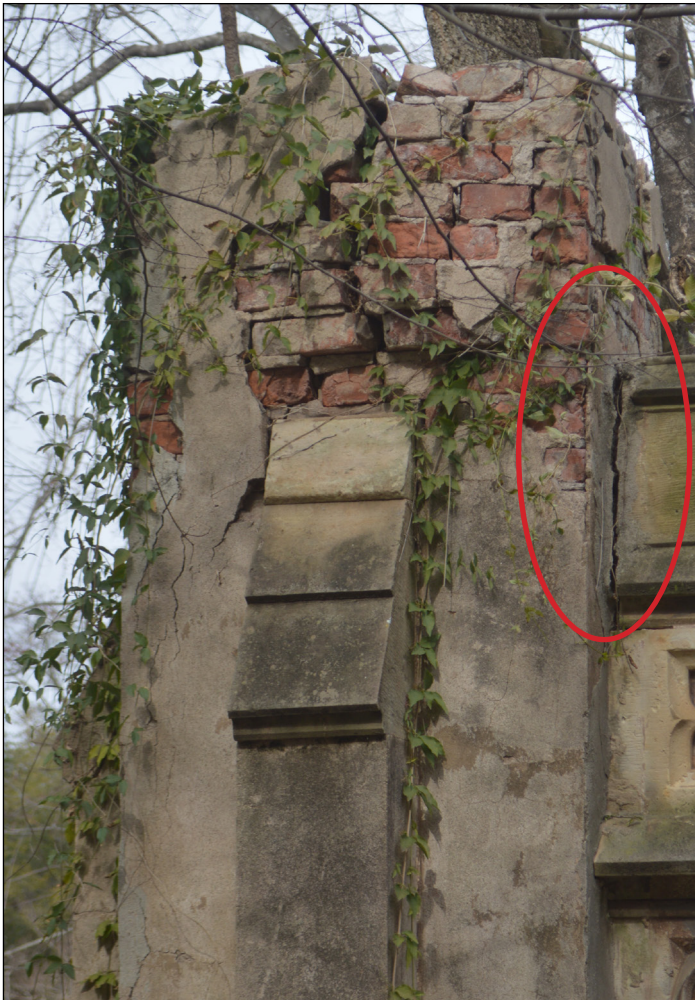
The west tower is in very poor condition. The tower is pulling away from the rest of the monuments front façade and is leaning to the left out of plumb. Due to this leaning, the connection between the tower and stone ornament on the top of the middle section has failed. The stucco of the tower is not connected to the stone even after what appears to be a later repair in an effort to reconnect the stone to the stucco. Below the roof, the decorative stone piece is still attached to the west tower.

Figure 4. Leaning of the tower to the left with the broken connection between the stucco and brick and the stone.

The west tower of the monument needs immediate attention. The tower must be stabilized, as it is currently unsafe for visitors to the site since loose stone pieces and bricks pose safety hazards. Craig Bennett, a local engineer and preservationist, was consulted to determine what course of action might be best for stabilizing the west tower. Six options were discussed during the consultation and are presented below:

2. Stabilization: Another option is to provide support behind the arch with a tie rod. It is recommended that the tie rod be black and thin, perhaps an inch thick, to prevent noticeability. The tie rod should be galvanized or stainless steel. Galvanized steel is easier to finish. The tie rod should then be secured in place with earthquake washers. The tie rod may also be secured by means of a split or round plate adhered to the outside of the buttresses or a small cut can be made and the rod slid in place. A second tie rod may be needed near the back of the interior section of the monument for full stabilization. In order to determine the best place for the rod to support the structure a finite element analysis can be undertaken by an experienced structural engineer. This test analyzes where the rod can best resist the thrust of the settling monument. However, it is an expensive procedure.

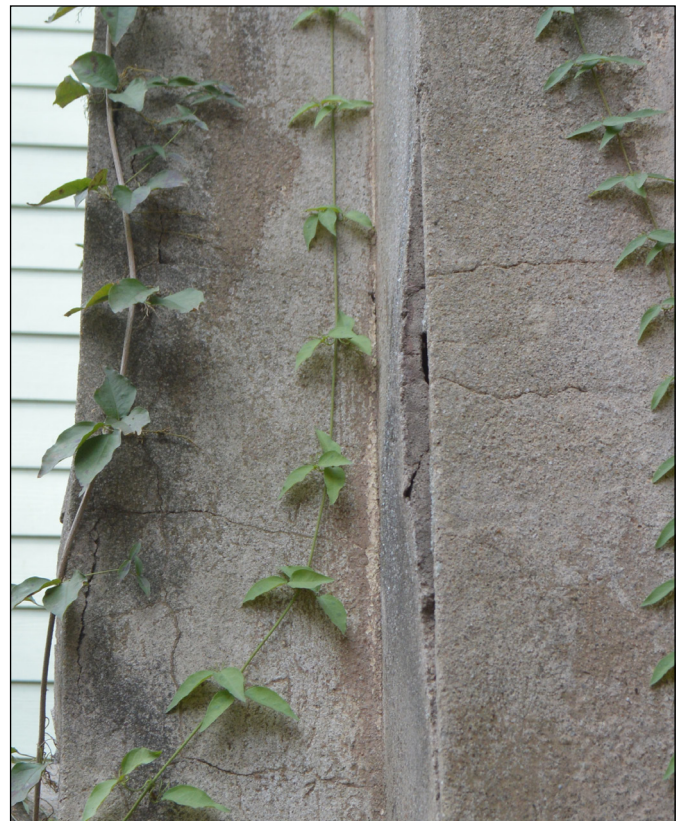
Figure 5. Bulging and delamination of the stucco.

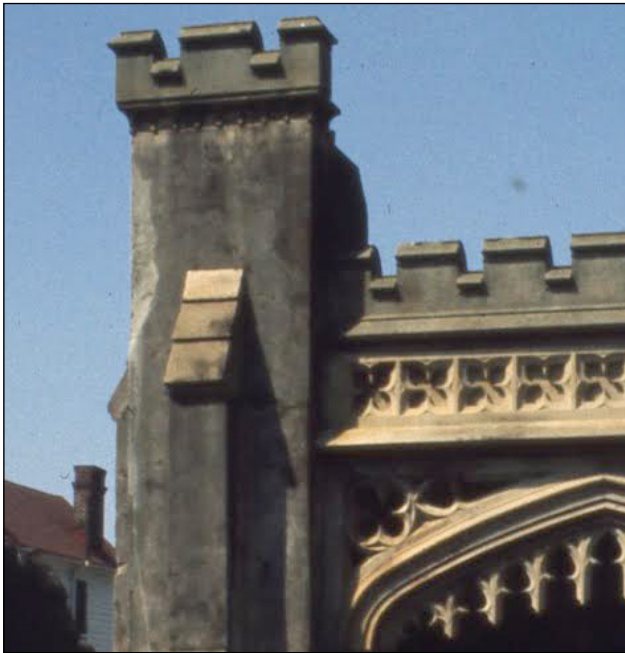
Historic photographs show the presence of stone work at the top of this tower. Some of the stone work is still apparent on the east tower, however another layer of stone was once on top of the stonework still present. The west tower has lost all of this material.

*Figure 6. Historic photograph of the west tower.*

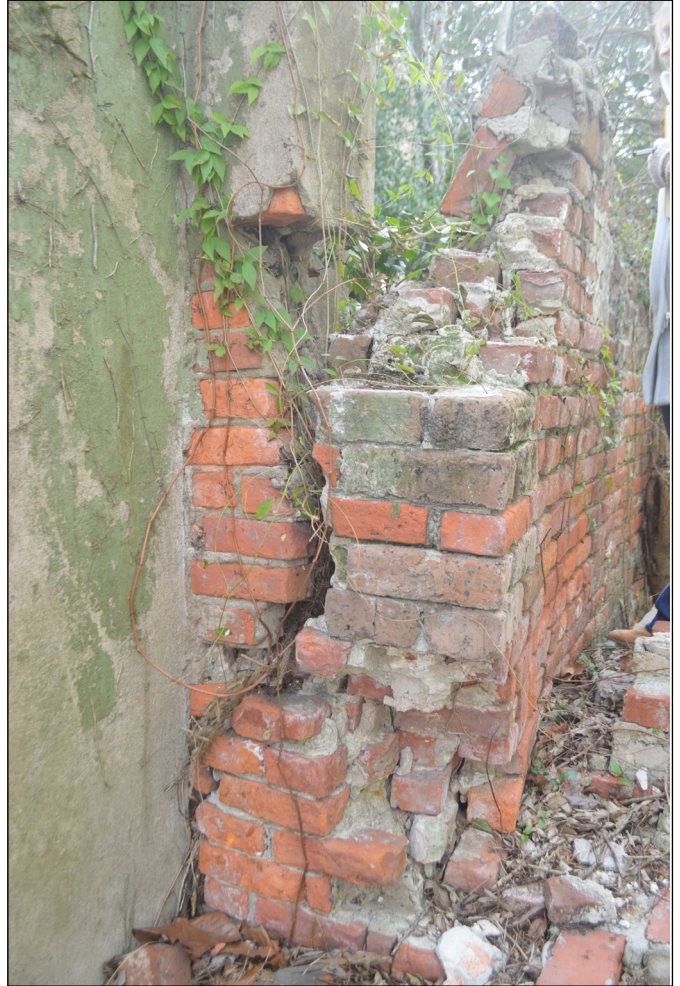
The buttress to on the west side elevation of the tower is no longer intact. Material loss is extensive as it appears that stone used as a structural as well as decorative feature of the monument has been lost. Brick, mortar and stucco has also failed in this area and there is a significant gap on the west side of the monument. The buttress is still partially connected with the wall surrounding the site and the foundation, however there are vertical cracks, indicating that the wall is leaning away from the buttress.

*Figure 7. The crack in the west buttress from the north side of the monument*

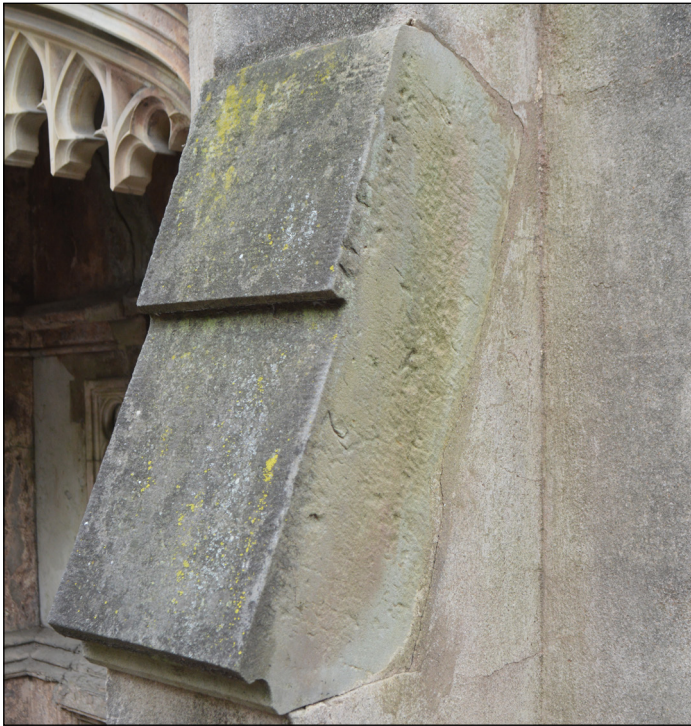
Figure 8. Staining and biogrowth present on the buttress

Water cleaning methods were chosen for removing soiling and biogrowth. The reasons are that water cleaning can be performed as many times as needed. Water cleaning must be done from top to bottom to avoid dirty water running over already clean areas. A garden hose can be used and should not be pressurized. Natural bristle brushes can be used in combination with the water to assist in removing soiling. A gentle non-ionic detergent may also be used for tougher to remove staining. A small amount of the detergent should be mixed in a bucket and applied using the natural bristle brush. Brushing the surface of the monument must be done lightly to prevent further delamination of stucco. The washing should be able to remove dirt and small biogrowth such as algae. If water is not sufficient for removing biogrowth, then a biocide such as D2 might be tested in a small area by a trained conservator.

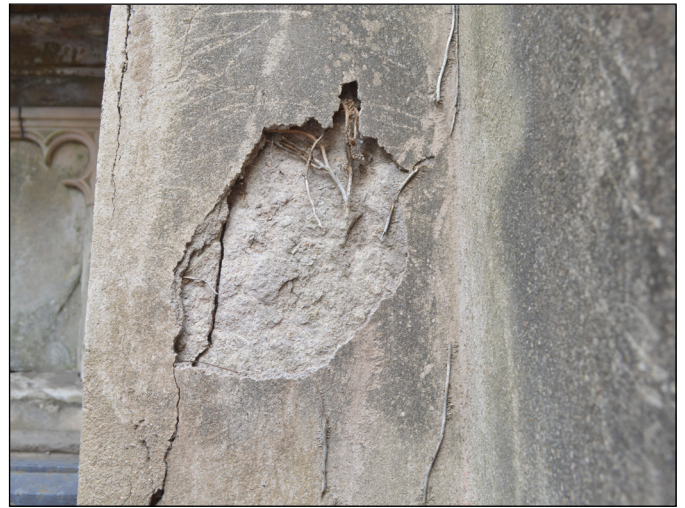
Figure 9. Staining and vines present on the east tower, vines have caused delamination, bulging and stucco loss.

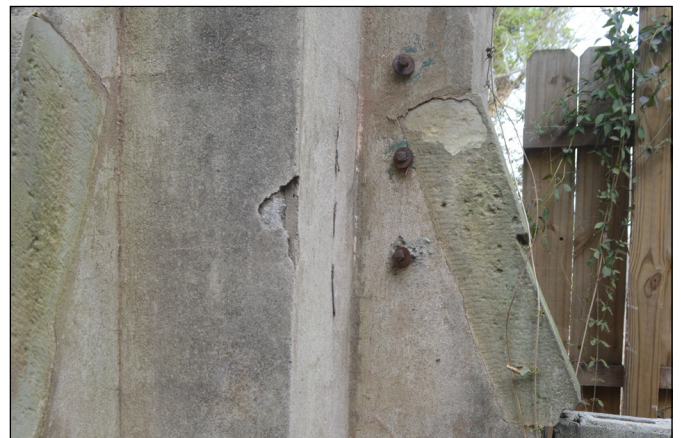
On each tower there is a buttress that helps to support the monument. On the east tower, there are iron bolts that protrude from the center of the buttress. The purpose of these bolts are not known. They are corroding though no cracks have formed around the bolts. The top of the tower is missing architectural features.

Figure 10. Bolts on the east side of the tower of unknown purpose

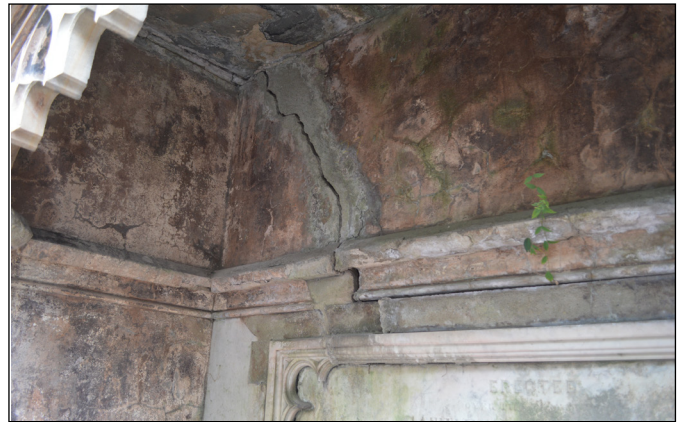
There are several large cracks on the center and interior of the monument. The most noticeable is on the stone archway over the metal railing on the front of tomb. The two pieces of stone that create the arch have separated due to settlement. There is another large crack that starts above the inscribed marble slab. It continues upward onto the ceiling of the interior of the tomb. There are several smaller cracks that are related to stucco or brick failure. Some of the interior stucco appears to be original and the remaining lime wash could possibly be first generation. Some delaminated stucco has been infilled with Portland cement. Bricks have softened and there is mortar loss in areas where the brick is exposed due to stucco loss.

Figure 12. Major crack on the interior of the monument.

Crack monitors should be used to determine if large cracks are active. If cracks are active and not historic then structural repair of the west tower must be considered. A lime-based mortar could be applied immediately as a temporary fix to the cracks. If the cracks are stable then a lime mortar can be mixed and injected into the cracks using grout filler or applied with small masonry trowels to prevent moisture or biogrowth from causing deterioration within the structure.

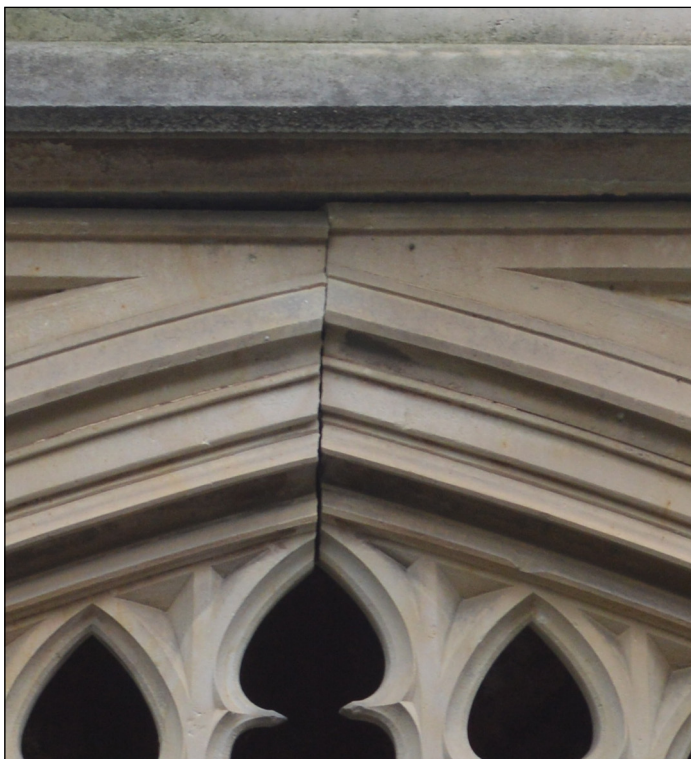
Figure 11. The shift in the center stones.

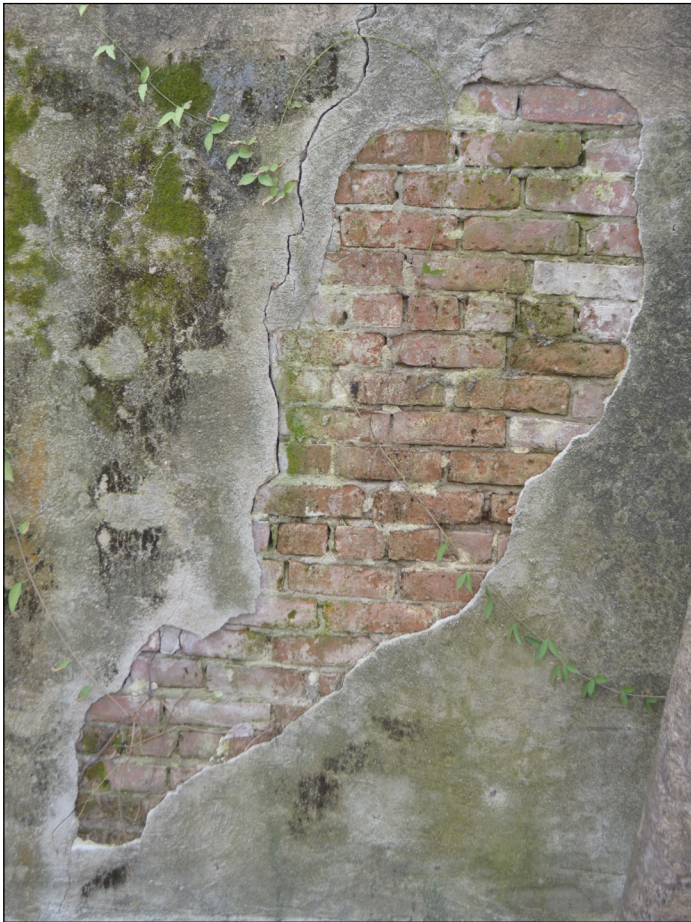
There is a large section in the center of the north elevation of the monument where the stucco has delaminated. Stucco failure is occurring over the entirety of the wall in the form of cracks especially along the top portion and western edge where it covers the roofing material.

Figure 14. Area of Delamination

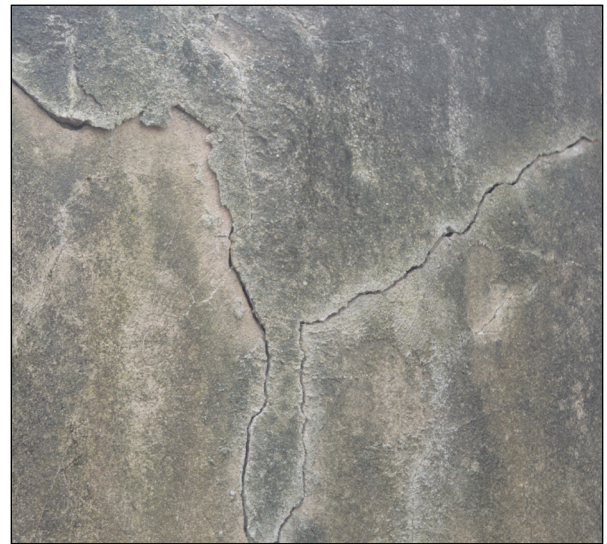
Figure 16. Area of delamination and poor repair.

Portland cement composite repairs have been used to fill in sections along the edge of the slanted roof and on the back of the section near the top of the monument. Portland cement has also been used to fill in the space where the top of

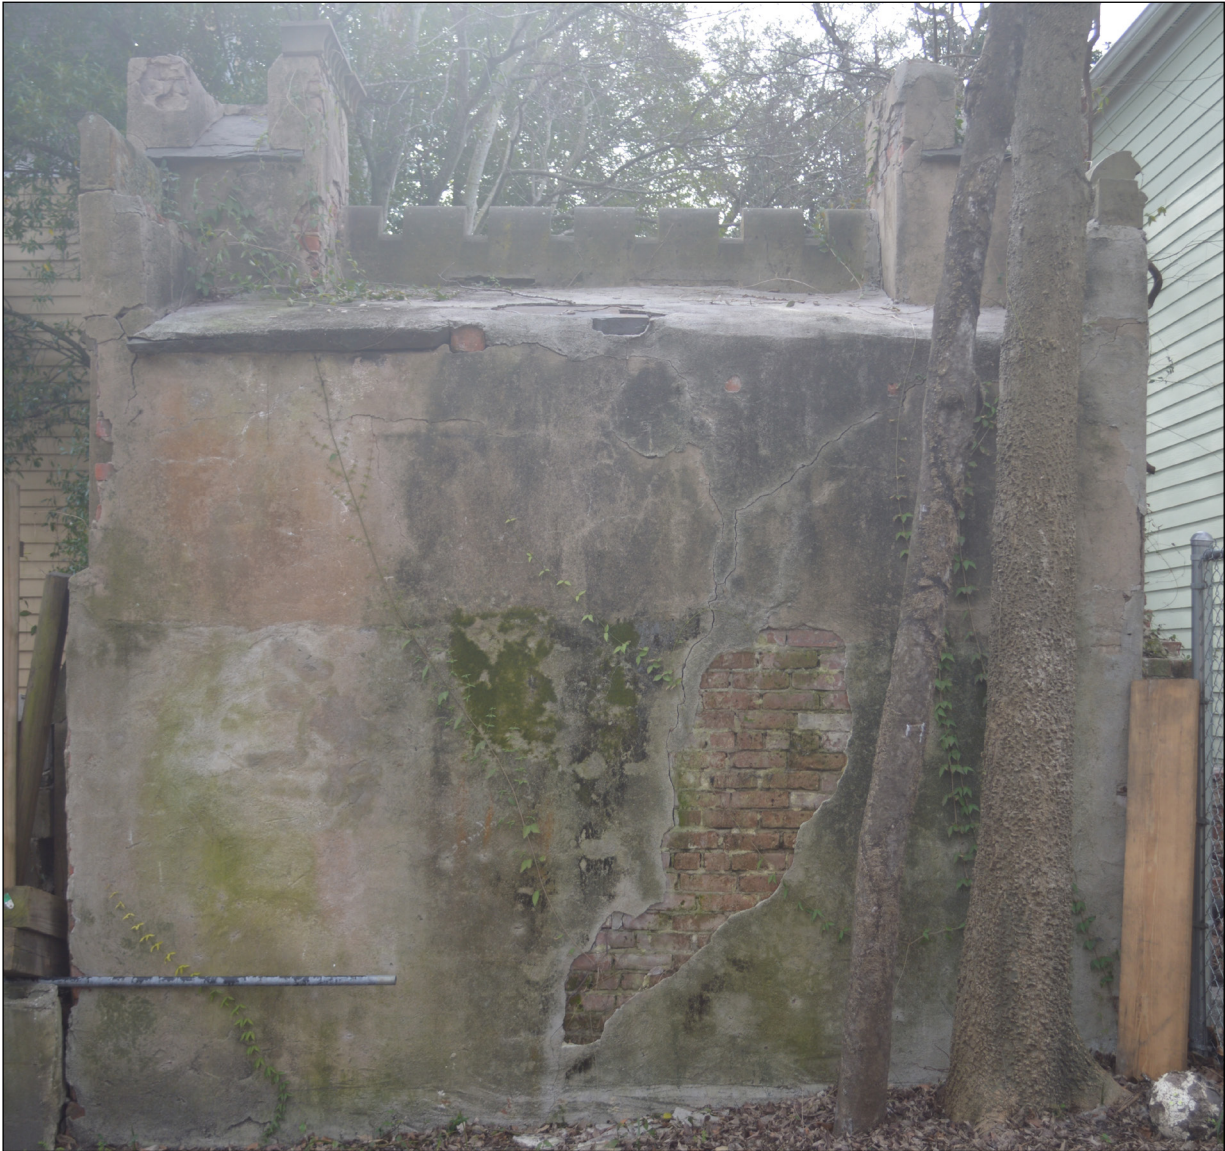
The slate roof covering the monument extends past the north elevation on the eastern half of the wall and extends it does not appear to be attached to the masonry structure beneath with mortar or fasteners. The slate roofing material on the western half of the north elevation remains covered with stucco or composite Portland cement repairs. Decorative stone work on the top of the west side of the north elevation is detached from the monument but remains in situ.

*Figure 17. Displacement of the monument.*

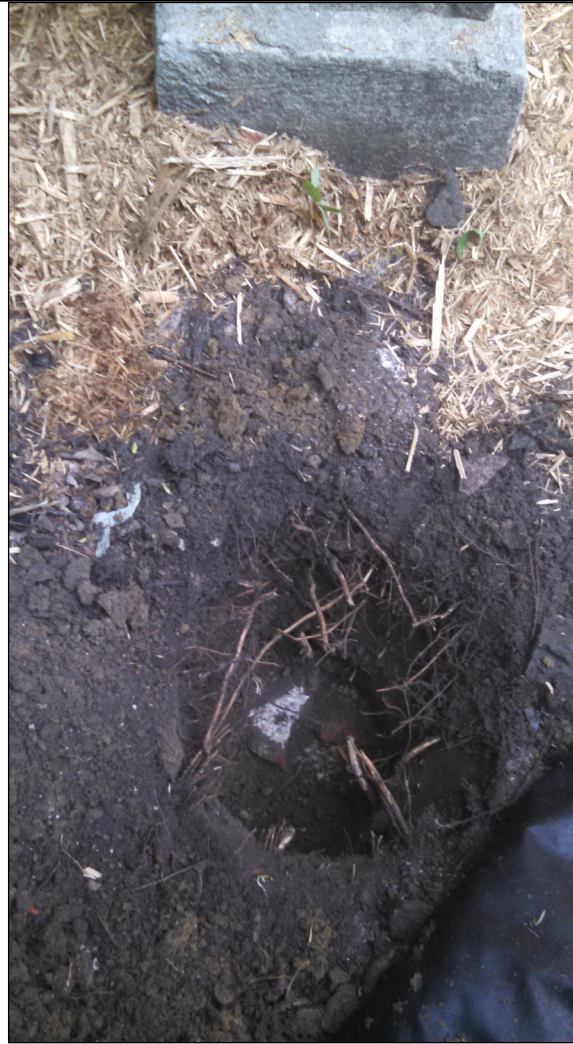
It is difficult to determine how much of the original foundation remains. The brick foundation appears to step out around the structure, similar in plan to the structure itself. On the south-west side, the foundation extends 1 foot 6 inches from the structure. But in the center of the south side, the presence of David Lopez slab monument disrupts the space. Here foundation appears to end 1 foot 5 inches from the structure, but it is impossible to determine if this was the original arrangement. On the south-east side of the structure the sidewalk and its footer have prevented probing to determine the extent of the foundation. The depth of the foundation is irregular, presumably from settling. Along the west side the foundation is approximately 7.75 inches below grade. While on the east side it averages 5.5 inches below grade. This supports other evidence that the west column has shifted more than the east column.

Figure 18. Area dug for investigation

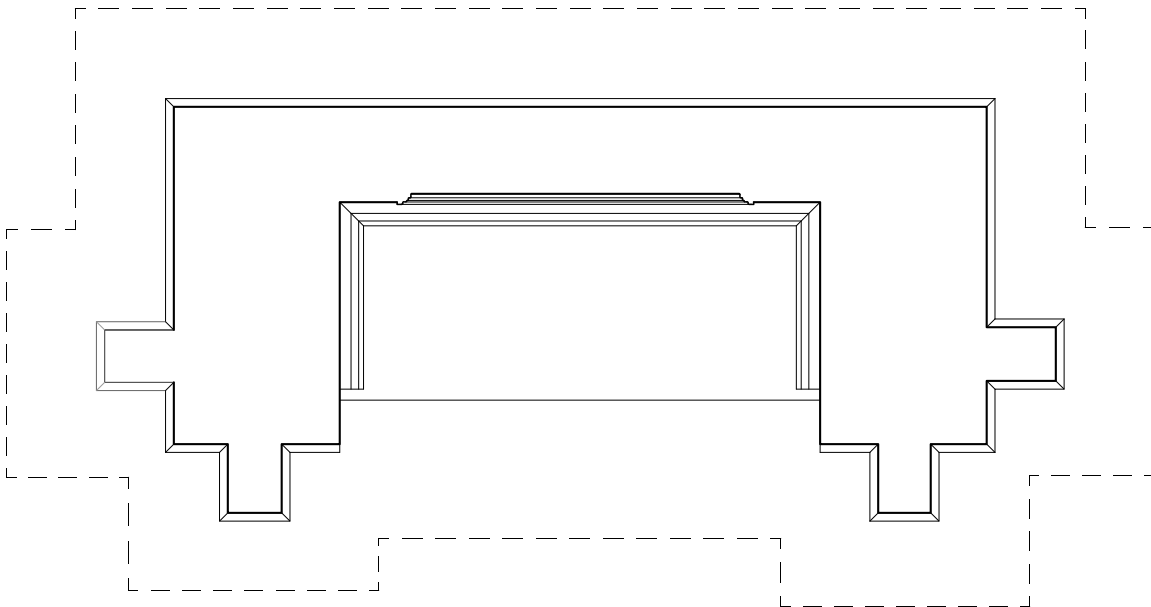
Figure 19. Hypothesized Foundation

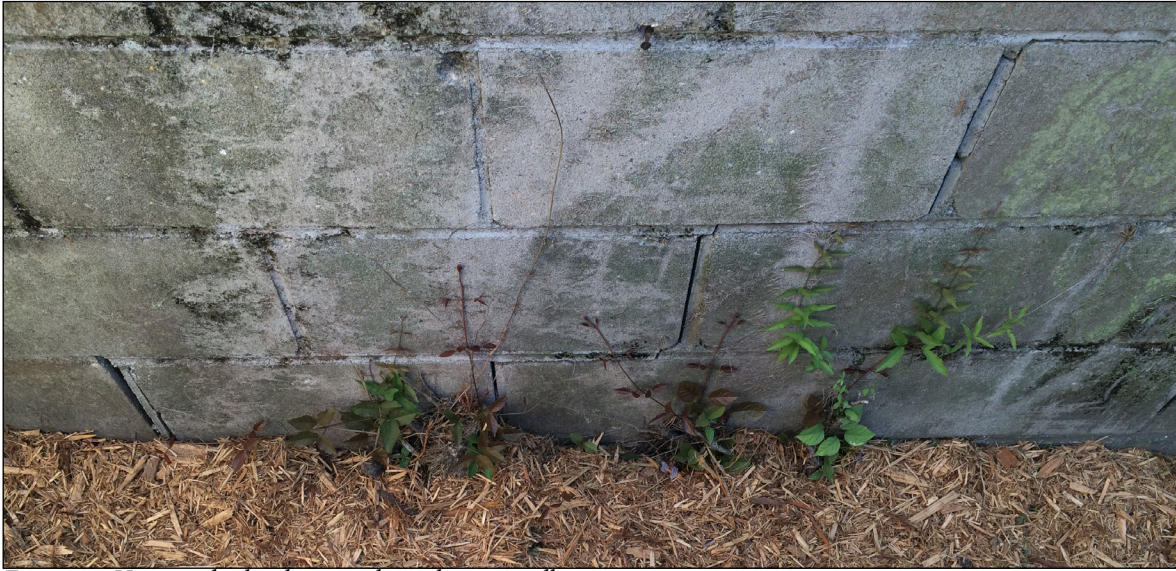
*Figure 19. Vines and other biogrowth on the east wall.*

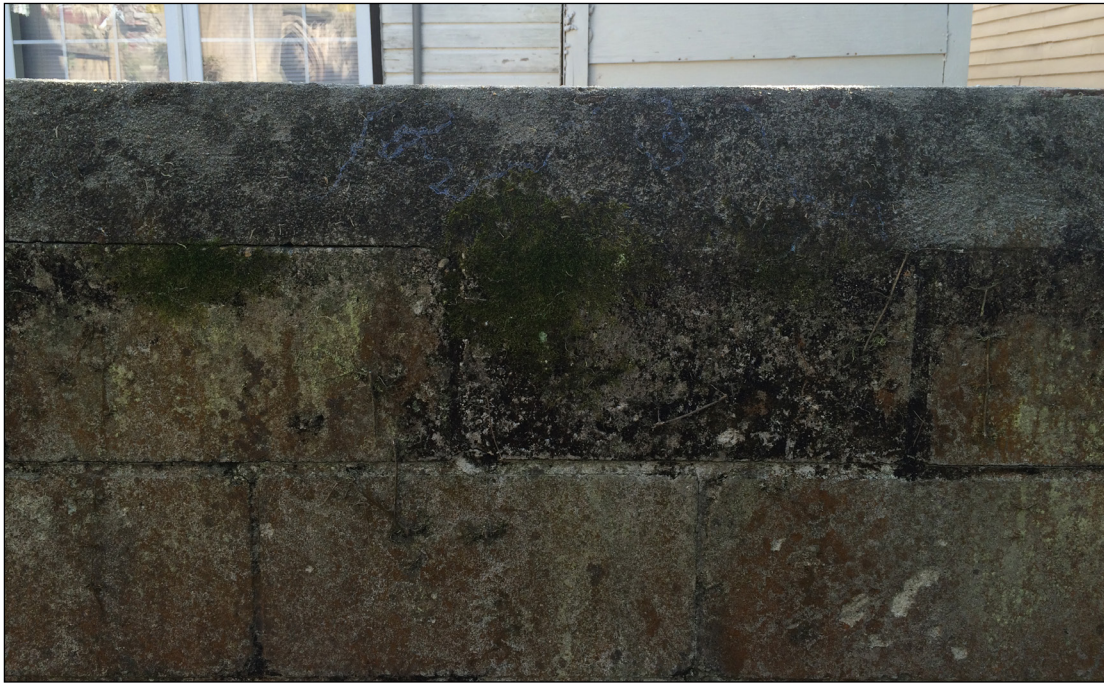
*Figure 20. Staining and biogrowth on the east wall.*

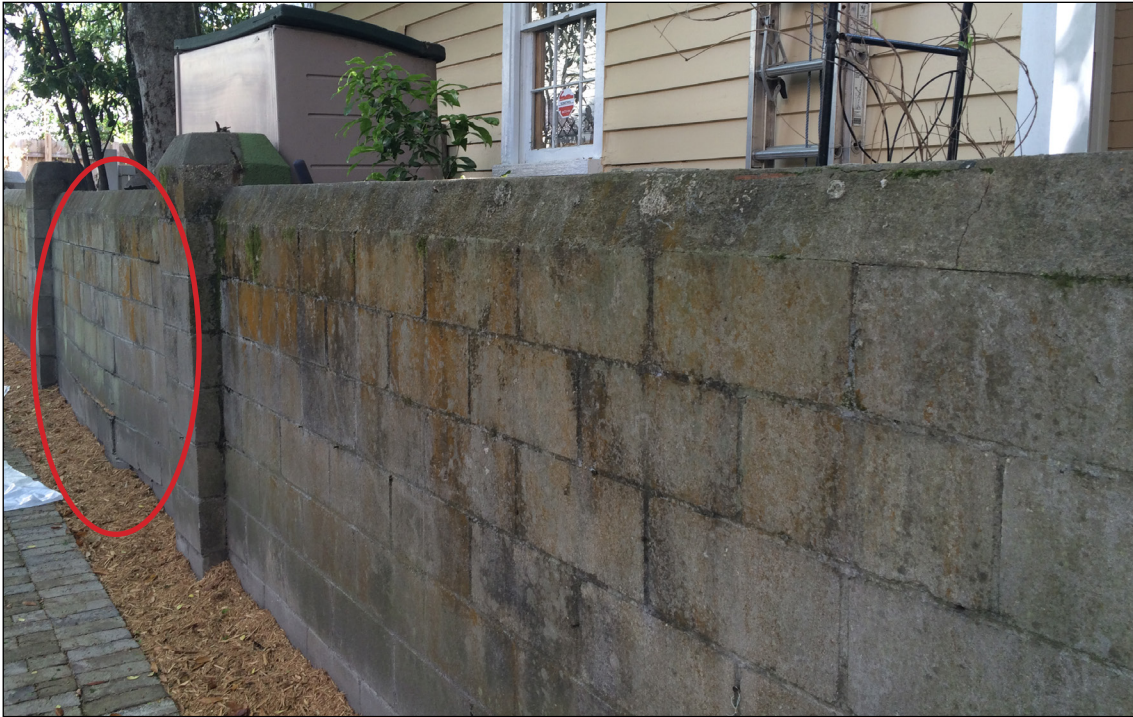
Figure 21. View of the east wall with bowed section

The walls around the Lopez section have many of the same types of deterioration as the Lopez monument. The bowing of both the east and west walls is caused by the trees that grow on the exterior of the wall. Their root systems pushed the wall out of plumb. Vines, moss, and delaminating stucco are also present and have the same causes as those on the monument.

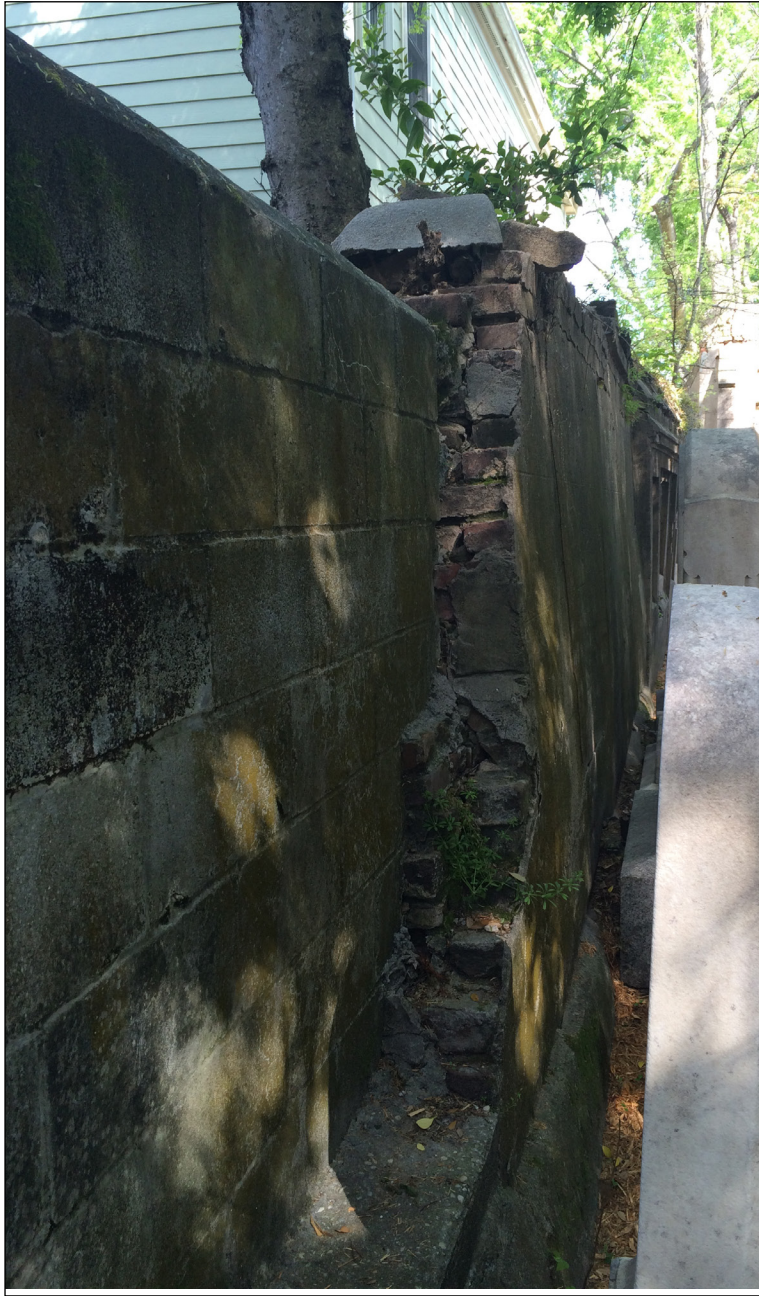
*Figure 23. View of the stuccoed masonry and CMU sections of the west wall. Biogrowth and staining is visible on the CMU.*

The west wall is made of two different materials: the northwest side of the wall is stuccoed brick and a very small portion of the southwest side is CMU with portland cement mortar. The CMU section is in fair condition and has the same biogrowth and staining issues as the east wall. The rest of the west wall is in poor condition. Vines cover the top of the entire wall and other plants grow from cracks on the side of the wall. Moss and lichens grow on the top half of the wall and stain the surrounding areas. There is a small

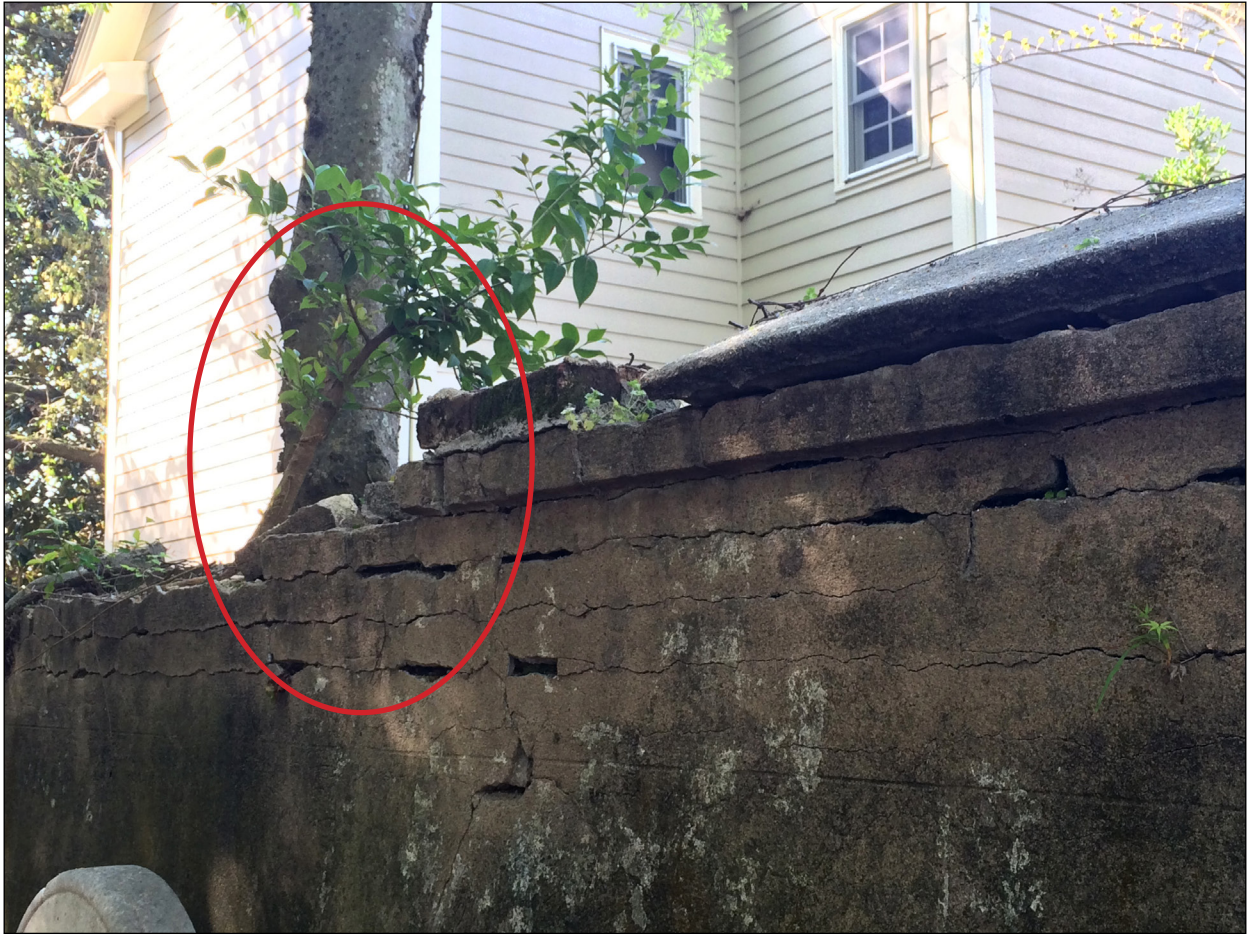
Stucco has delaminated from the brick in many areas. The exposed brick has deteriorated mortar joints and plants that grow in between the bricks. The majority of the cracks in the west wall run horizontally. Some of the vertical cracks have been filled in with portland cement. The entire wall is bowed.

Figure 24. Horizontal cracks, biogrowth, and staining on the west wall. The small tree is growing from the top of the wall.

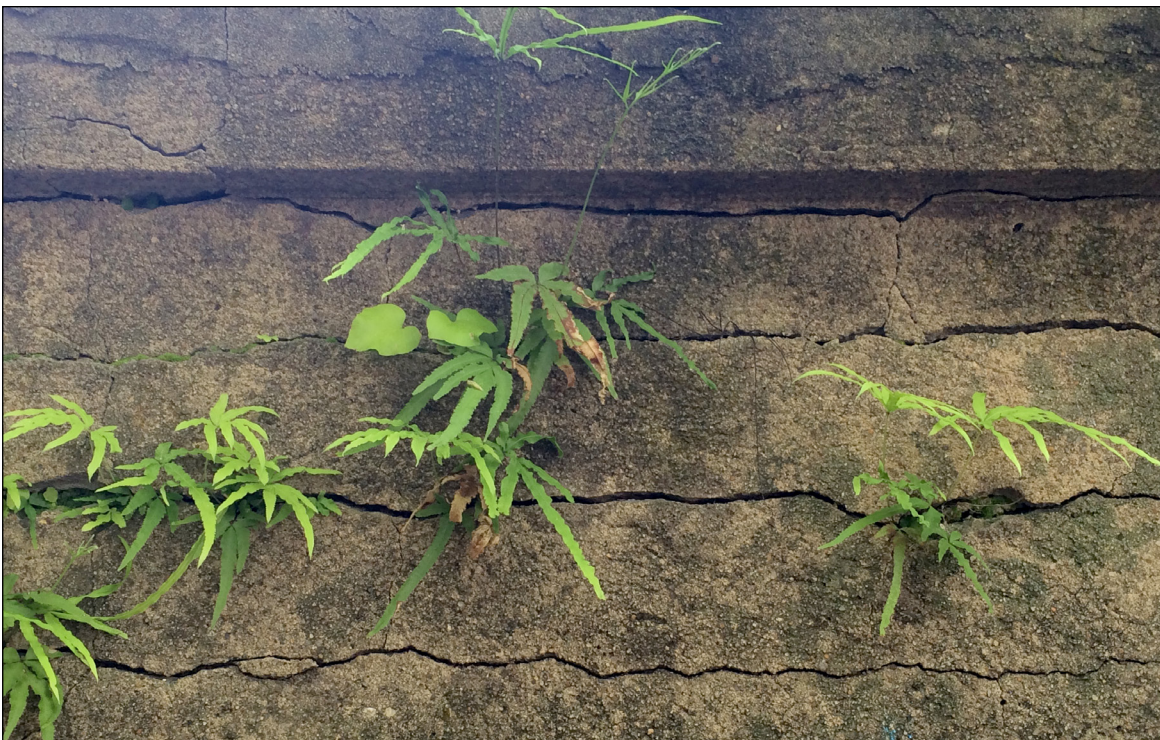
Figure 25. Detail of biogrowth in the horizontal cracks
