Investigation, Documentation, and Conservation of

Pompion Hill Chapel

Berkeley County, S.C.

Clemson University & The College of Charleston
Graduate Program in Historic Preservation
Fall 2014

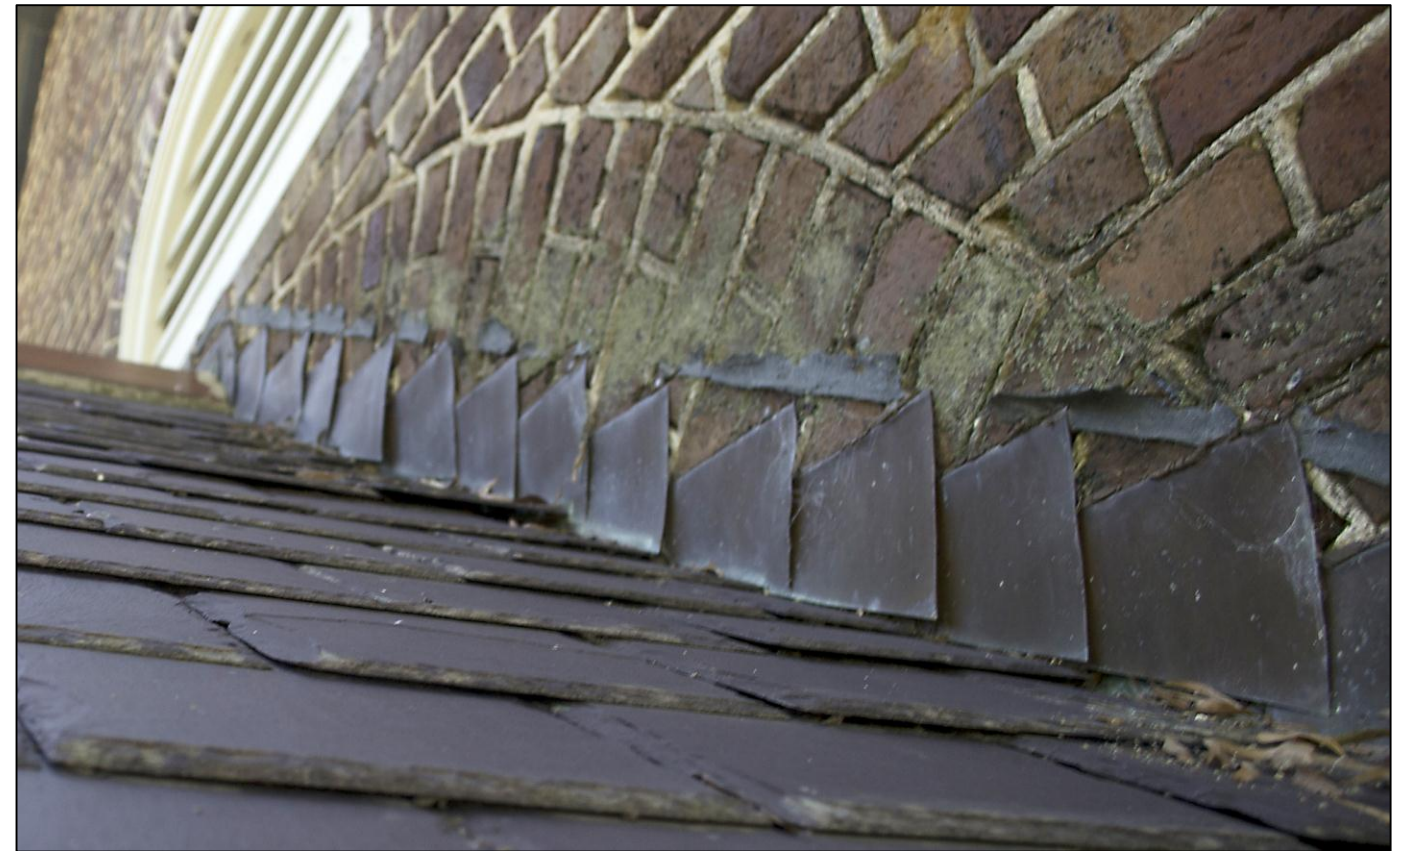
The flashing on the building's eastern end is of high quality and does a good job creating a water-tight barrier; its color indicates that it was replaced recently, likely in 2005. The flashing on the vestry end is in worse shape; it appears to be either older or of inferior quality to that on the eastern end. It does a poor job creating a sealed barrier between the nave and the vestry, all a product of the vestry structure pulling away from the nave.

A detail of the flashing on the chancel. This shows the arch supporting the bay below.

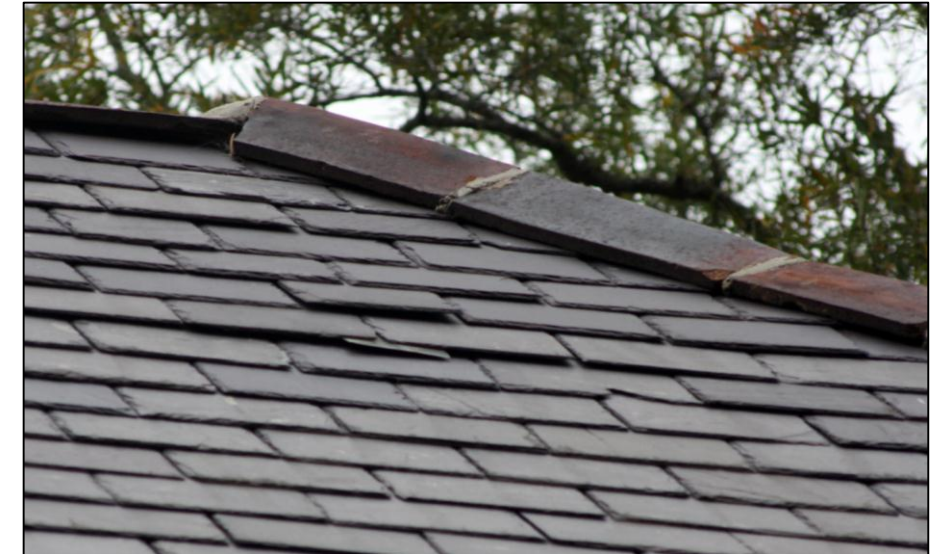
The terra cotta ridge caps are in good condition and holding their position. Held together by mortar, there appears to have been at least one re-pointing campaign using Portland cement that should be monitored (the use of Portland on these joints likely coincides with the rebuilding of the vestry using a Portland mortar).

A detail of the ridge cap on the vestry.

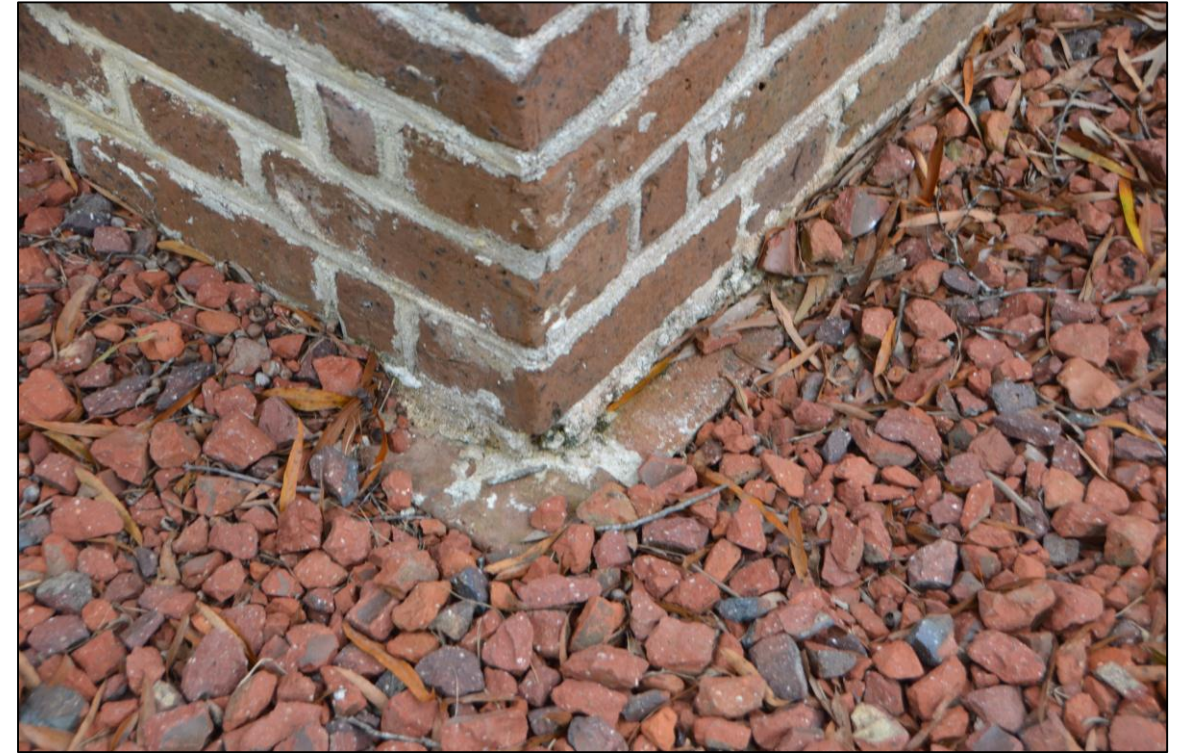
The foundation is in excellent condition, and should continue as such long as both systems are in place and in working order. There is minor bio-growth especially along the southern wall which receives little consistent sunlight. This however is not a major concern.

The French Drain surrounds the perimeter of the building.

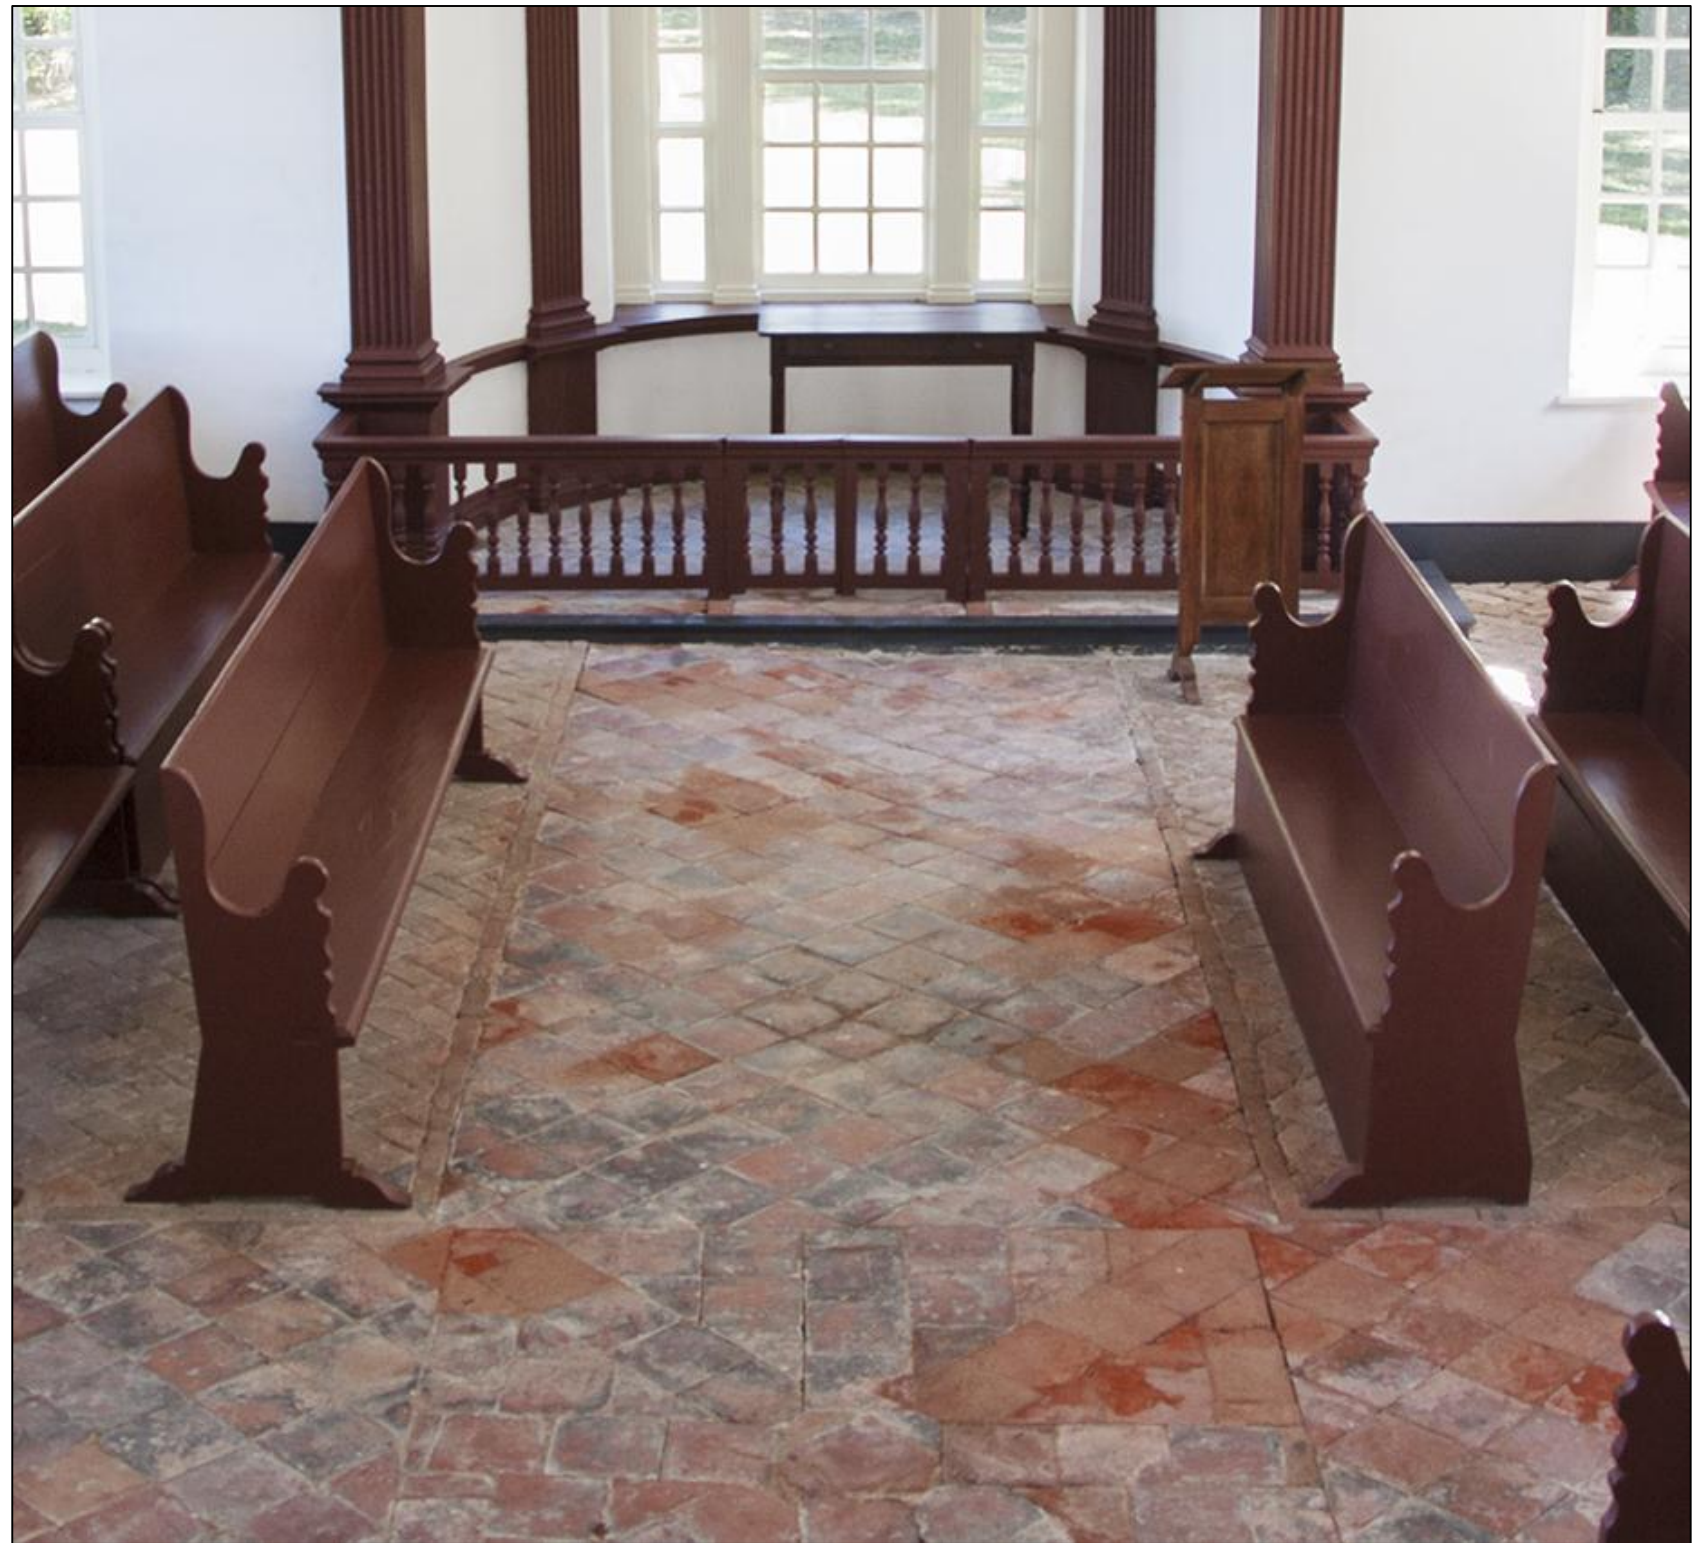
Above: The flooring today is deteriorated in the main walkways. The variations of color present are signs of wear.

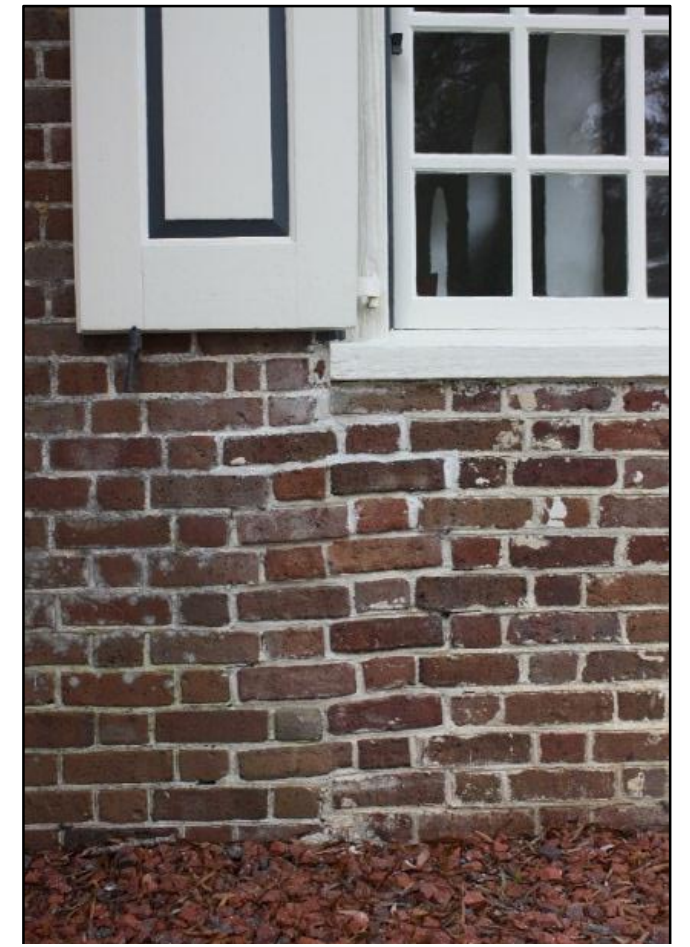
This is a current photograph of the Northeastern corner. This corner failed; most likely due to the arched window.

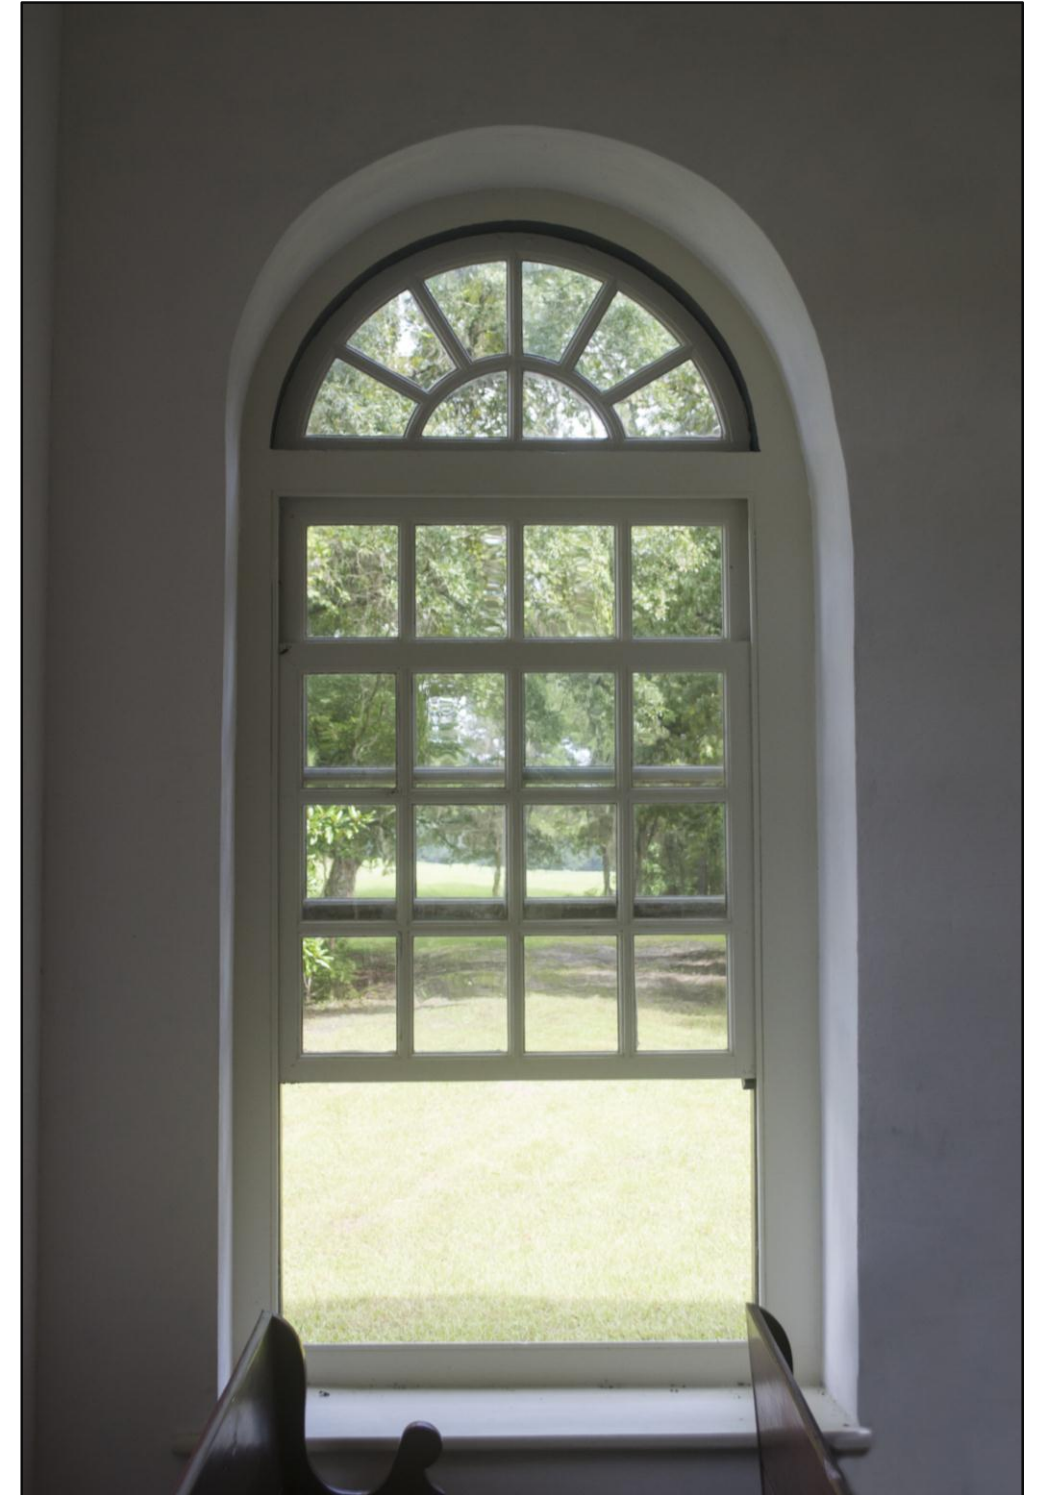
The windows are in excellent condition.

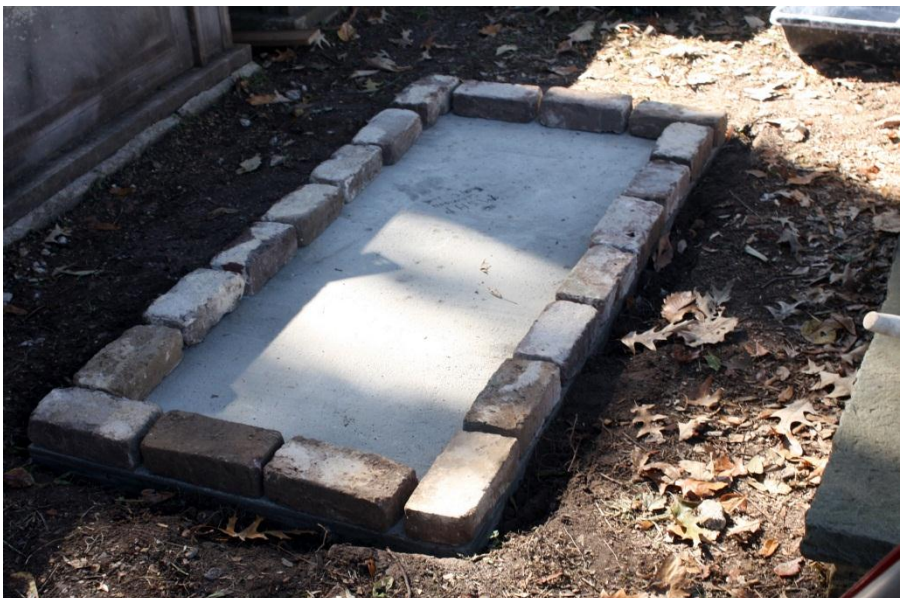
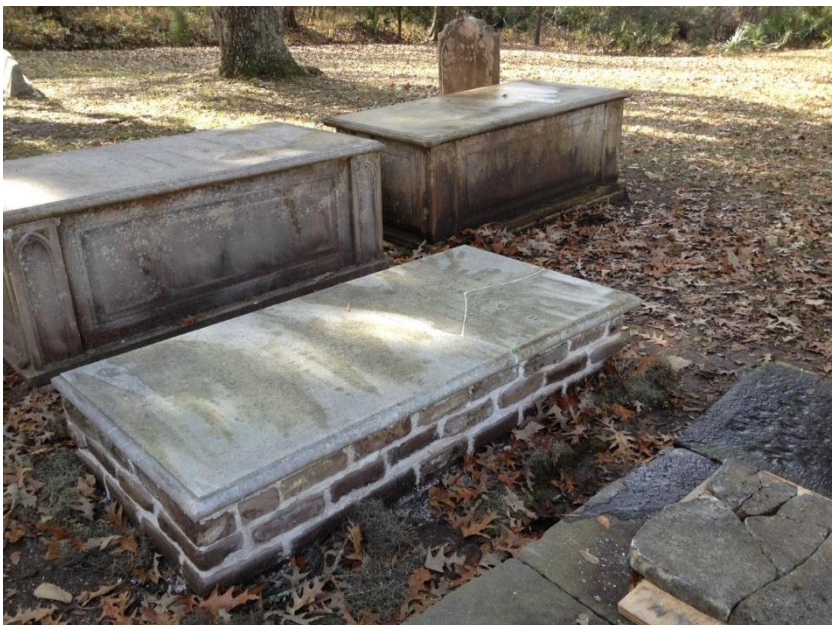
New foundation laid

Also, a box tomb needed a new foundation and the ledger needed to be put back together. Plot number 5 received a new foundation of cement. The original brick was laid with historic mortar made up of one part white Portland cement, one part white masons lime, and 6 parts sand. Repointing historic mortar is added to the joints. Lastly, the ledger was put back together with epoxy and laid back on box.

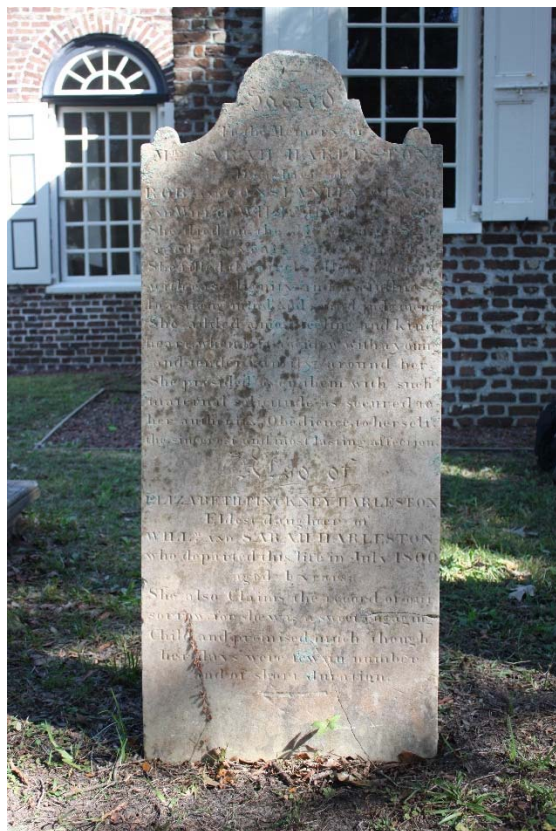
West Elevation, before cleaning.
Note staining and biogrowth

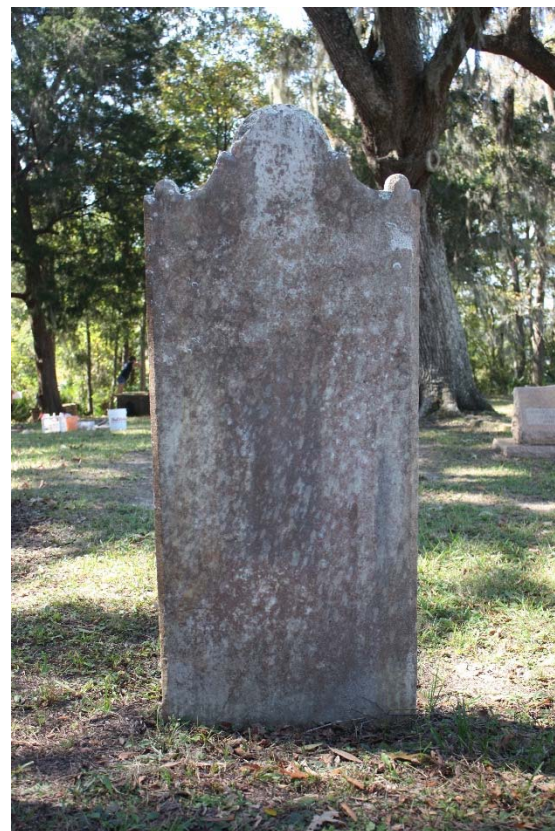
East elevation, before cleaning.
Note staining.

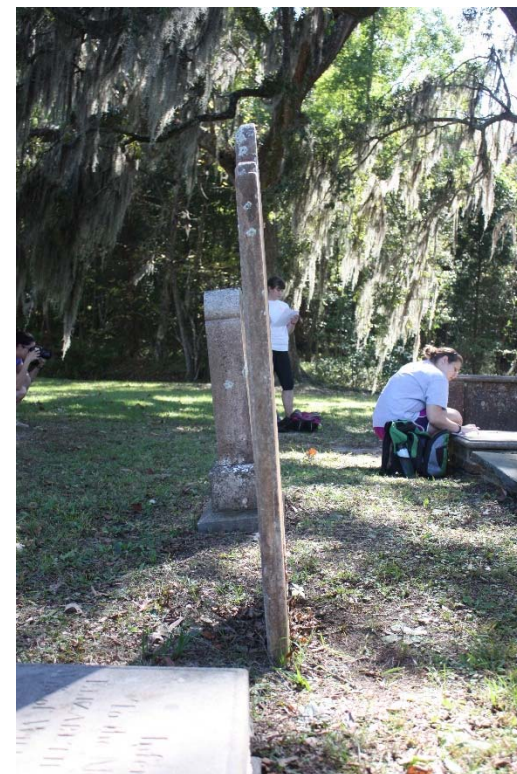
Monument is out of plumb, leans toward the east. (north elevation)

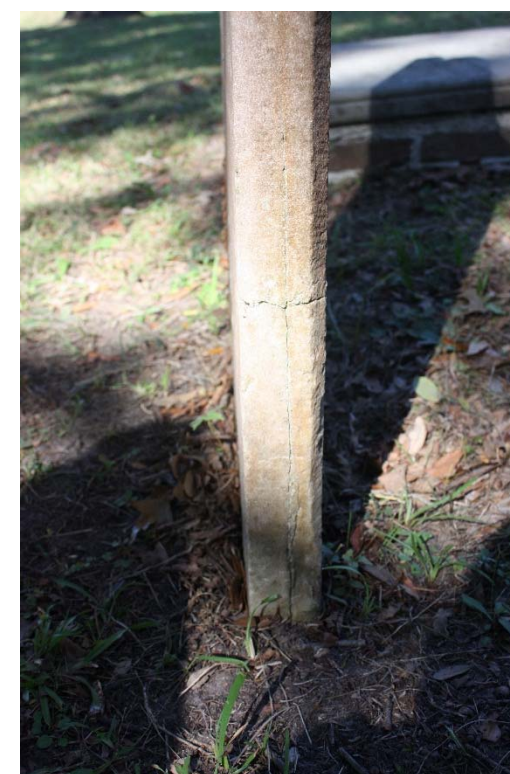
Cracks running down south elevation.
Similar cracks also run down north elevation.

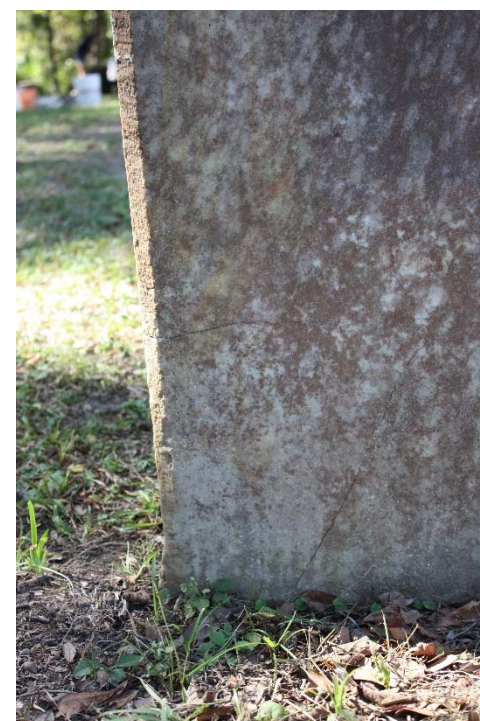
Chipped edge of stone on east elevation.

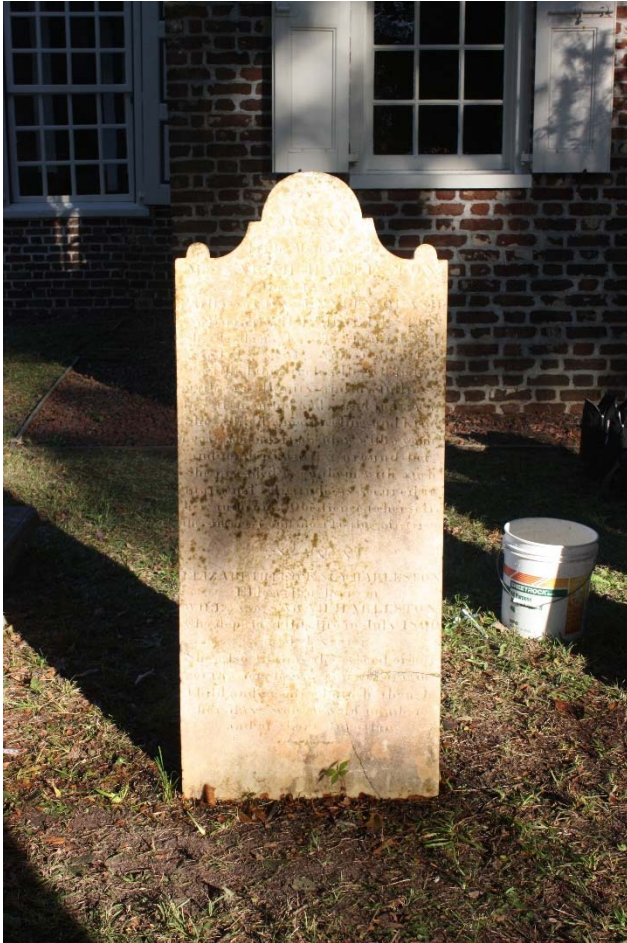
West elevation after cleaning. Staining and biogrowth are greatly reduced.

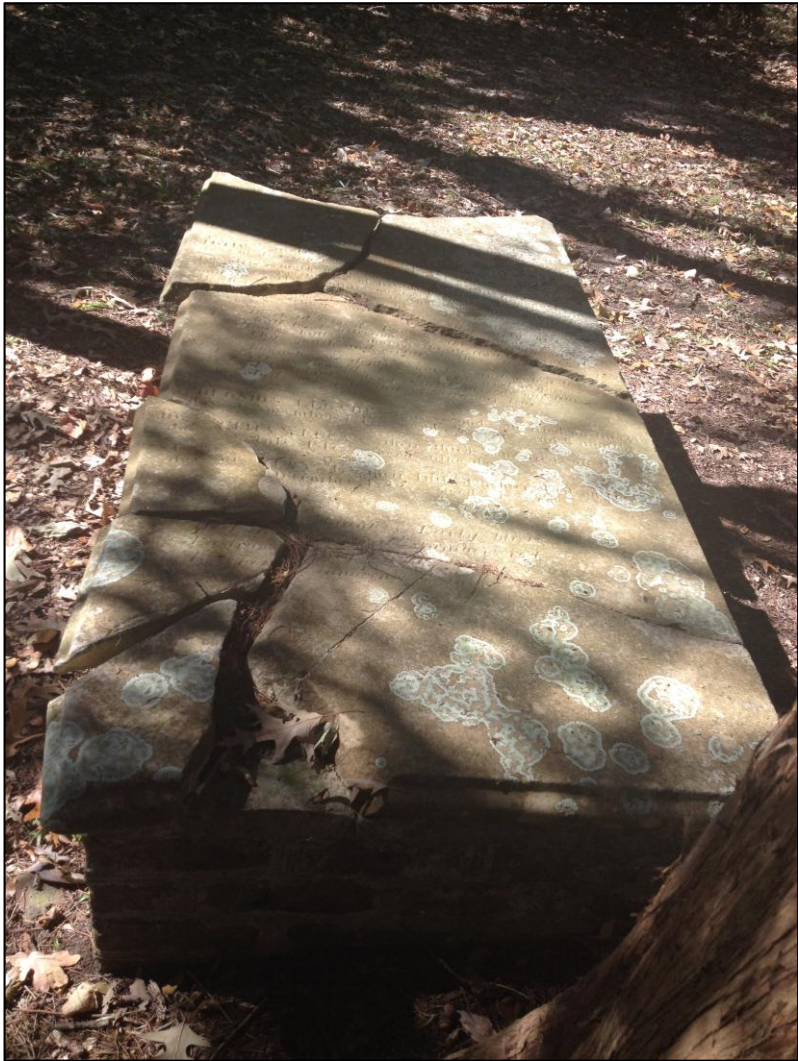
The tomb was found to be in considerable state of disrepair, especially with regards to the condition of the ledger. A deep and thorough scrubbing of the top side of the ledger - initially with water, and then if necessary using a soap solution - should comprise the initial step towards treatment. Large, loose fragments of the ledger should be lifted and set aside in order to thoroughly clean the cement on which the ledger rests. Edges of the ledger pieces should be thoroughly cleaned with a dry brush in order to prepare them for adherence. Vines growing upwards from within the tomb should be trimmed back or eliminated. Initially, a two-part epoxy will be used to reattach larger fragments of the ledger to one another. Once cured, visible cracks should be mended with the application of jahn.

Condition as Found

The top surface of ledger was cleaned thoroughly using only brush and water. Bio-growth and soiling were greatly eliminated in this simple process, taking the incised text of the ledger from nearly indecipherable to clear legibility and revealing low-relief carvings of an angel and trumpet near the top corners of the ledger. Next, large, loose portions of the cleansed ledger were carefully set aside to allow brush and water cleaning of the cement base on which the ledger rests. Roots and vines growing upwards from within were then gently pulled and removed where visible. A dry brush and small wire brush were used to clean and prep the edges of the large disarticulated portions of the ledger for a two-part epoxy binding. The epoxy mixture was applied to these edges, reattached, and then clamped to set. Acetone was used to eliminate any evidence of epoxy mistakenly bonded to the surface of the ledger. Once the epoxy mixture had cured, a two-step jahn application was applied to the surface cracks of the ledger, left to dry and then carefully smoothed flush. The surface of the ledger was then wiped clean with water and a soft sponge.

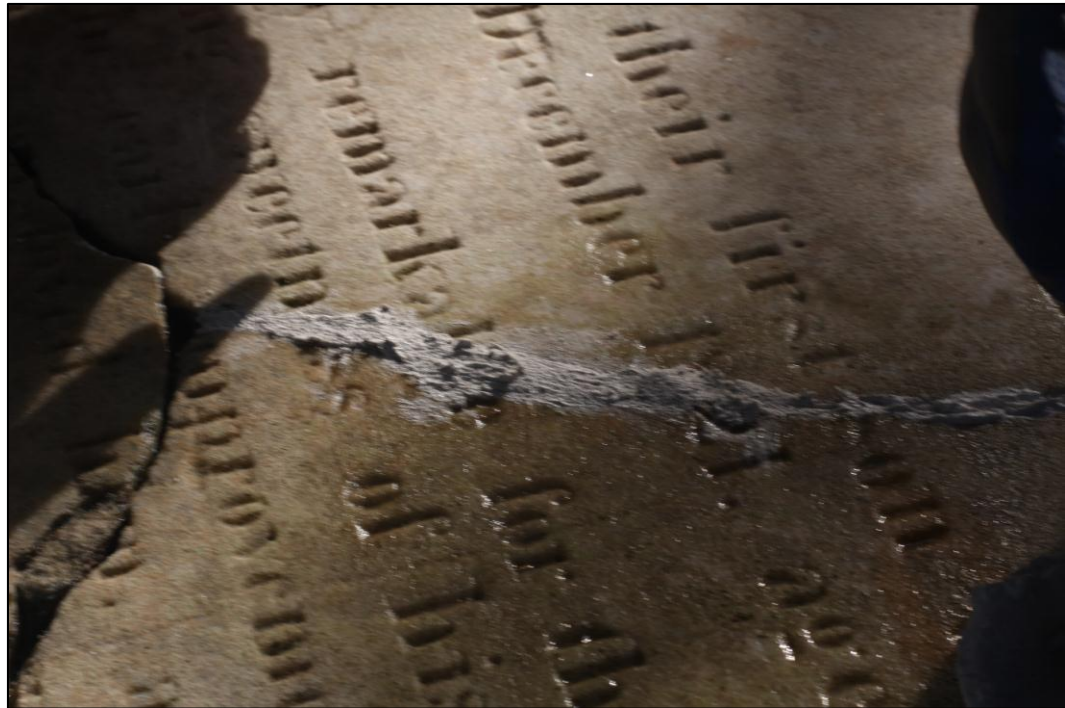
Application of Jahn
