# The Progressive Club

Johns Island, South Carolina

Preservation  
Studio  
Spring  
Term  
2015

Graduate Program in Historic Preservation

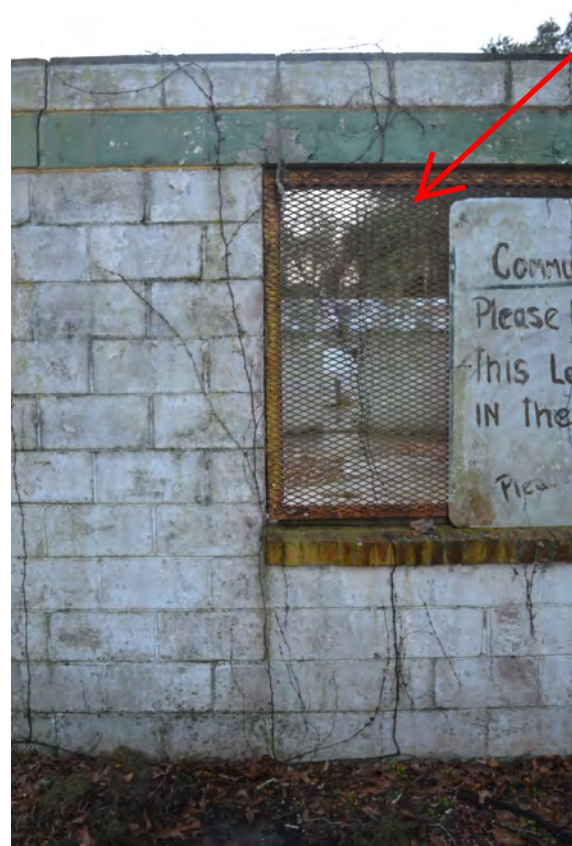
The metal diamond grating that has been inserted into the large window on the northern facade is rusting, causing staining on brick window sill and surrounding CMUs.

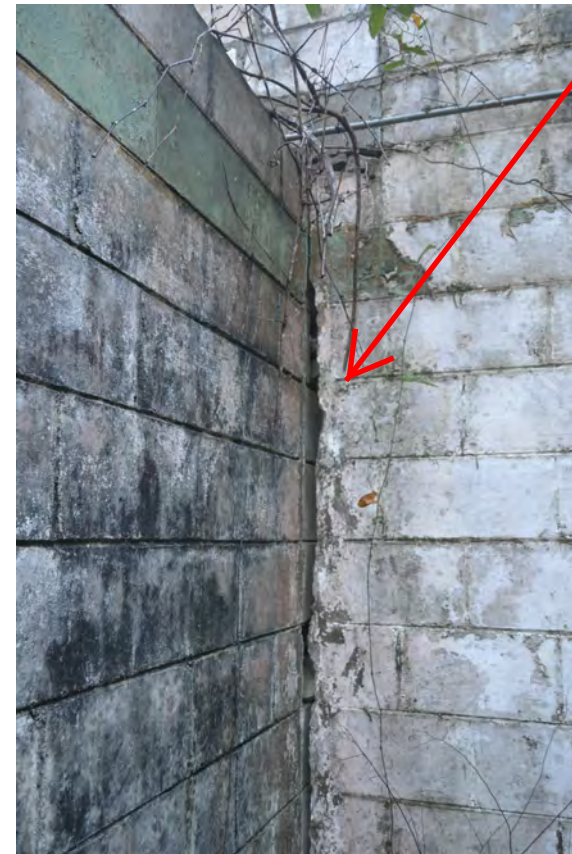
This large crack in the northern wall is where the original grocery store area is pulling away from the gymnasium section. The crack is also visible from the interior bathroom space.

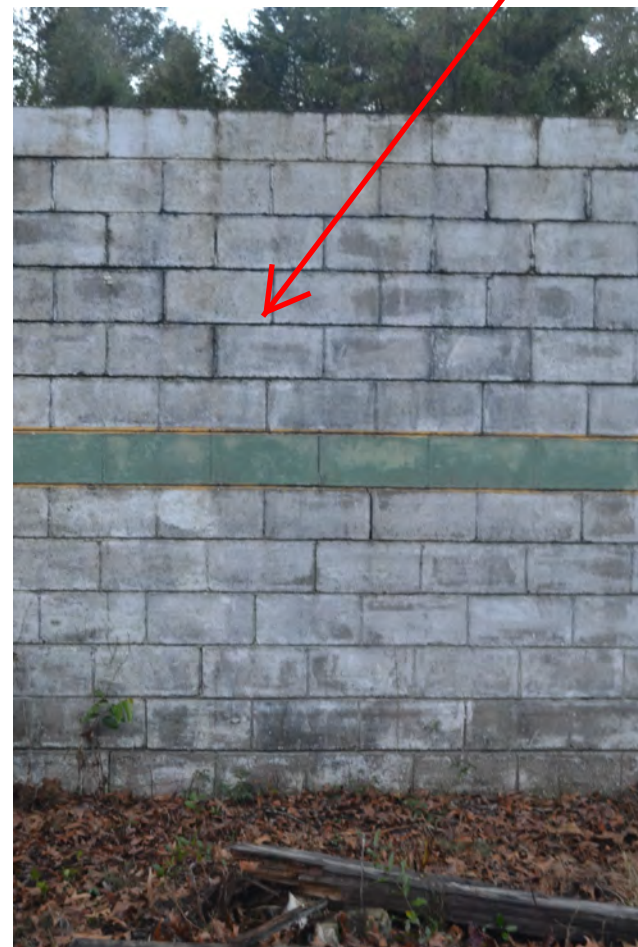
The east exterior wall has a large stairstep crack running two thirds of the wall height.

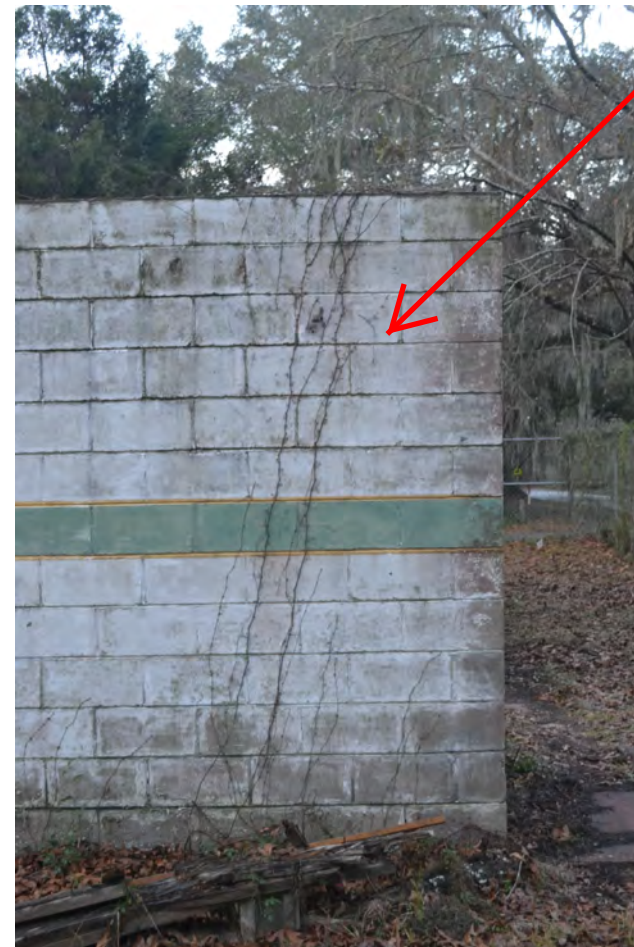
The northern corner of the east exterior wall has a large amount of biogrowth. If not removed the vines will continue to weaken the structural integrity of the wall.

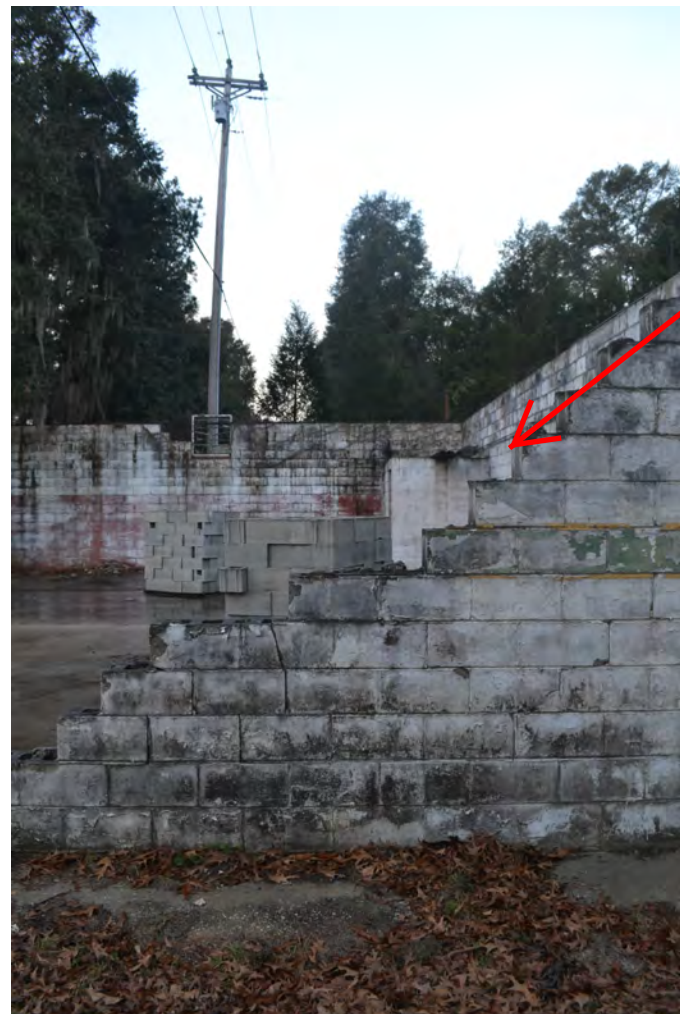
The east exterior wall of the large gathering space has lost all strength after collapsing. The remaining sections of wall are cracked and are susceptible to failure at any time.

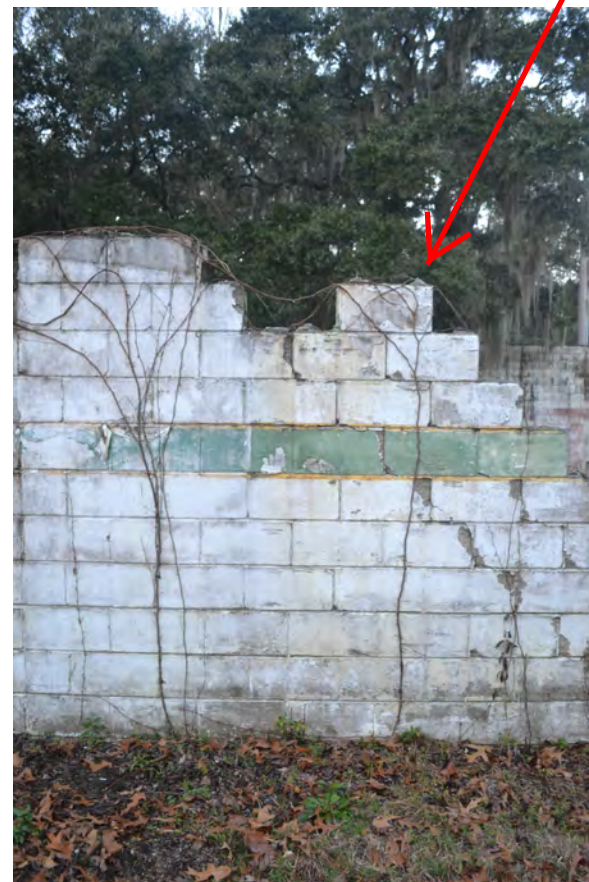
The eastern wall of the dormitory space is cracked under the sill and debris is sitting at the foundation. Portions of this wall have already fallen.

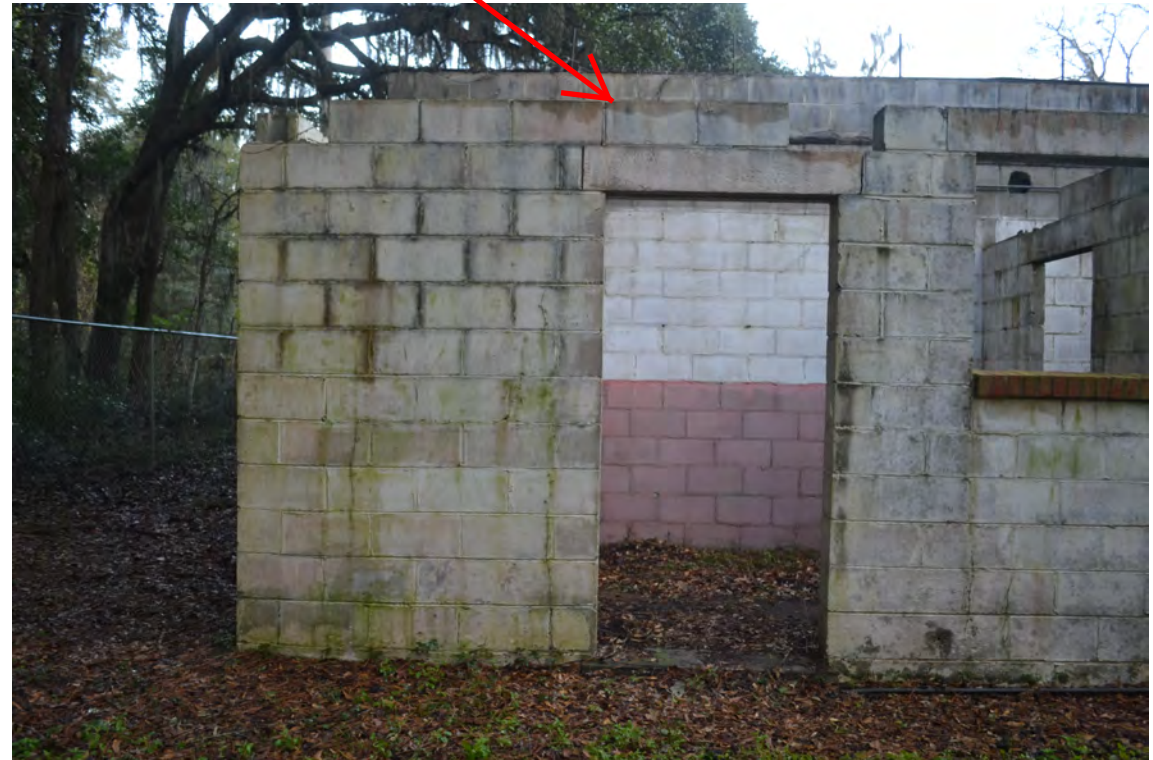
The dormitory walls are not tied in to the main structure and sections of wall are falling off leaving cracks and holes in the interior and exterior walls.

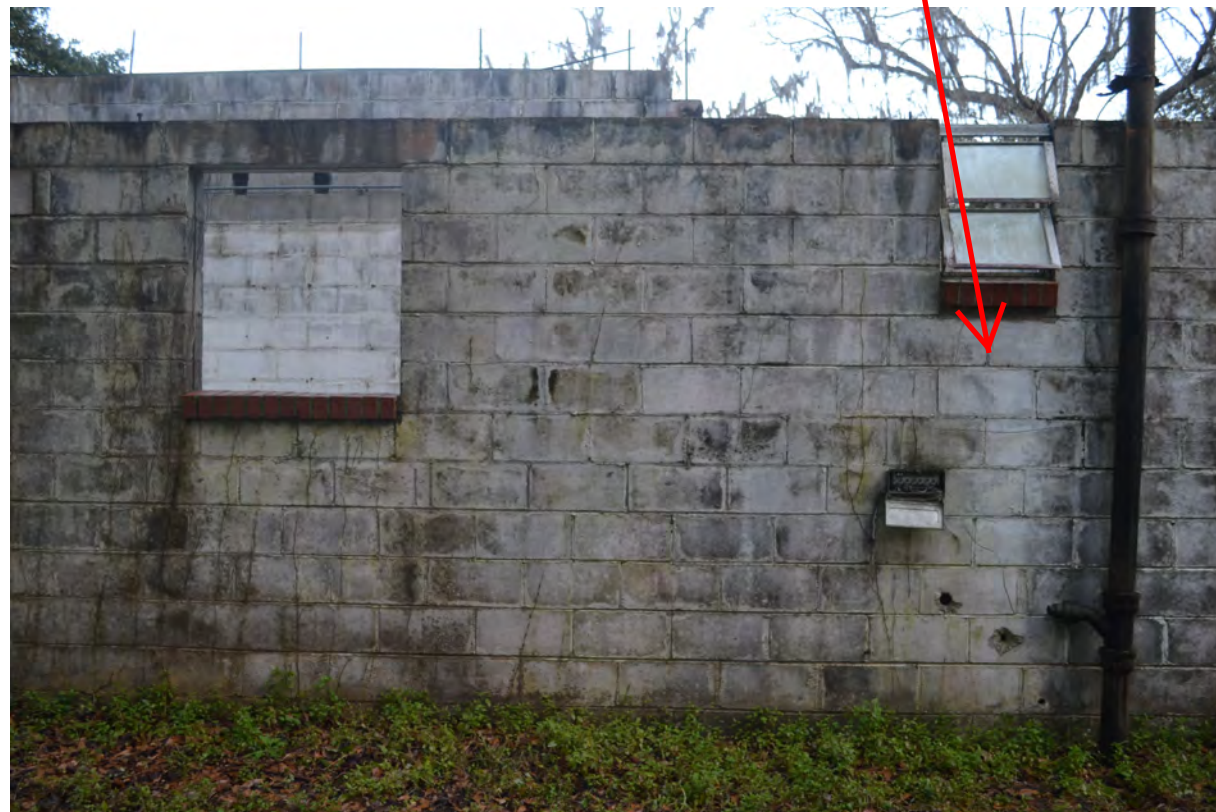
The south exterior wall is not tied in to the main structure and additions of pipes and electrical boxes to the exterior have rusted further weakening the structural integrity of the CMUs.

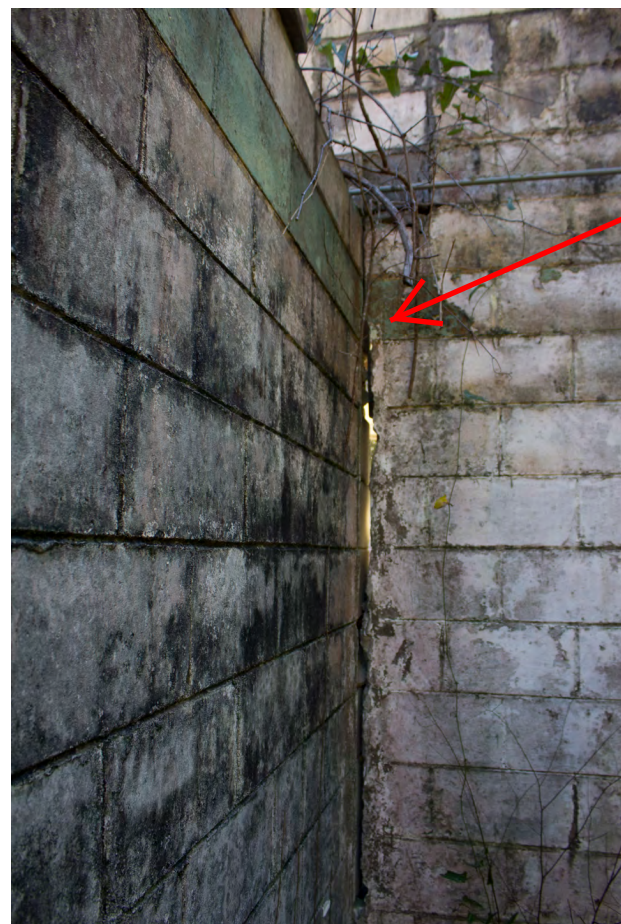
The front store area was not tied into the addition of the gathering space. The walls are separating and a large crack has formed. Although the gathering space wall is held by a tie rod, the wall and intersection are very unstable.

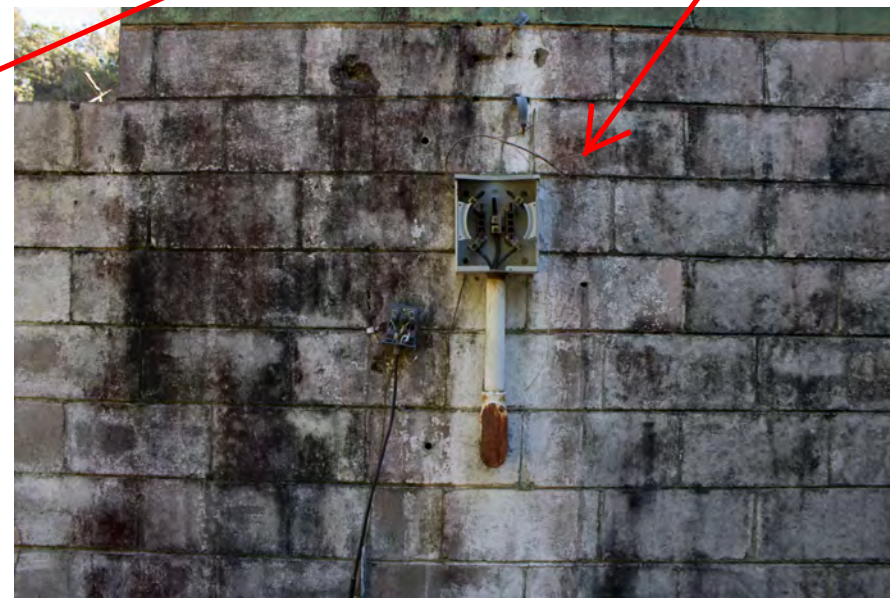
An electrical panel attached to the wall weakening the CMUs and causing staining. This wall gets very little sun and black mold is prominent along the west wall.

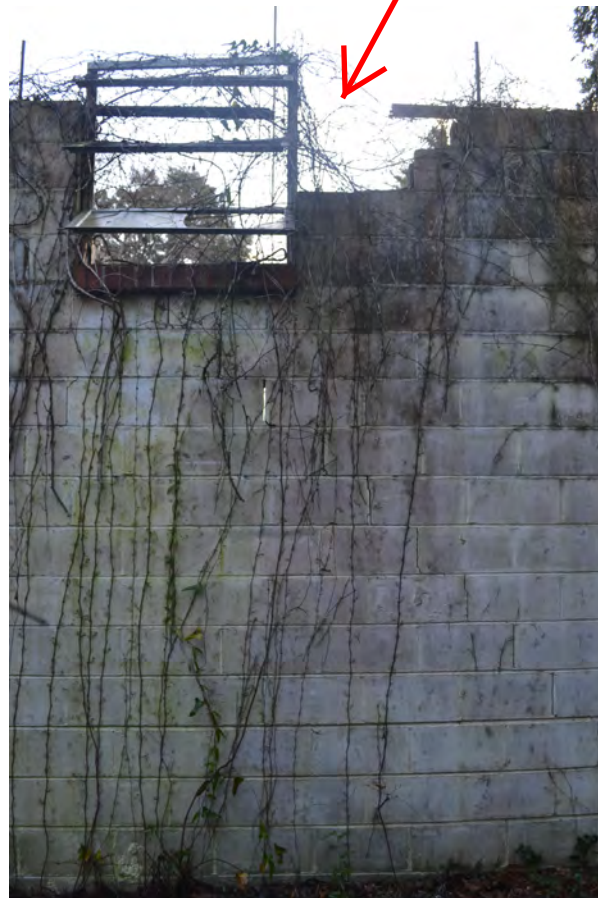
The west exterior elevation is bowed outward. This was likely caused by the collapse of the roof, leaving nothing to support the wall. Tie rods were added in two areas in 2008 to aid in supporting the wall, however, the invasion of vines along the wall and soft ground have added to the instability of the wall.

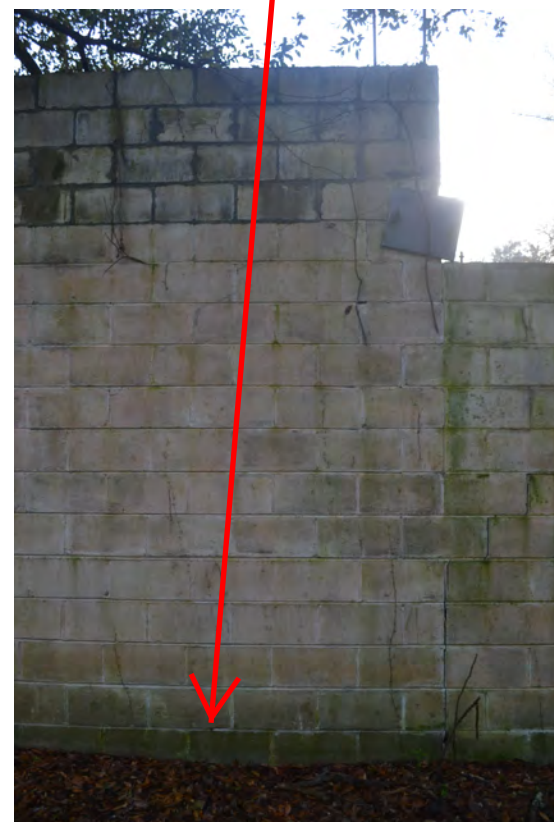
Low point in ground plane that is exposing the foundation and likely a source of the crack under the window.

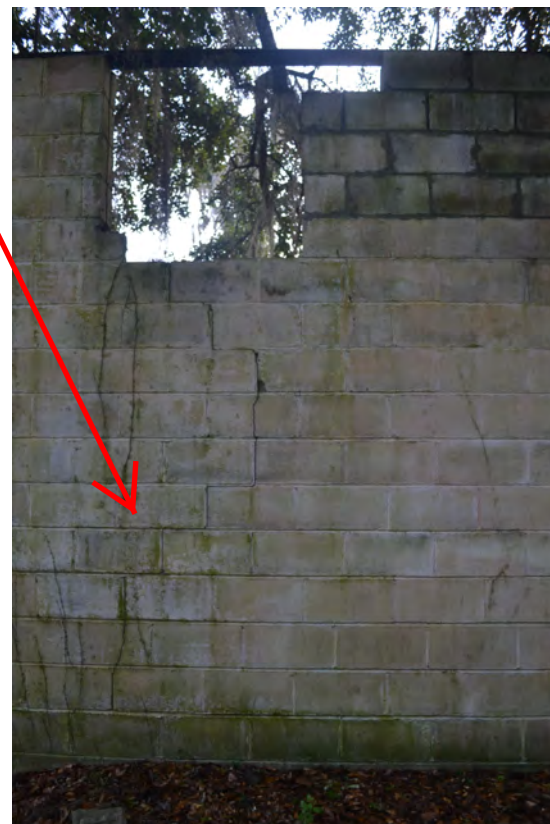
Large stairstep crack extending from the window to the foundation. Vines growing near the crack help it spread and allow for water intrusion.

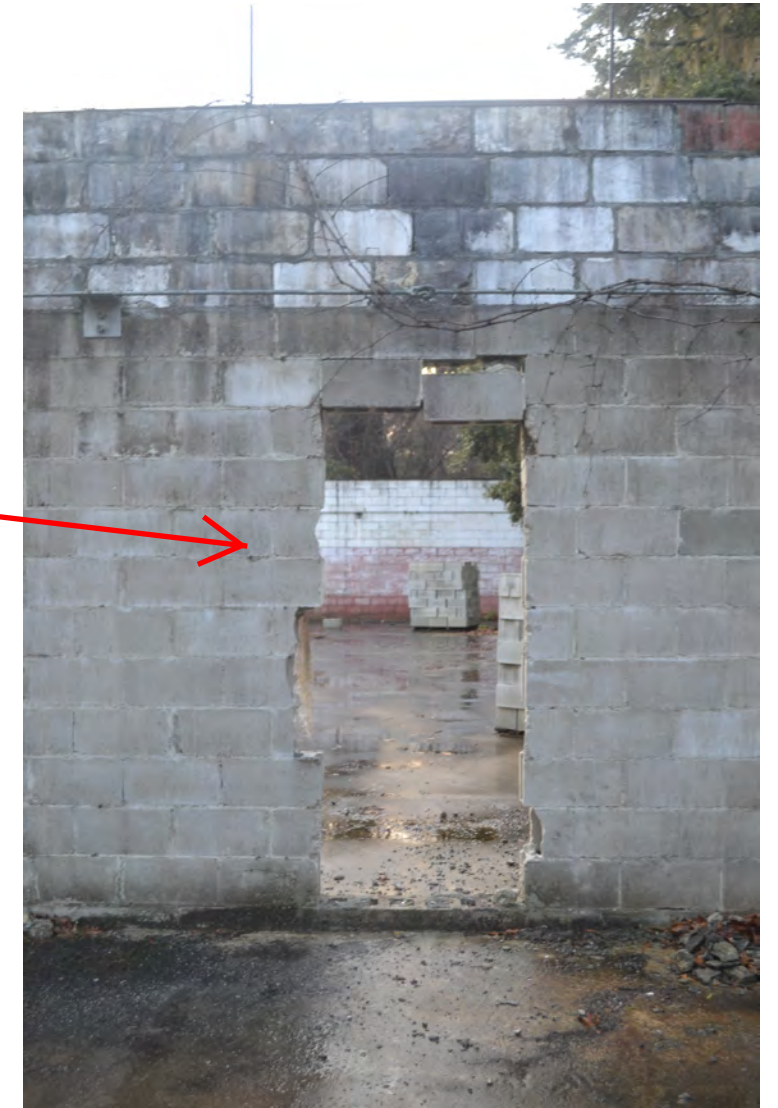
There are also places where a new window or door opening has been cut through the existing concrete walls without installing any sort of lintel. Since the structure was built without any horizontal reinforcement, the CMUs directly above these openings are totally unsupported. Most concerning is the doorway cut between the commercial space and the gathering space, where an unsupported concrete block has already begun to slip and is certain to fall (see page 14 of the Condition Drawings). This poses a serious life safety issue. This opening, as well as the others, must be properly supported to transmit the gravitational loads across the opening and secure material at the head of the opening from falling.

Opening between store and gathering space that was cut through the CMUs after original construction. The opening has no reinforcement and CMUs are starting to come loose creating both a structural and safety hazard.

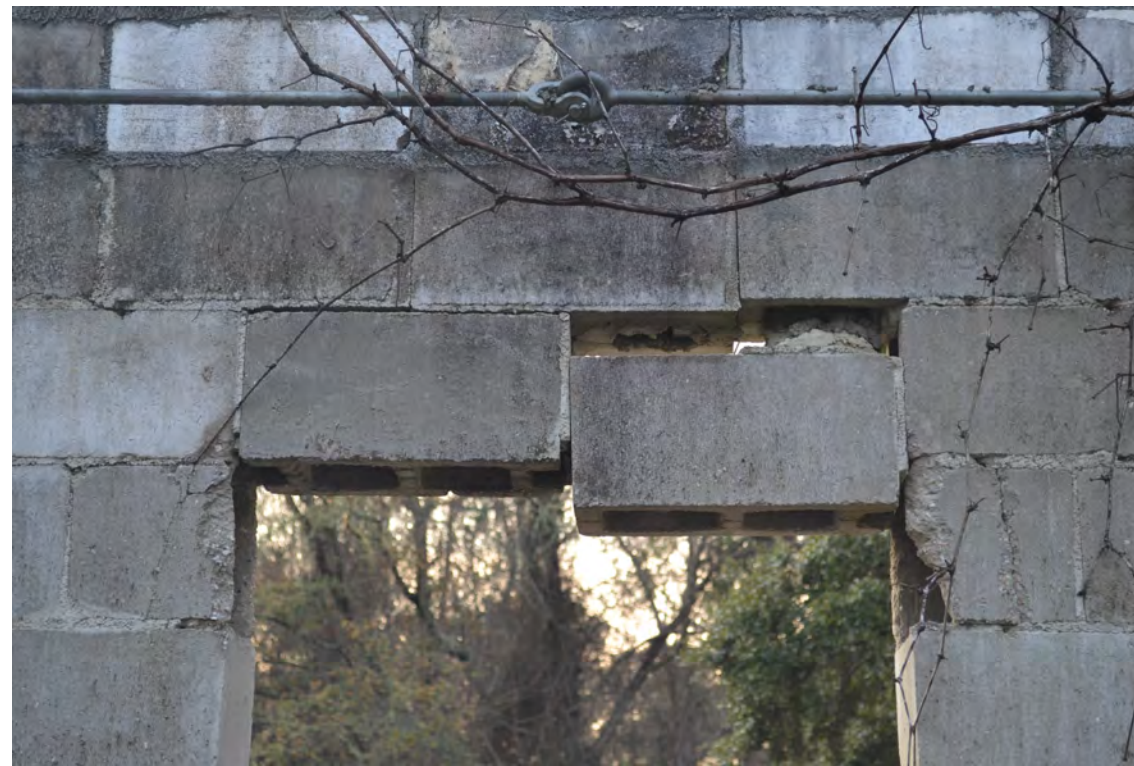
Detail of top of opening.

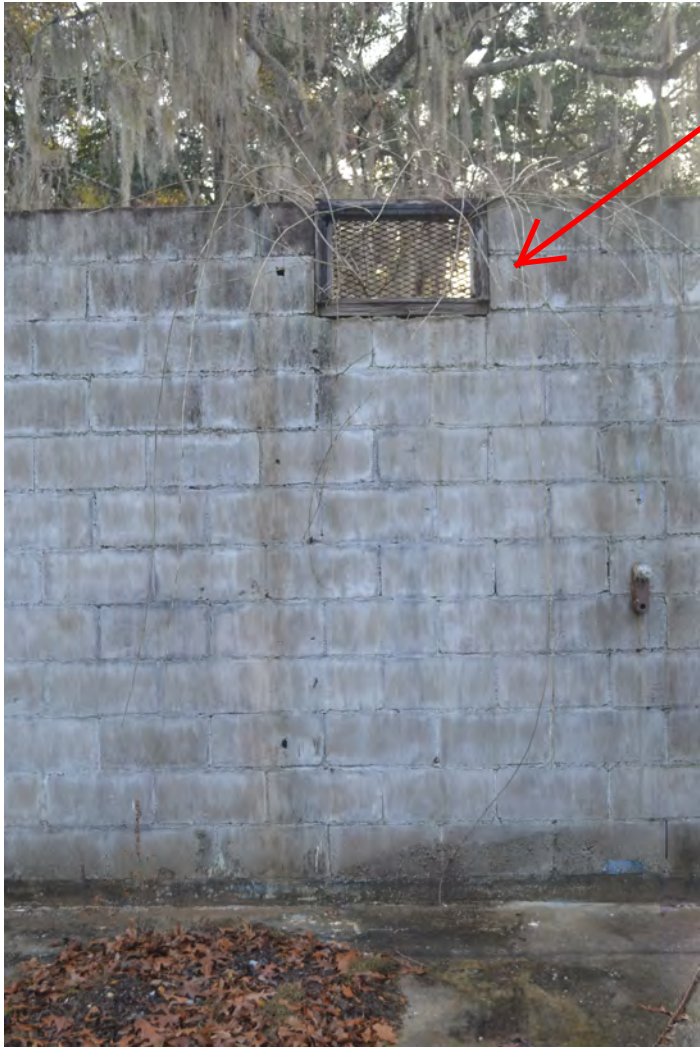
Metal diamod grating in original window opening is rusting and causing staining on the wall. The adjacent oak tree is starting to send branches through the grating.

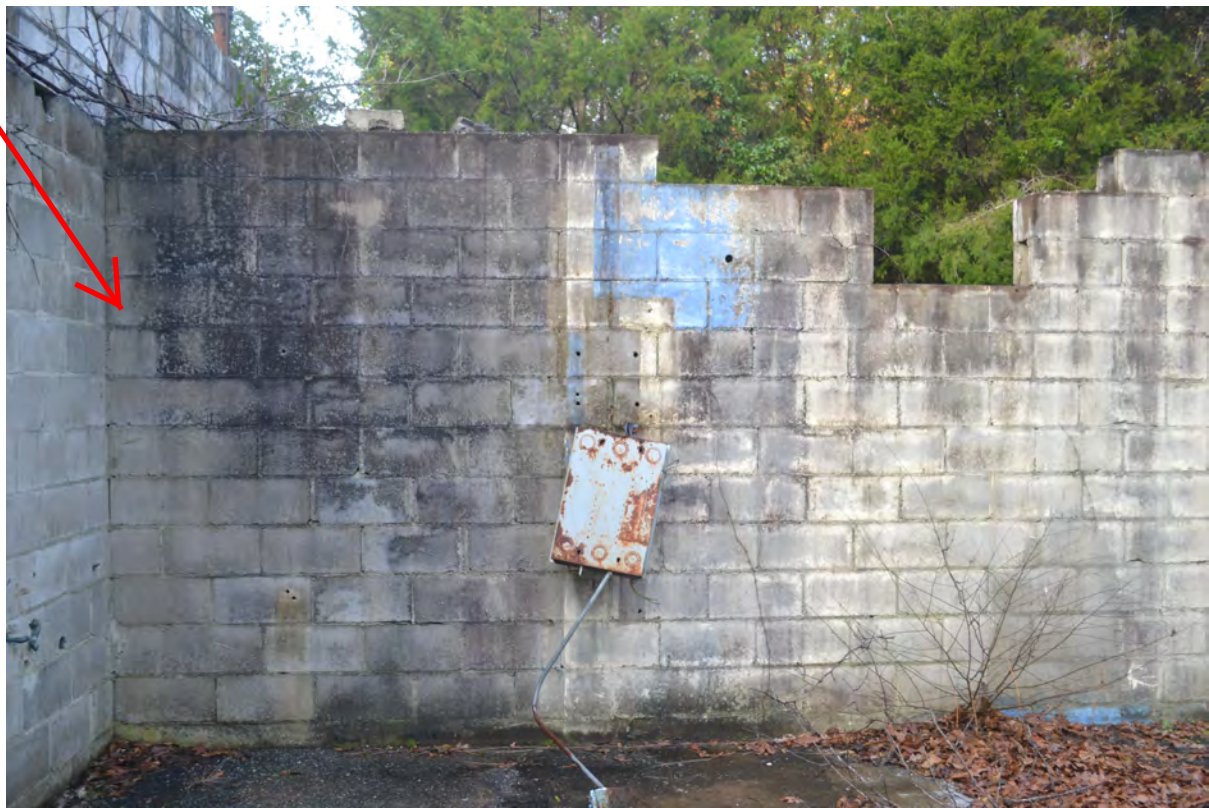
This wall of the store is not tied in to the wall it shares with the gathering space. There is a large crack where the two walls meet and this wall is beginning to bow outward.

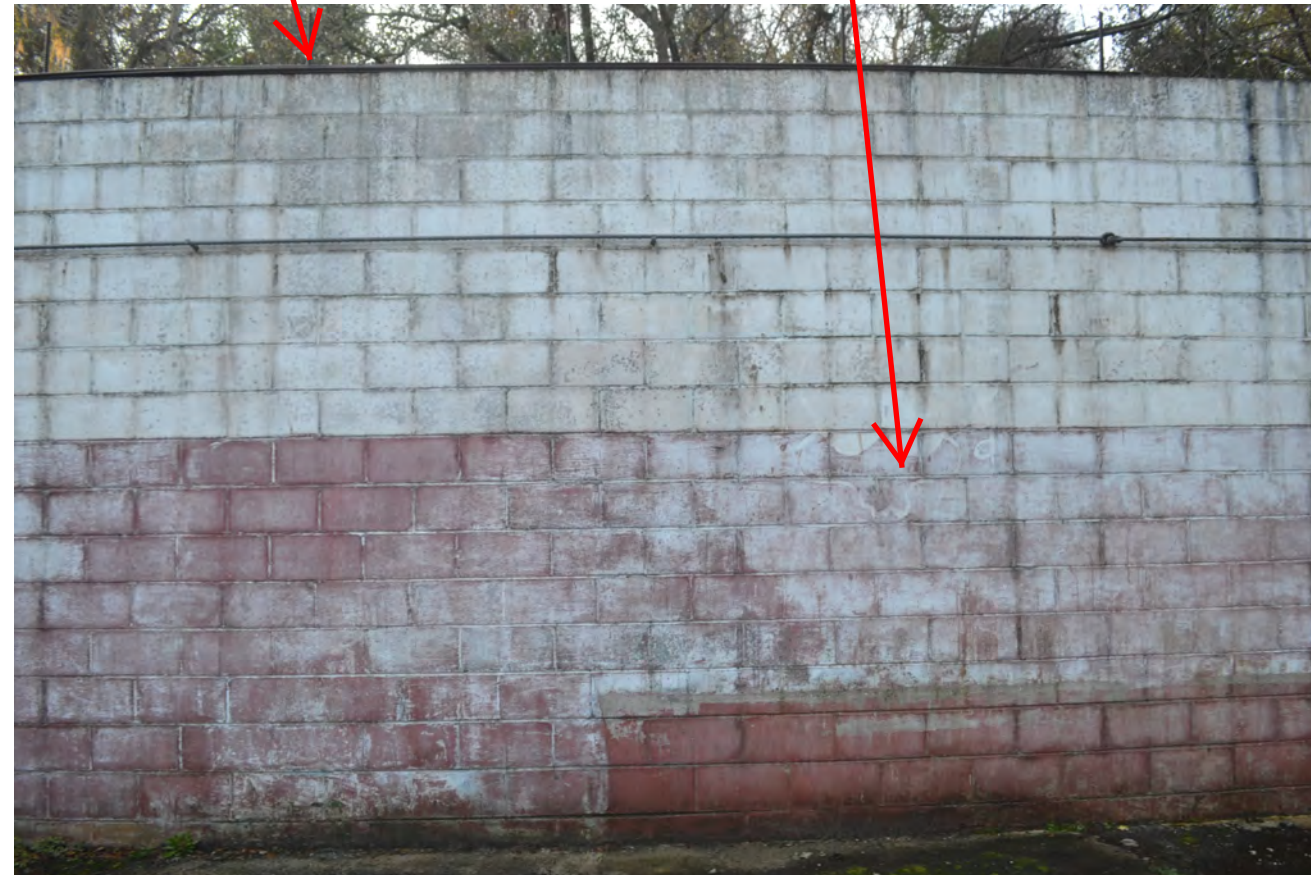
An attempt to clean former graffiti off the wall has left a residue and washed out stain resembling sand blasting. Additionally, the rebar placed along the top of the wall is rusting and causing stains.

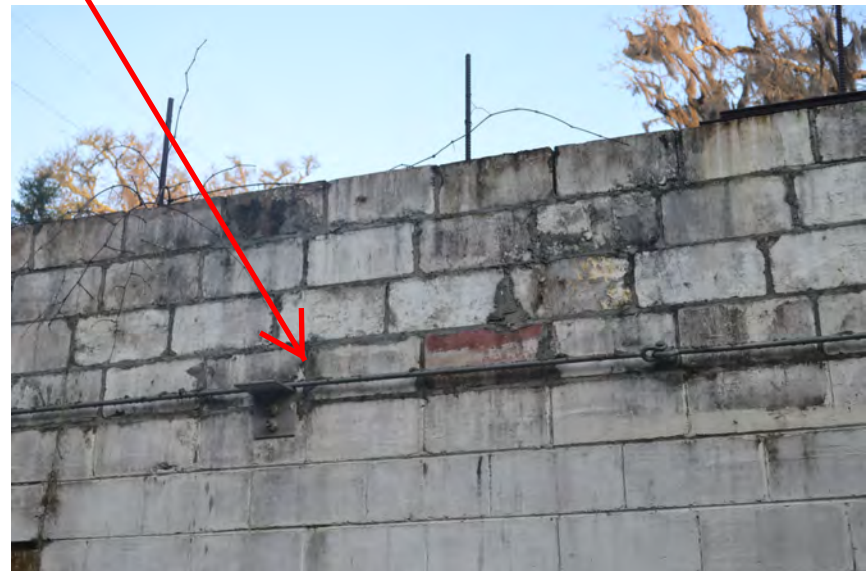
Improper cement repairs at the upper portions of the wall are visibly failing and causing blocks to shift.

Large cracks are visible in both bathrooms and are structurally concerning as they connect to the exterior frame of the building.

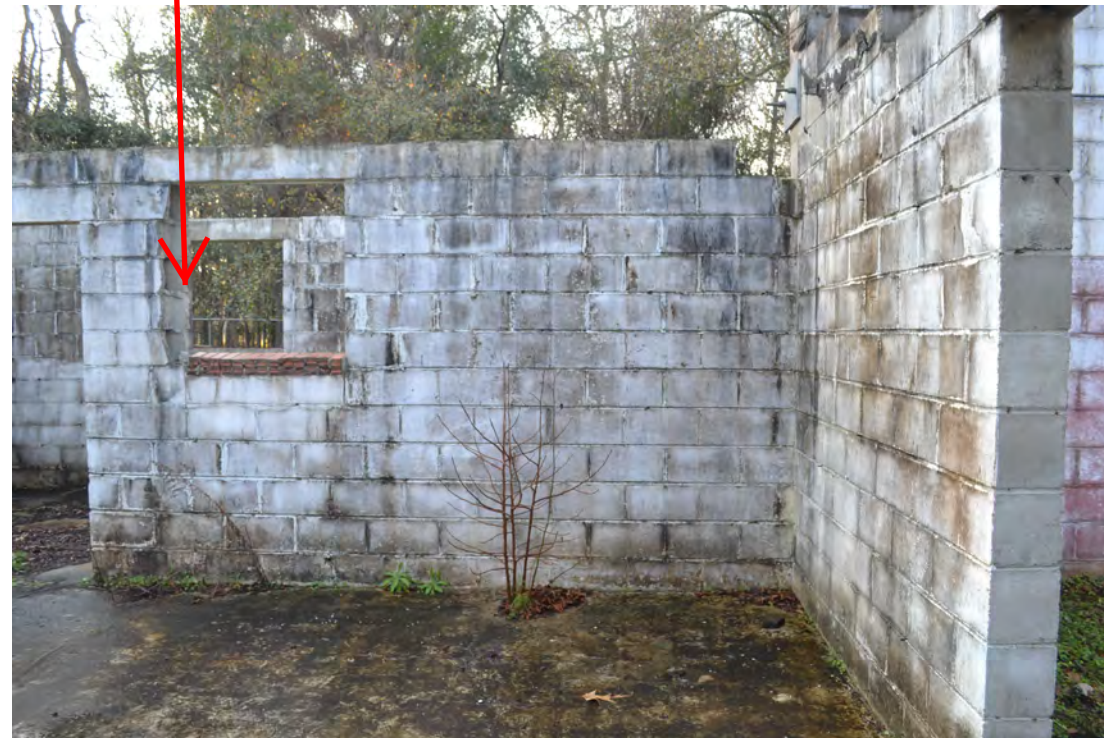
Wall 10

The sun porch has been greatly exposed to biogrowth and plants, which are interrupting the joint where the wall meets the foundation.

Additionally, the window is causing significant issues. The brick sill is loose and there is a large crack forming underneath it. The left portion of the window has been roughly cut diminishing the structural integrity of those CMUs.

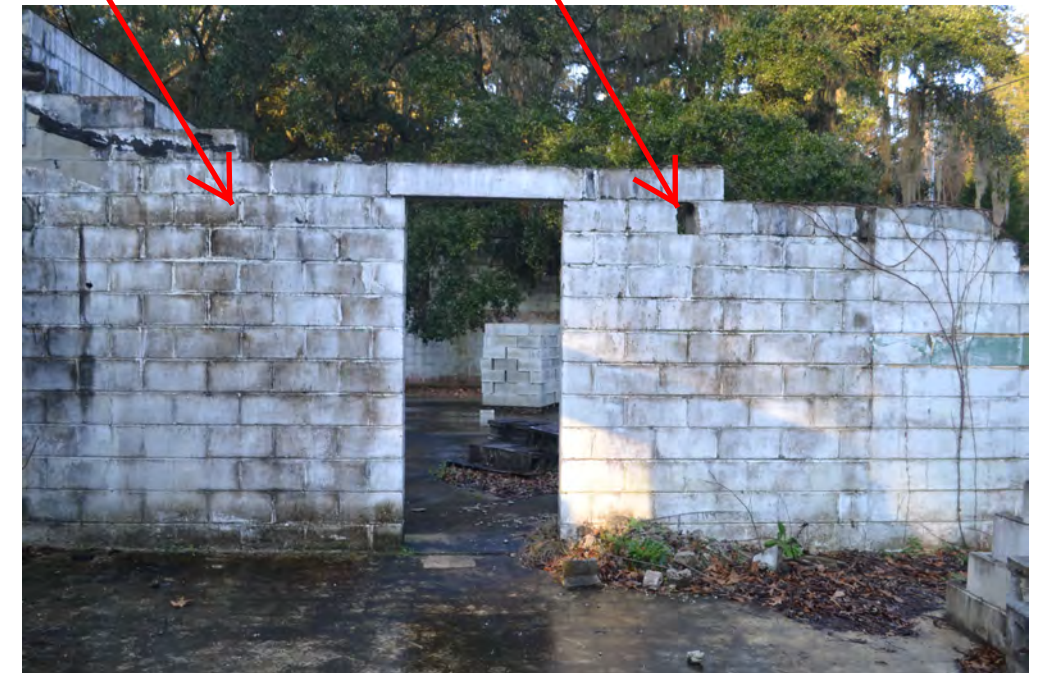
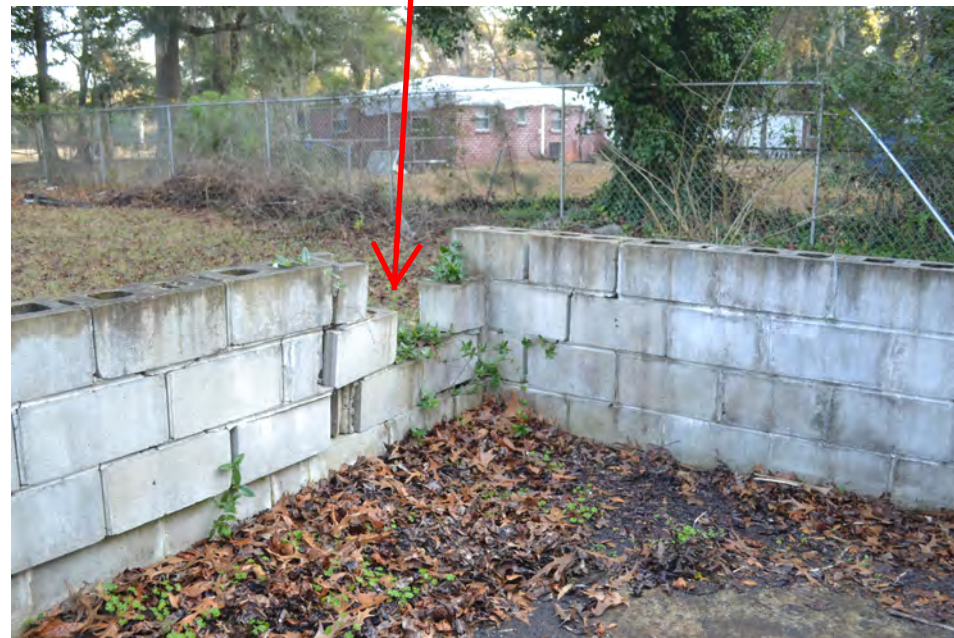
Wall 12

Potentially due to the collapse of its roof, the sun porch is extremely structurally damaged. The corner of the low wall is being overcome with plant growth, causing the CMUs to shift considerably due to the plants' roots.

Missing CMUs and large upper cracks also express concern for a wall collapsing or the door lintel moving in the near future.

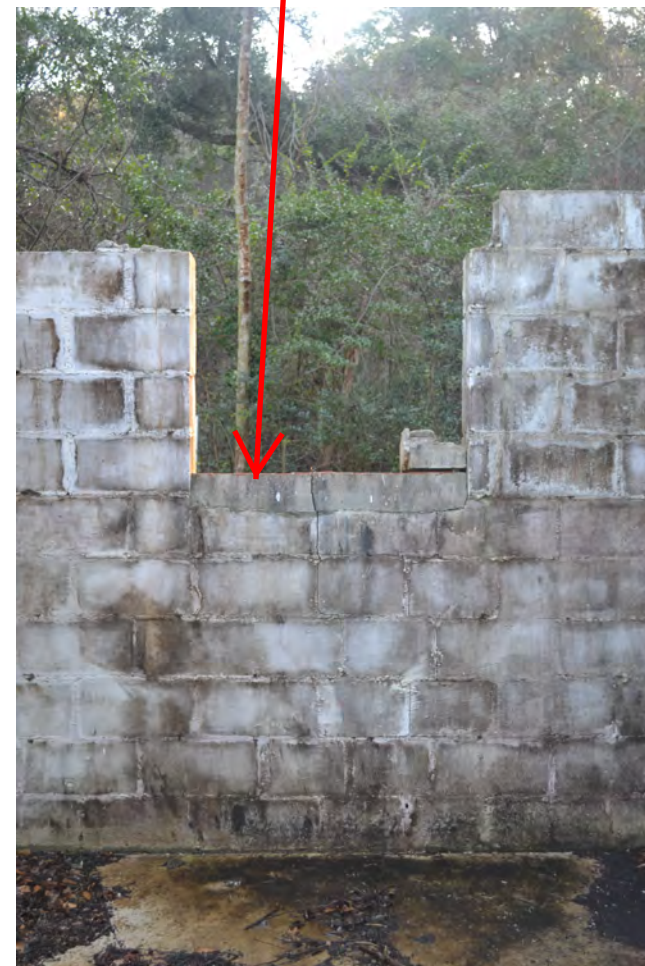
Wall 14

Biogrowth is affecting all the walls and floor of this room. Black mold can be easily seen on the walls. This can be contributed to the lack of sunlight that reaches this portion of the building due to overhanging trees.

The loss of a lintel has caused CMUs to be exposed consequently allowing more to fall off the top of the wall. The brick sill on the window is sloped outwardly and down at an angle not originally intended. This stress is causing a crack beneath the window opening which will potentially develop further.

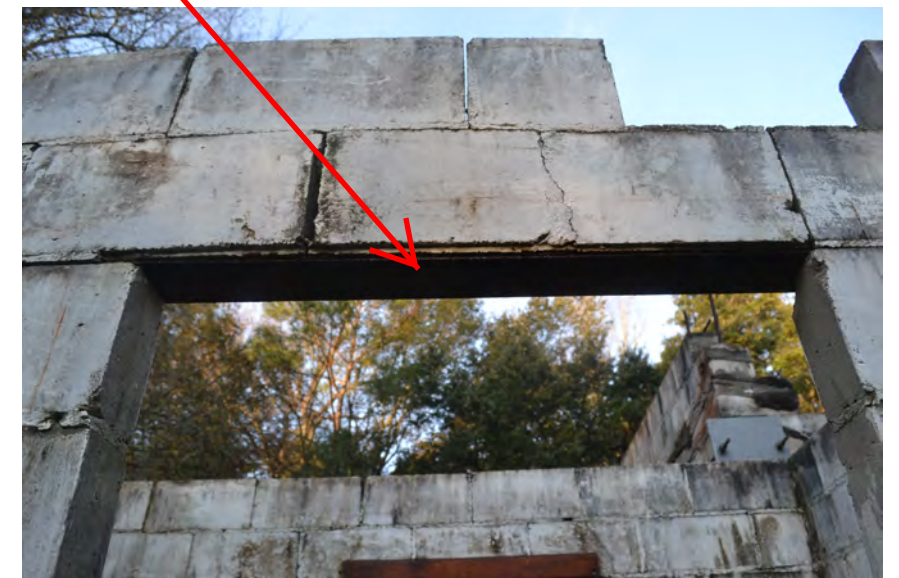
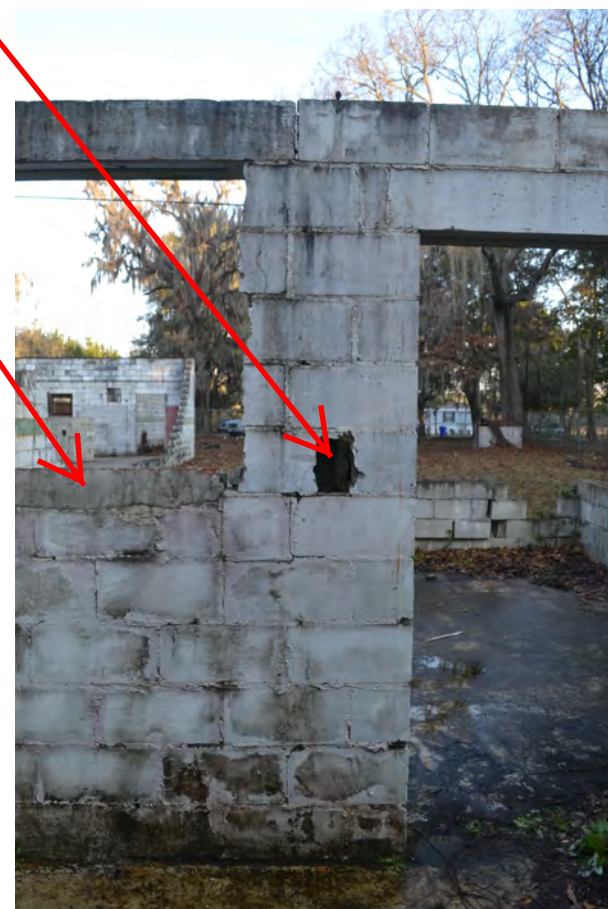
Throughout the dormitories and bathrooms in the back of the structure, metal lintels have been placed at the doorways. They are severely rusted and corroded, posing potential failures. Some iron staining is also detected at the sides of the doorways.

The structural integrity of the CMUs has be compromised by rough cutting the window opening, as well as the large hole near the door. Rust staining from previous iron intrusions are detected across the wall.

The rough window opening causes future concern for the position of the lintel overhead.

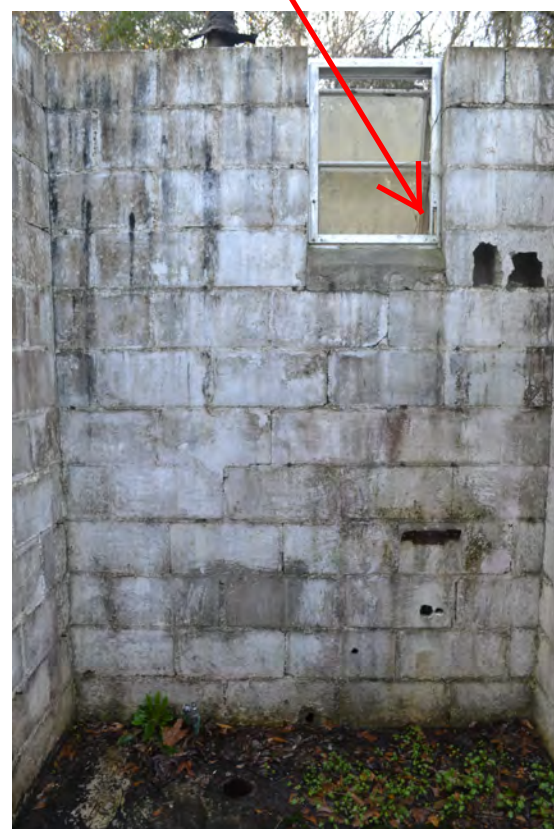
Wall 18

Two holes have been punched through an exterior CMU wall diminishing the structural integrity. The wall has other staining from mold and rust caused by the metal clip.

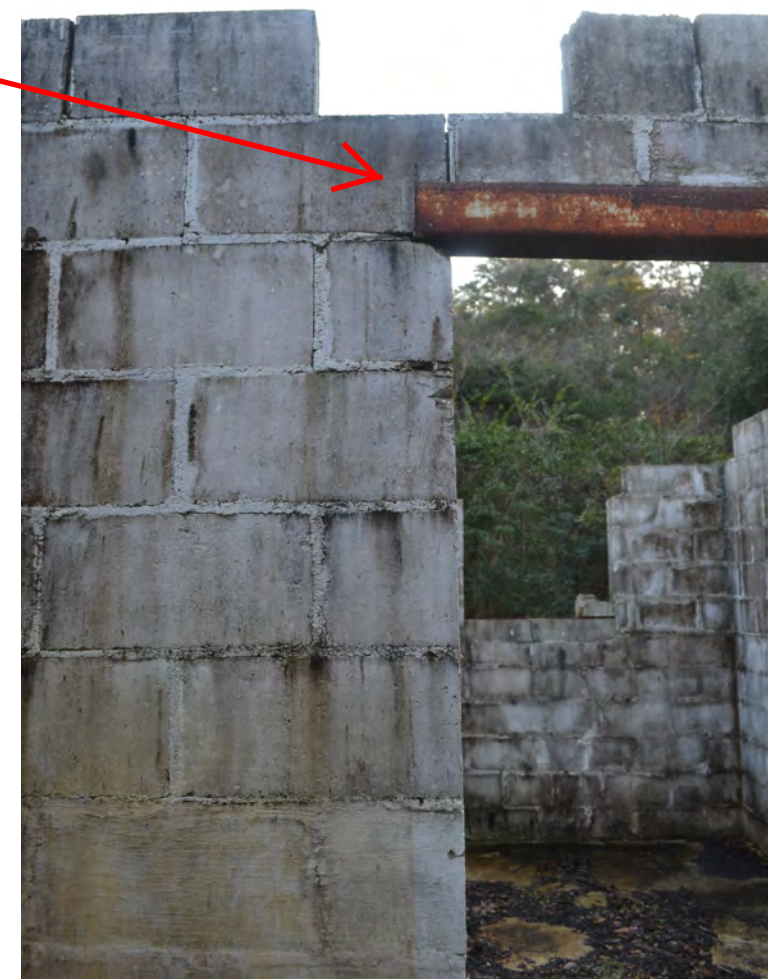
Metal lintel is rusted and the natural expansion of the metal has shifted some CMUs above the doorway out of plumb.

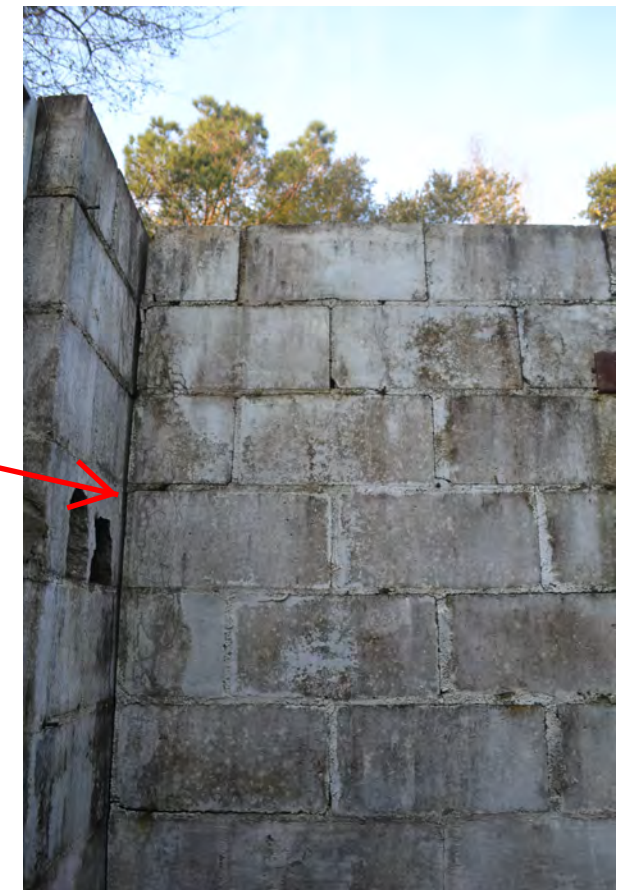
Interior wall is not structurally tied to exterior. Separation where two walls meet is visible. Section of wall is susceptible to imminent collapse.

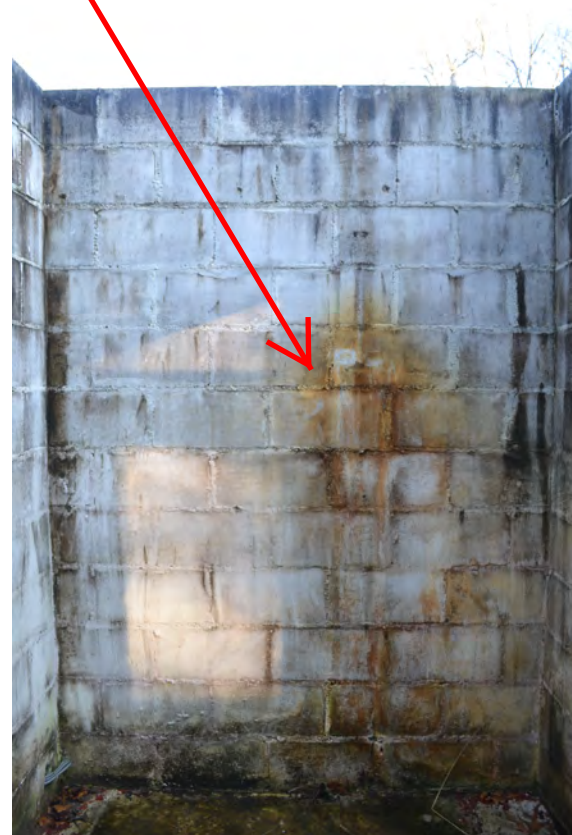
An unknown stain/chemical reaction has occurred on this wall. The stain is raised from the surface of the CMU and has a thick consistency.

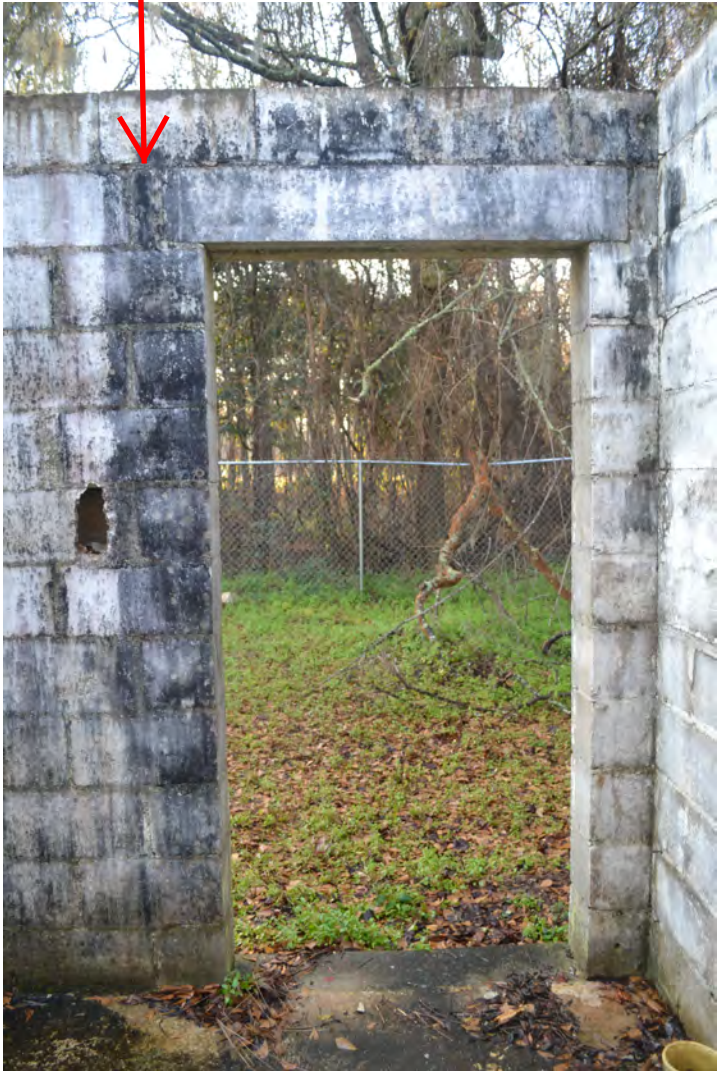
Detail of rusted metal lintel supporting CMU's above doorway. Expansion of metal plate has caused some CMUs to shift out of plumb.

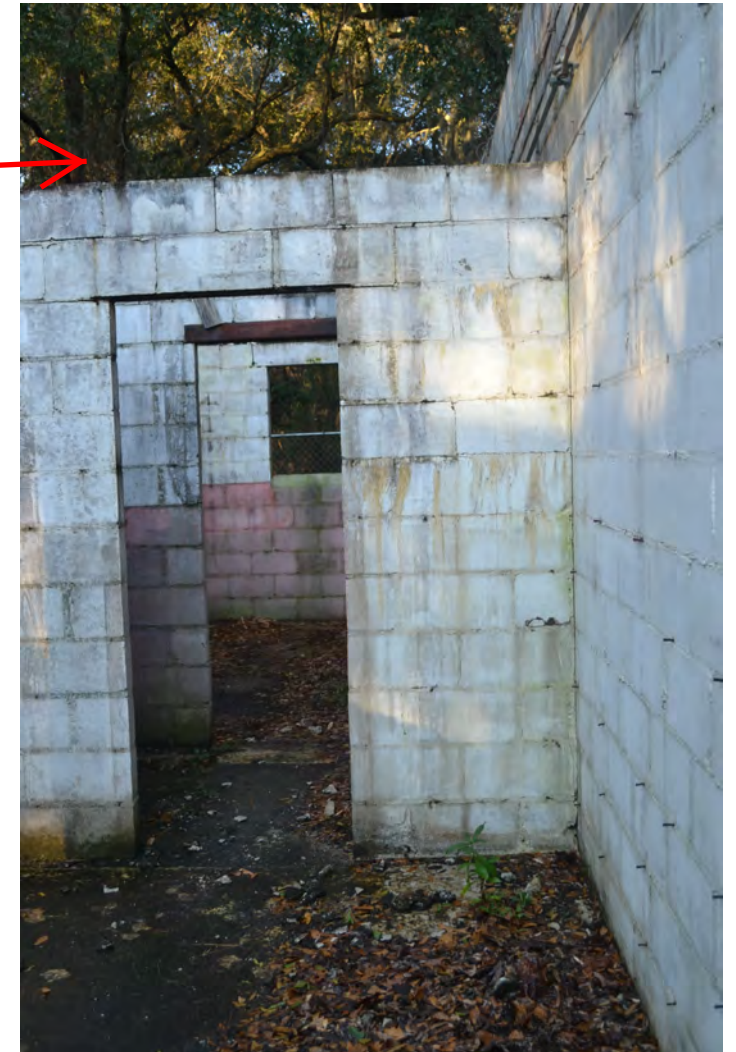
Wall 28

Metal plate supporting CMUs above doorway is rusting. This causes staining and the plate has also expanded, pushing CMUs out of plumb.

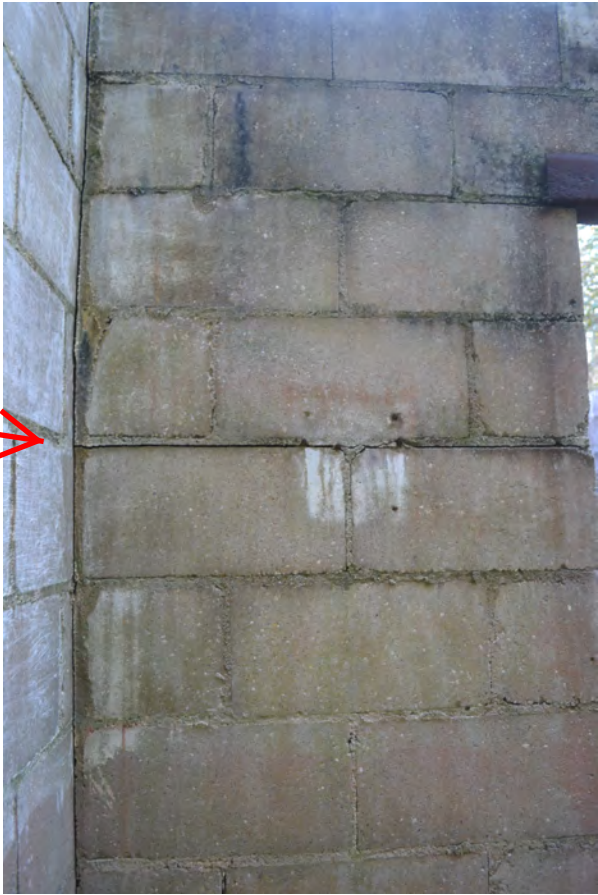
Wall 30

Wall is not tied to exterior walls and a crack spans to the doorway. The top portion of this wall could collapse at any point.
