# The Progressive Club

Johns Island, South Carolina

Preservation  
Studio  
Spring  
Term  
2015

Graduate Program in Historic Preservation

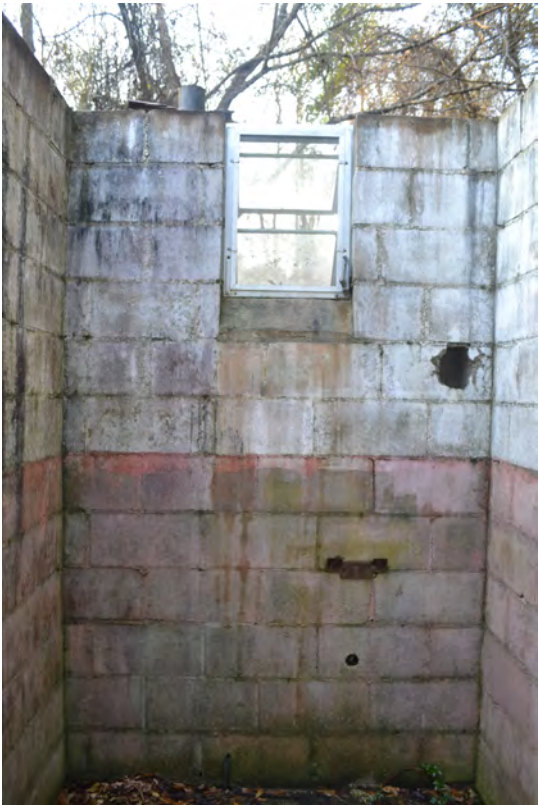
This wall has staining from the window and metal clip. A hole has been punched through one CMU, greatly diminishing the structural integrity of that area of the wall.

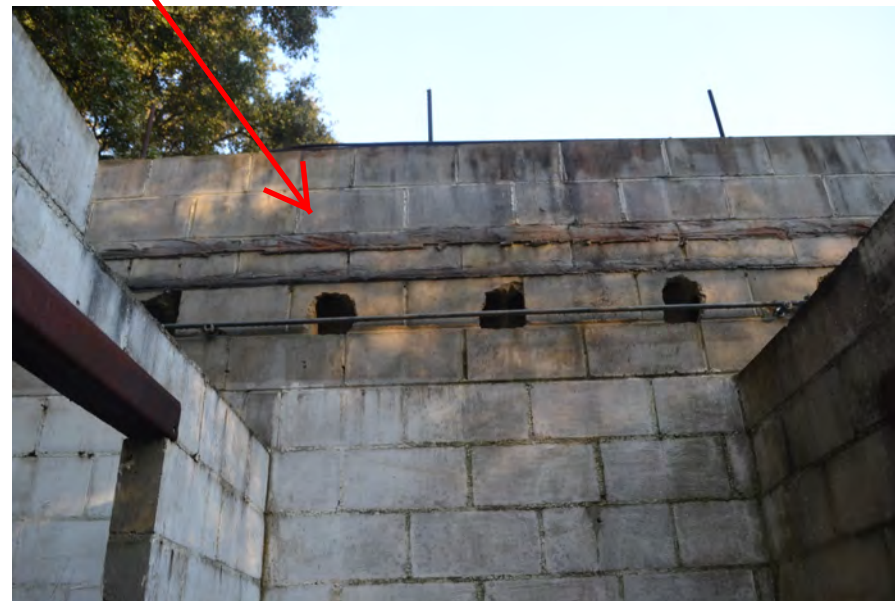
Wall has large holes that are likely rafter pockets from the roof that covered the dormitory space. A ghost mark was left behind by other roofing materials.

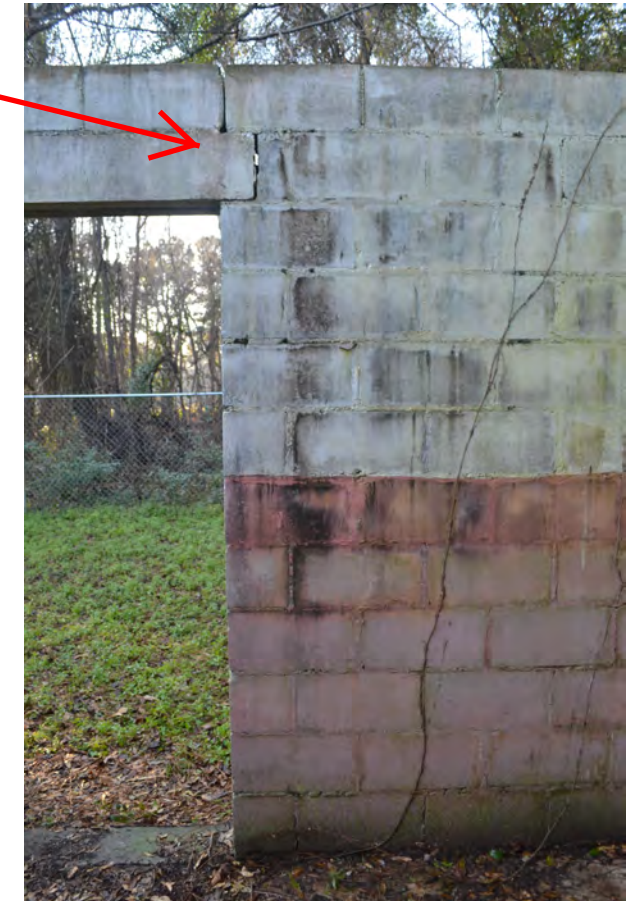
Lintel detail with context of doorway.

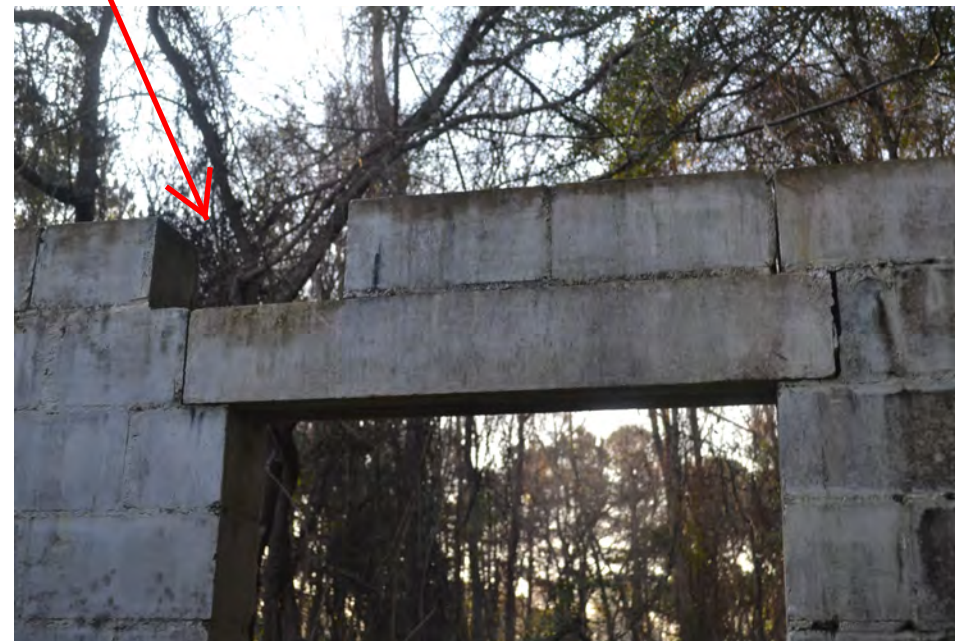
Door frame is missing CMUs and lintel has lost almost all mortar holding it in place. Doorway is a safety hazard due to structural instabilities.

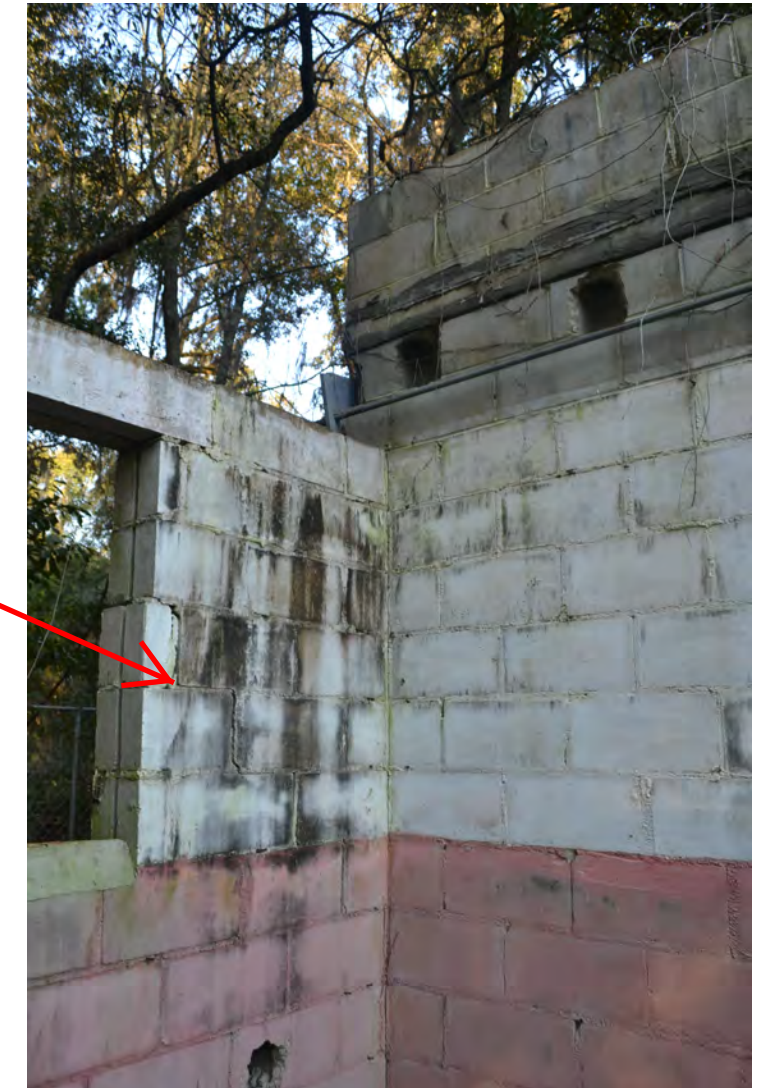
Black mold is present throughout the structure. Large sections of wall receive little to no sun and the surfaces never completely dry out.
