RAMMED EARTH ARCHITECTURE'S JOURNEY TO THE HIGH HILLS OF THE
SANTÉE AND ITS ROLE AS AN EARLY CONCRETE

A Thesis
Presented to
the Graduate Schools of
Clemson University & The College of Charleston

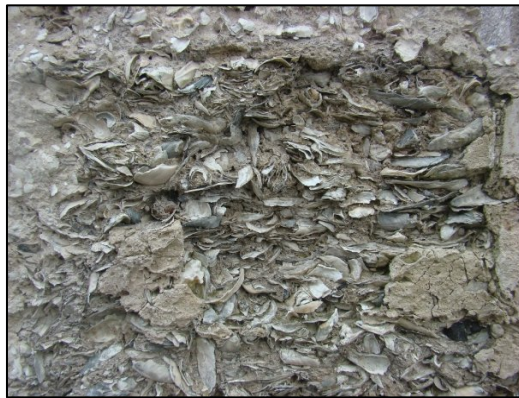
Figure 11. Close view of a tabby wall in Beaufort, South Carolina. (Photo: Author)

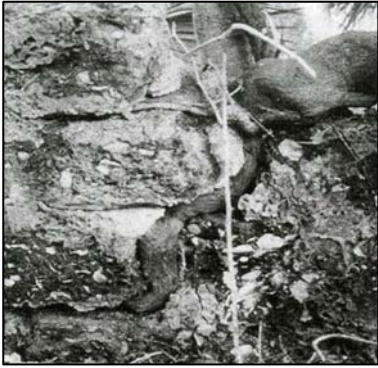
Figure 13. Vine damage in a tabby wall. (Photo: Lauren B. Sickels – Taves.)

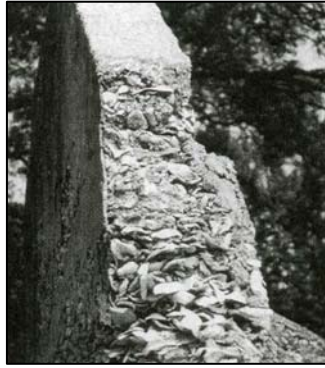
Figure 14. Damaged tabby wall with previous cement repairs at top. (Photo: Lauren B. Sickels- Taves)

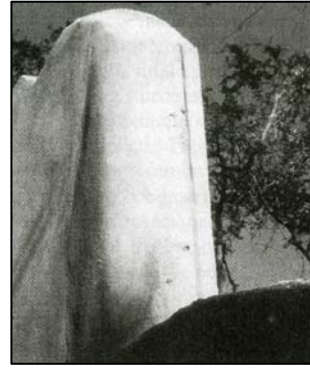
Figure 15. Same wall as in Plate 7 repaired with a new compatible stucco. (Photo: Lauren B. Sickels – Taves)

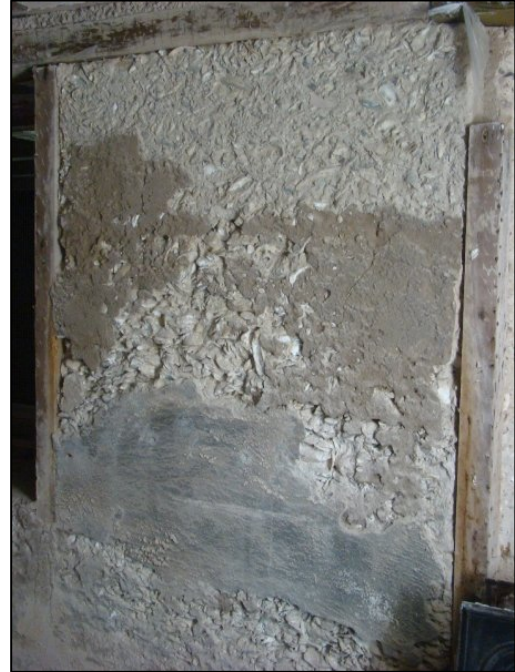
Figure 17. Tabby foundation in a house in Beaufort, South Carolina. (Photo: Author)

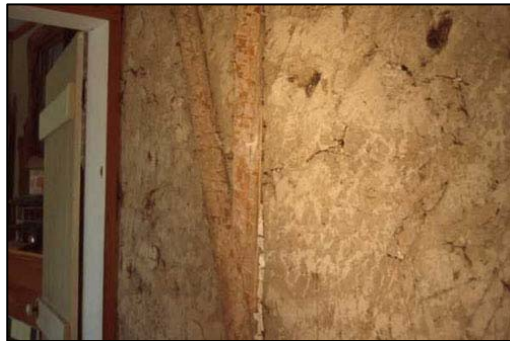
Figure 4. A bousillage wall at the Millet House in Louisiana. (Photo: www.louisianafolklife.org)

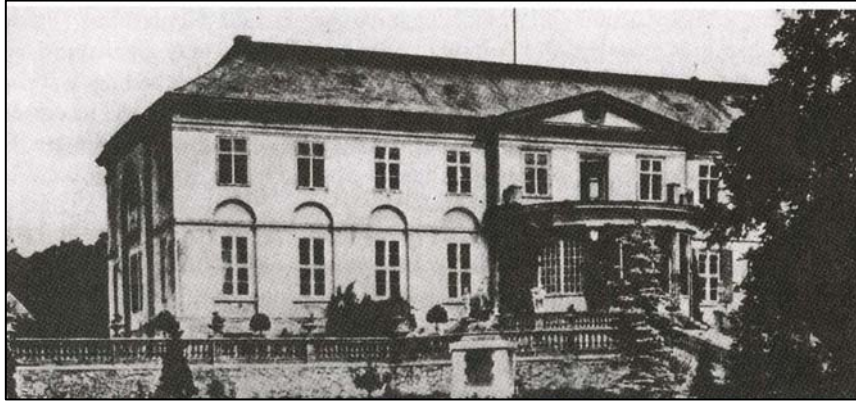
Figure 39. The finished Palace Kleinmachnow in 1919 before sustaining damage during World War II. (Image: Louis Cellauro and Gilbert Richaud)

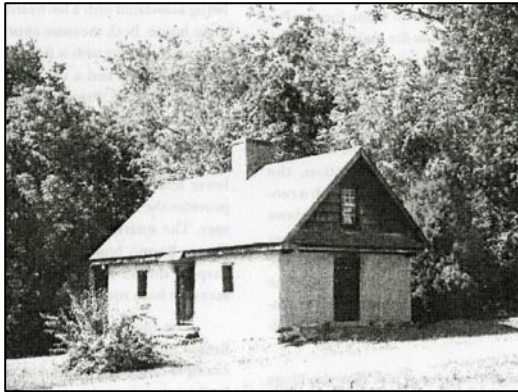
Figure 49. Pisé slave quarters at John Hartwell Cocke's Bremo Plantation. (Image: Gardiner Hallock)

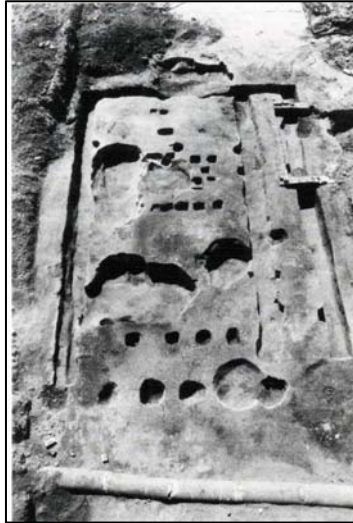
Figure 58. Archaeological remains of Feature 79 at the Judicial Center Site. (Photo: New South Associates)

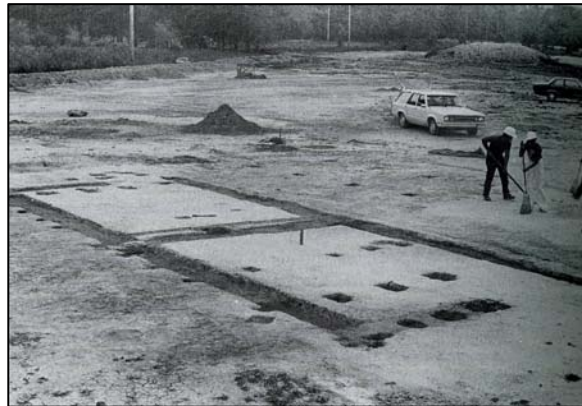
Figure 59. View of archaeological remains of an earth walled house at Curriboo Plantation. (Photo: Leland Ferguson)

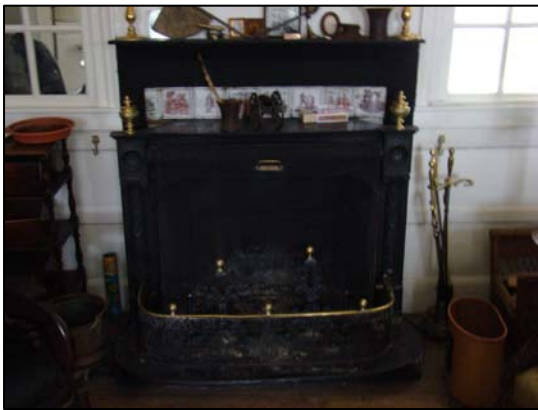
Figure 64. One of the fireplaces that was installed by the Hoopers in the 1790s and replaced earlier fireplaces. (Photo: Author)

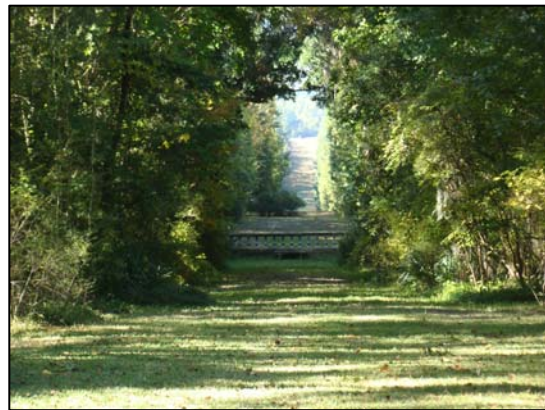
Plate 65. The Broadwalk installed with Mrs. Hooper's English style garden. (Photo: Author)

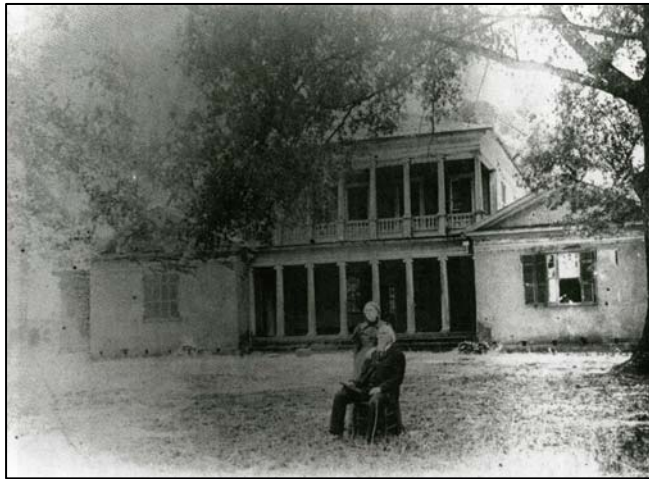
Figure 70. Photograph from the 1910s of Dr. Anderson and his wife on the front lawn of the Borough House. (Image: John Poindexter)

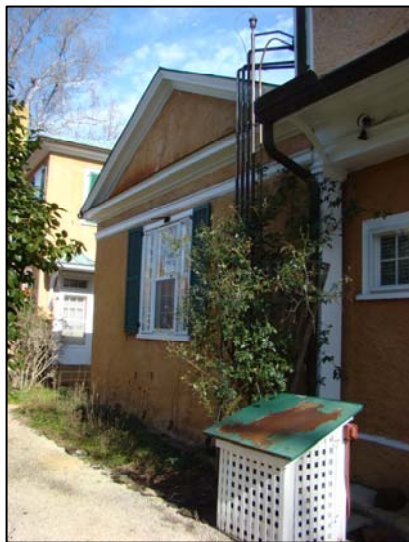
Figure 76. The northern pisé wing of the Borough House.
(Photo: Author)

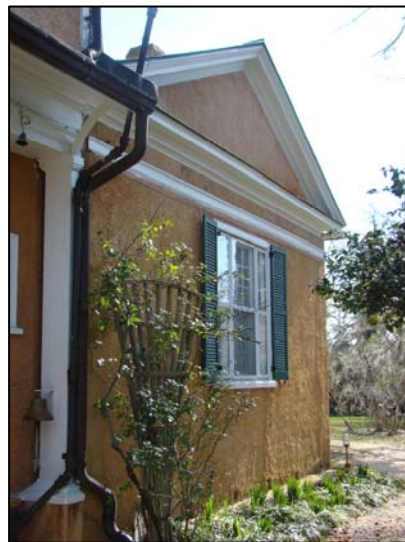
Plate 77. The southern pisé wing of the Borough House.
(Photo: Author)

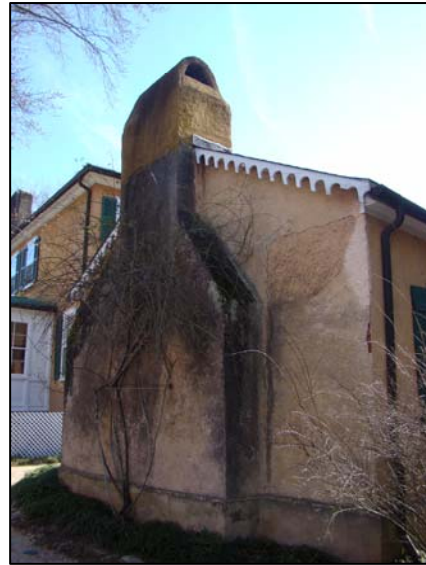
Plate 81. The north façade of the dairy/kitchen building. (Photo: Author)

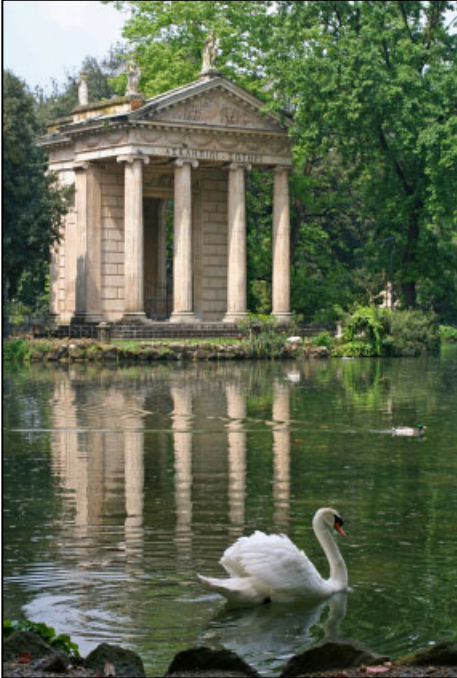
Figure 85. Garden folly in England modeled on the Temple of Aesculapius. (Photo: Catena Historic Garden Archive)

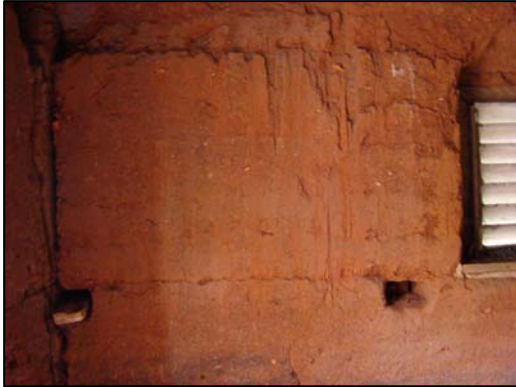
Figure 87. The original pisé walls of the dry well, which were left unfinished. (Photo: Author)

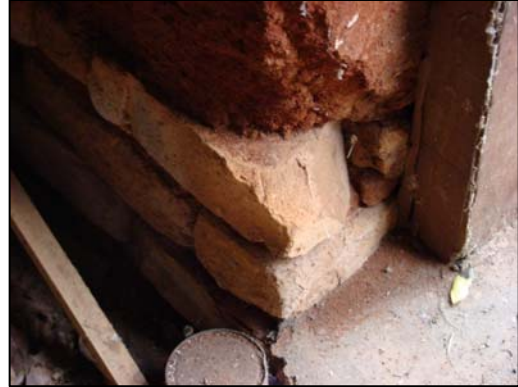
Figure 88. The visible foundation of the dry well constructed of locally made bricks. (Photo: Author)

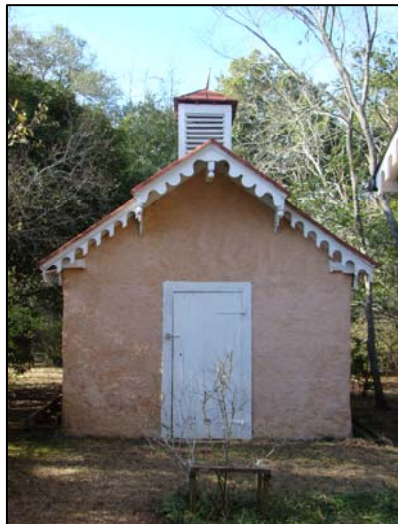
Figure 89. The exterior of the dry well with decorative barge boards added in the 1880s. (Photo: Author)

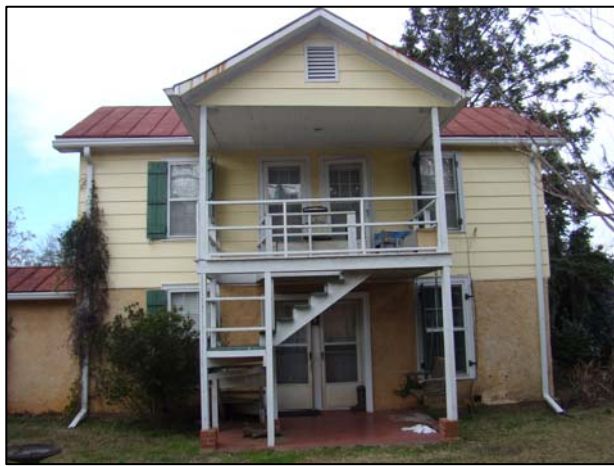
Figure 91. The cook’s house, which now serves as the caretaker’s house. It originally consisted of two stories, the bottom of pisé, and the top of wood. The wing to the left and an ell addition to the rear were built in the 1970s.
(Photo: Author)

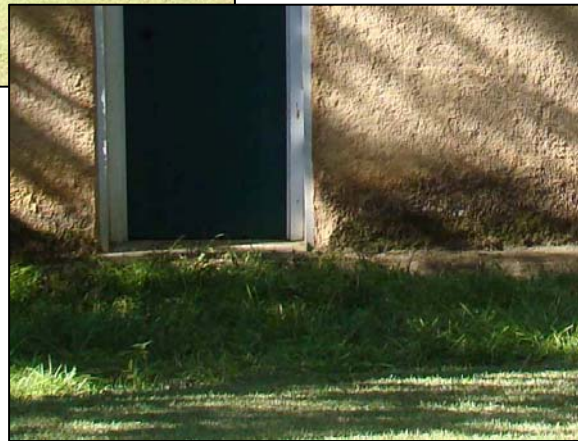
Figure 93. Closer view of the staining. (Photo: Author)

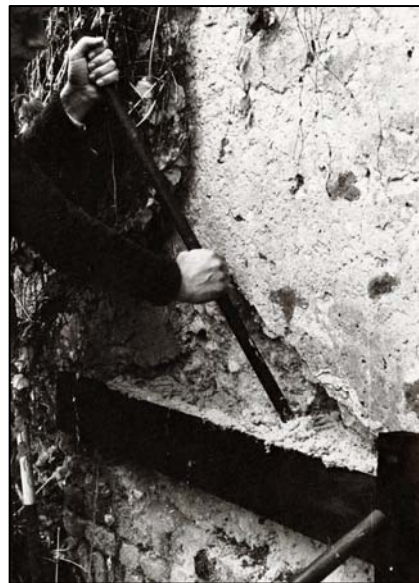
Figure 96. A cob wall being repaired and filled in with temporary shuttering. (Photo: John and Nicola Ashurst)

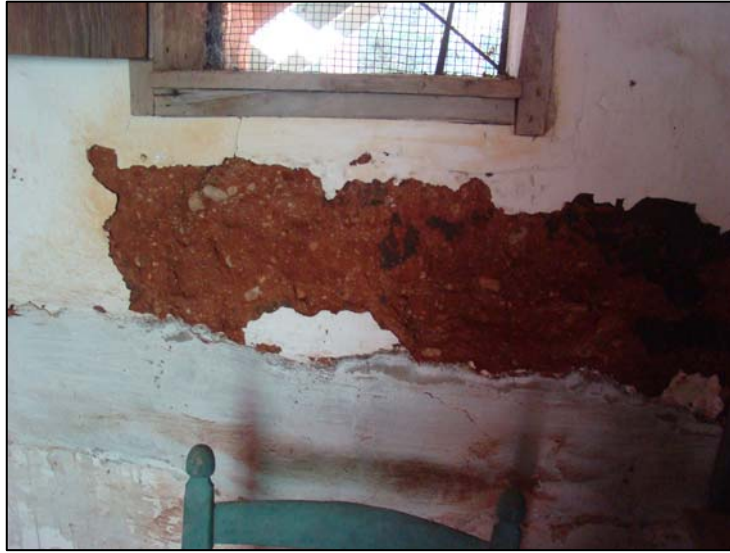
Figure 98. Interior wall showing some plaster loss inside the dairy/kitchen. (Photo: Author)

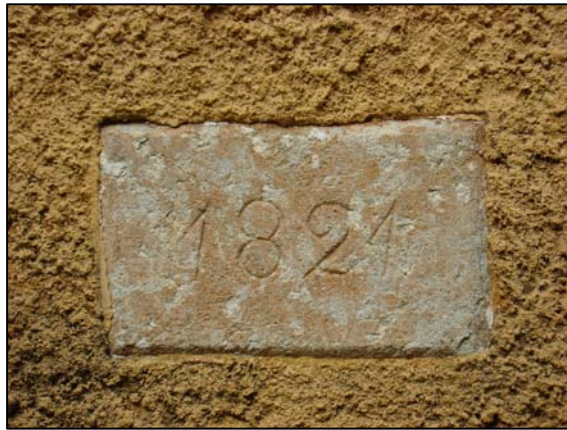
Figure 102. The cornerstone on the north wall of the dairy/kitchen put in by Dr. Anderson when he began building his pisé structures. (Photo: Author)

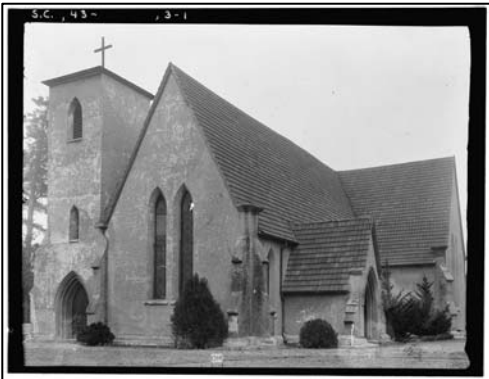
Figure 105. HABS photograph of the Church of the Holy Cross prior to the steeple being restored. (Photo: Library of Congress)

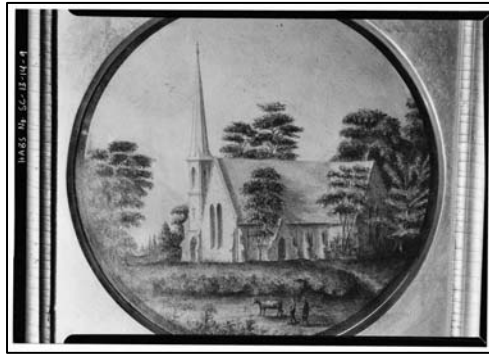
Figure 107. HABS photograph of a sketch done by the architect Edward C. Jones after it was built. (Photo: Library of Congress)

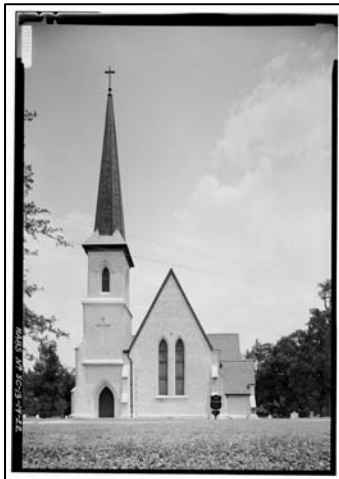
Figure 108. HABS photograph of the exterior of the Church of the Holy Cross after the 1974 restoration. (Photo: Library of Congress)

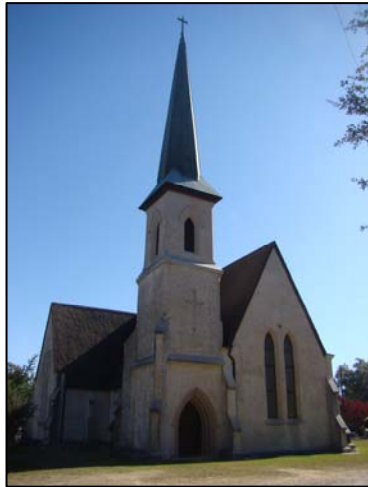
Figure 110. The Church of the Holy Cross in 2008 during the current restoration. (Photo: Author)

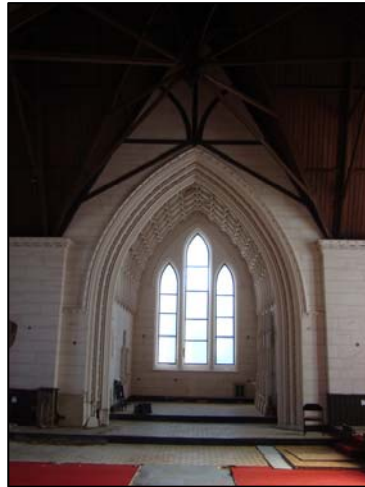
Figure 111. The nave of the Church of the Holy Cross in 2008 after the stained glass and furnishings had been removed. (Photo: Author)

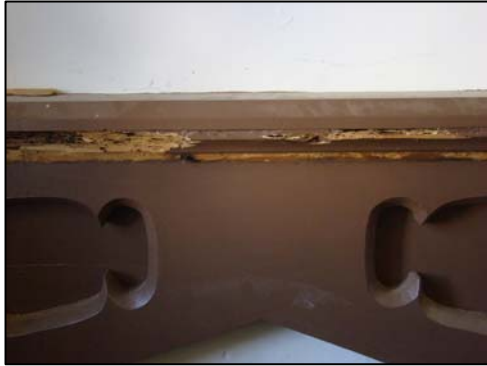
Figure 112. Termite damage on the mantle in Sacristy. (Photo: Author)

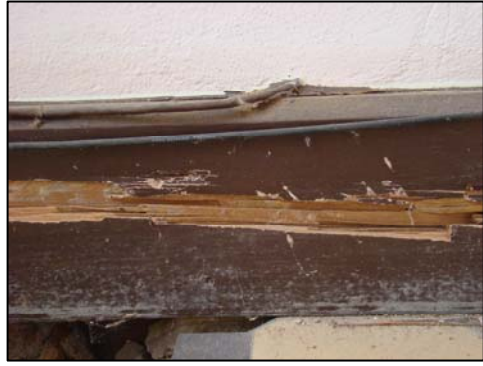
Figure 113. Termite trails on the baseboard in the Chancel. (Photo: Author)

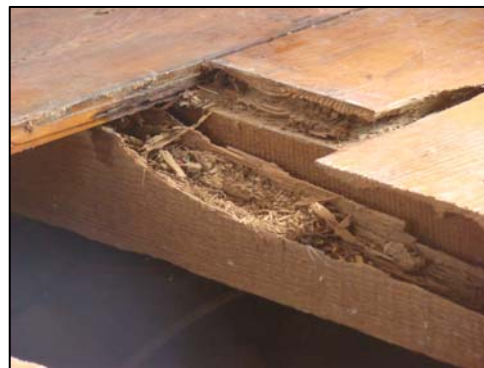
Figure 117. Severe termite damage on floorboards under choir area. (Photo: Author)

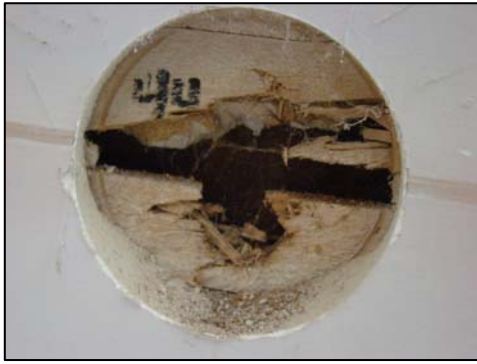
Figure 118. Holes cut in plaster to monitor termite damage. (Photo: Author)

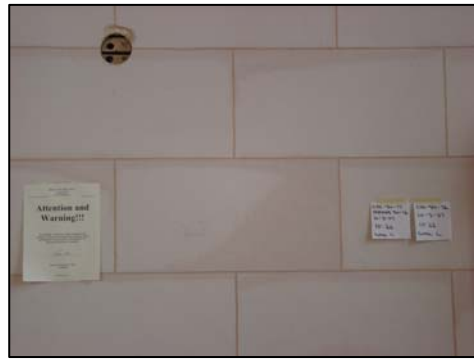
Figure 119. Holes cut in plaster to monitor termite damage. (Photo: Author)

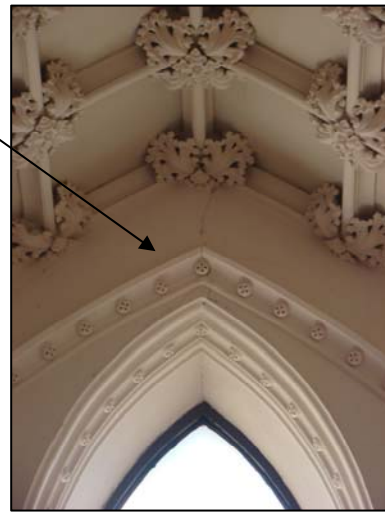
Figure 121. Arrows point to cracks due to weakened structure. (Photo: Author)

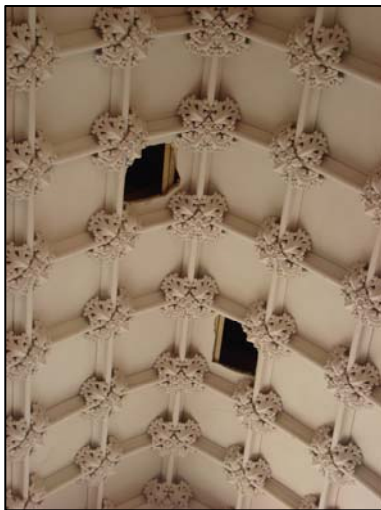
Figure 122. Holes cut in the Chancel ceiling to inspect and monitor termite damage. (Photo: Author)

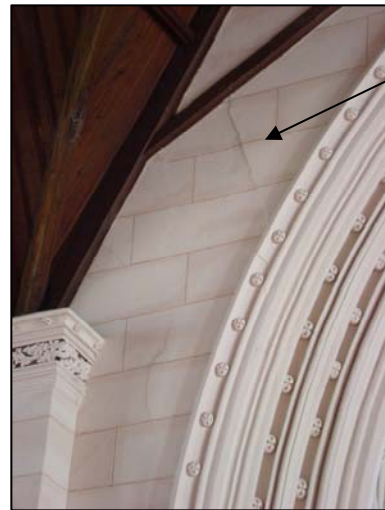
Figure 123. Arrows point to cracks due to weakened structure. (Photo: Author)

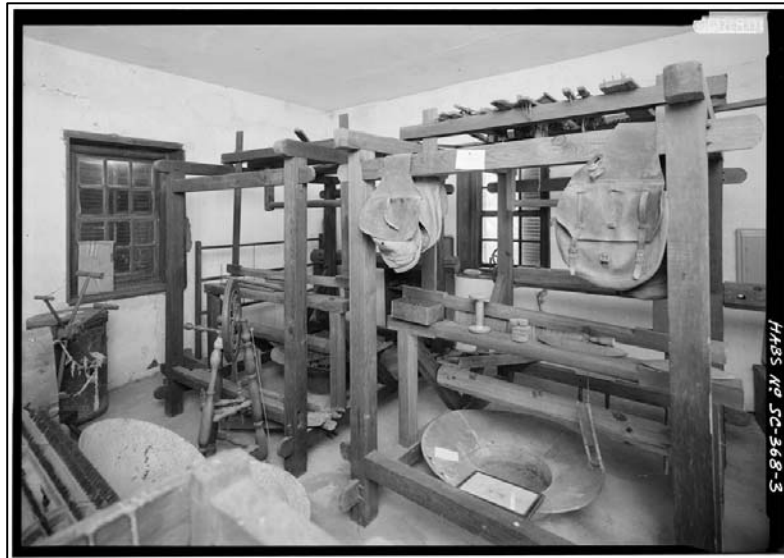
Plate A7. Interior of the loomhouse showing the looms that are currently in poor condition. (Photo: Library of Congress)

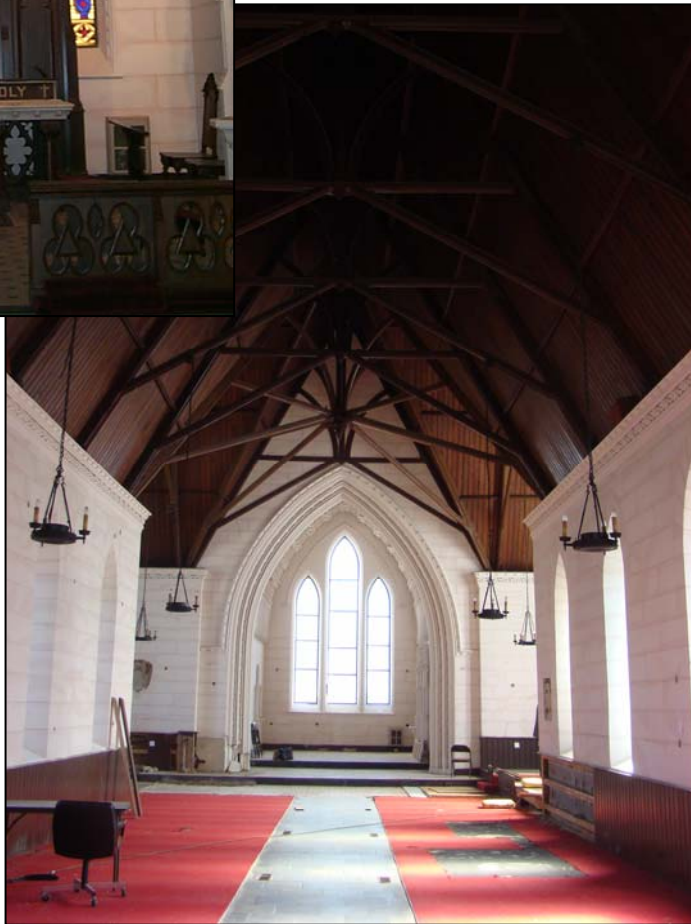
Plate A20. View looking east from the nave to the Chancel in 2008. (Photo: Author)

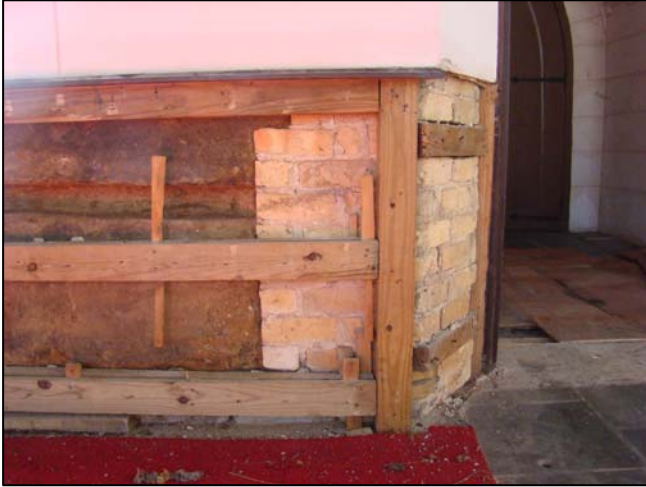
Plate A21. Brick repair made near the porch entrance on the south elevation. (Photo: Author)

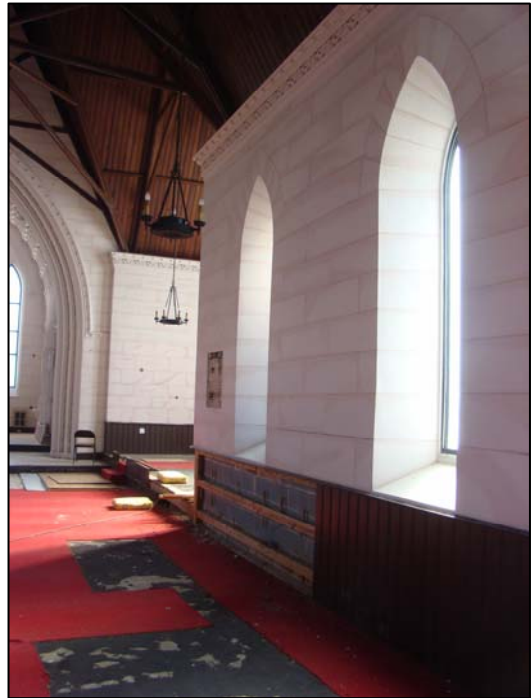
Plate A22. Concrete block repair made after the collapse of a portion of the south wall in 1974. (Photo: Author)

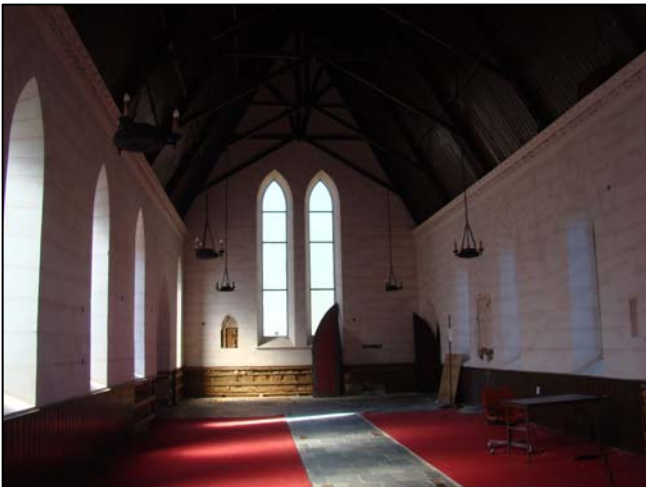
Plate A23. View looking west from the Chancel to the nave and entrance of the church. (Photo: Author)
