DRAFT Crane Creek Watershed Management Plan

PREPARED FOR:

Richland County Department of Public Works
400 Powell Road
Columbia, South Carolina 29203

CENTER FOR
WATERSHED
PROTECTION

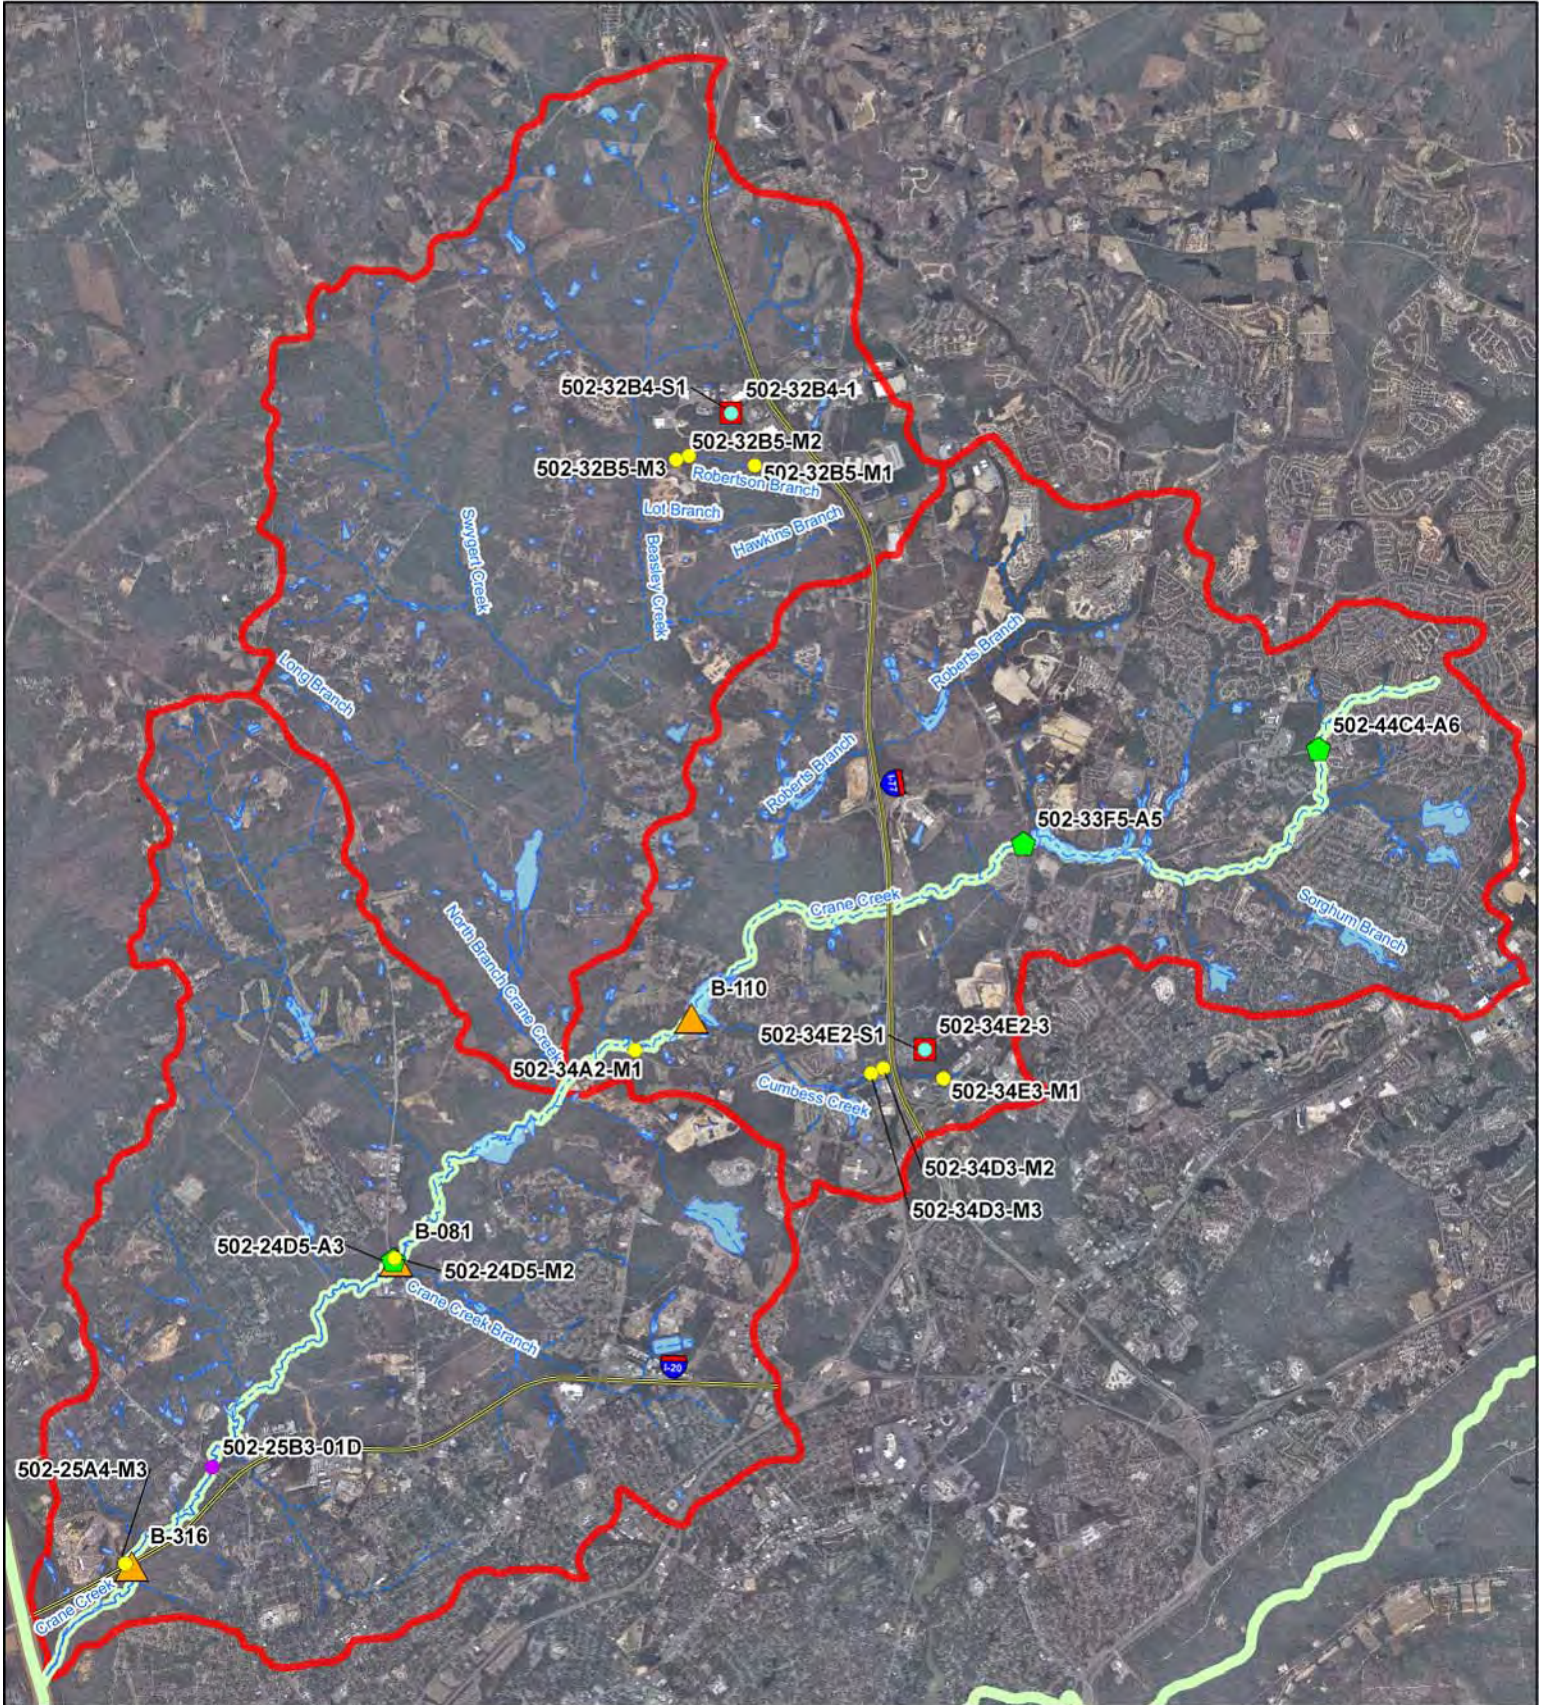
Figure 2.3. Locations of the SCDHEC water quality monitoring stations.

TMDL for fecal coliform. Two State water quality gauging stations are located in the Crane Creek watershed; Station # B-316 , a primary station sampled year round (Crane Creek at S-40-43 under I-20 – North Columbia), and Station # B-110 a secondary station sampled May-October (Elizabeth Lake at US 21). A third station, # B-081 (Crane Creek at US 321) is used for macroinvertebrate community assessment (SCDHEC, 2008a). These stations have been in use for more than a decade to collect water quality data. Figure 2.3 shows the location of these State monitoring stations.

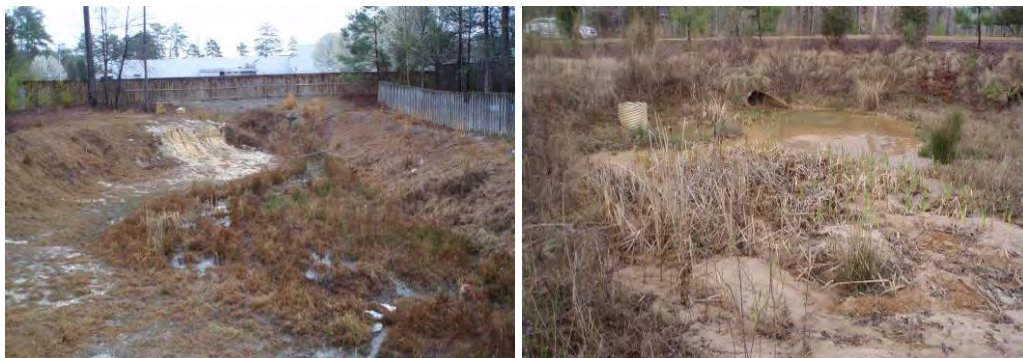
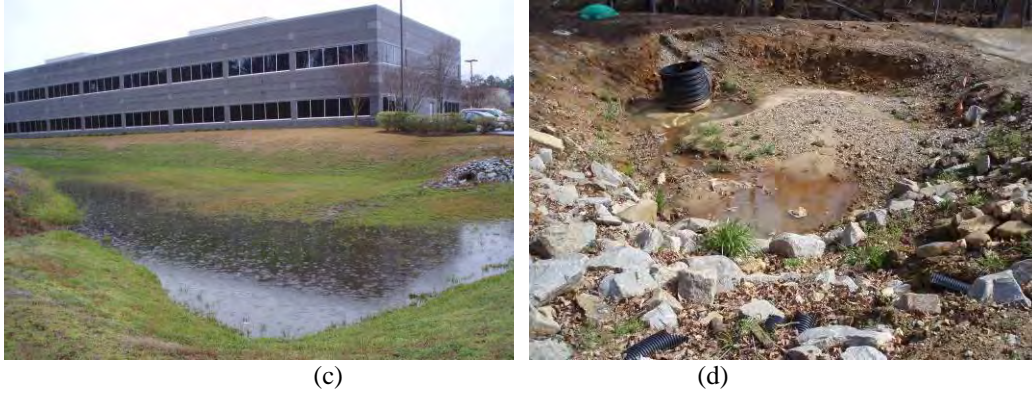
Figure 3.2. Poor functioning stormwater management practices. (a) erosion in a neighborhood dry pond (F-RRI-35); (b) stormwater pond with unstable drainage area (C-RRI-19B); (c) flood-control pond at business park with no water quality control (H-RRI-200); and (d) undersized neighborhood dry pond (A-RRI-21A).

At several field sites, inadequate or poor treatment of stormwater through stormwater dry and wet ponds was observed (Figure 3.2). Common problems included stormwater by-pass of the treatment mechanism, lack of water quality treatment, pond erosion, and pond sedimentation. These problems often appeared to be a result of poor design, lack of maintenance, or poor stabilization of the pond area or contributing drainage area.

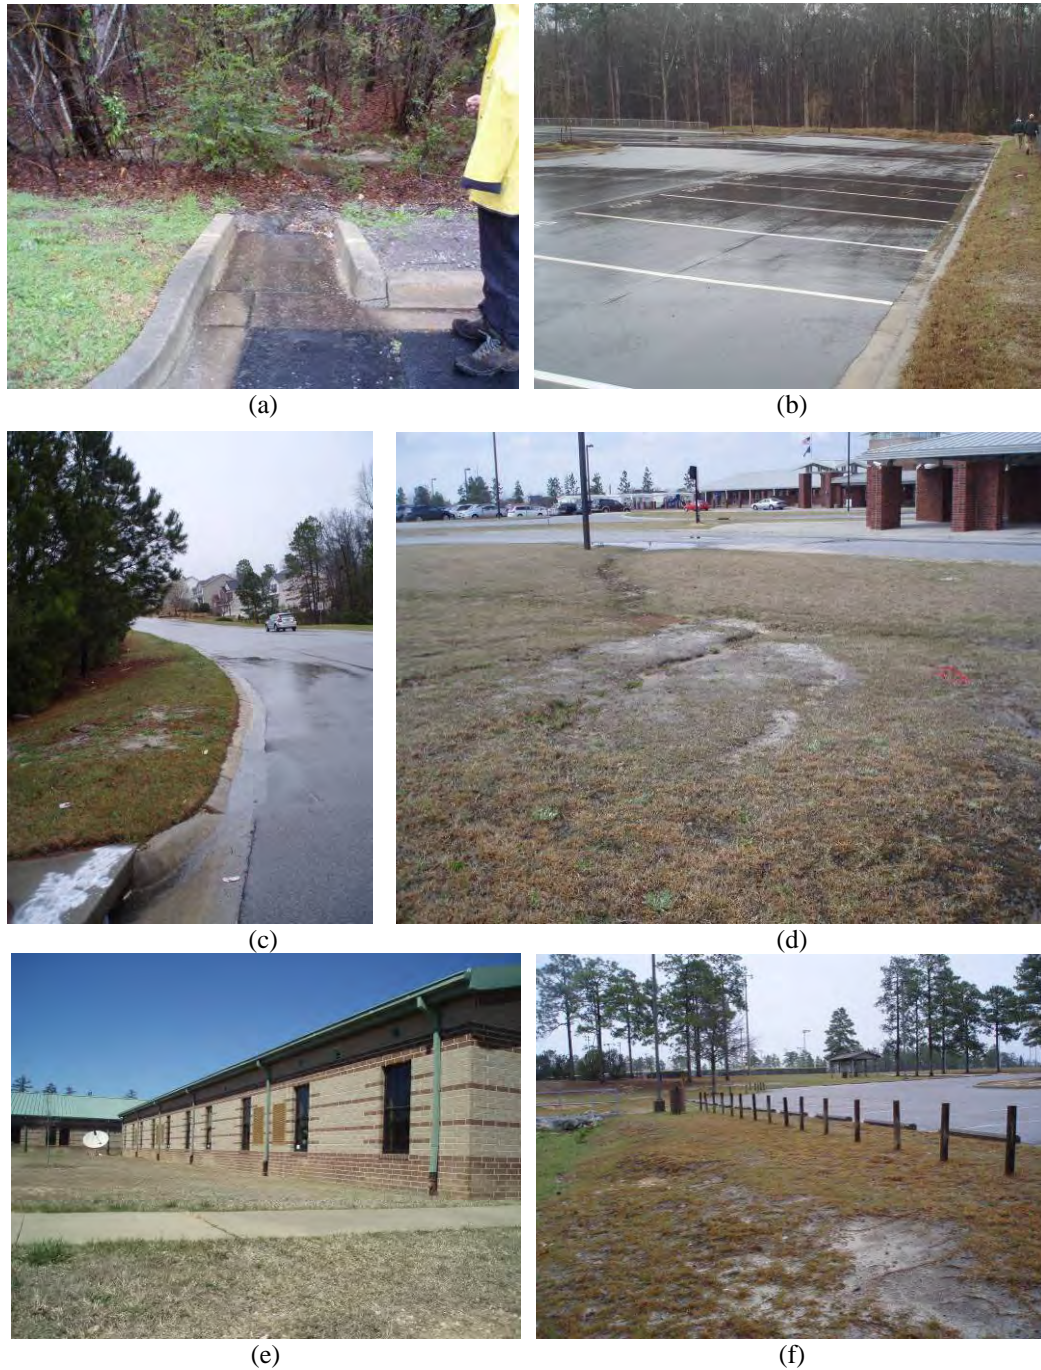
Figure 3.3. Stormwater retrofit opportunities. (a) Untreated business park parking lot runoff travelling directly to stream (H-RRI-24B); (b) untreated school parking lot runoff travelling into forested area (I-RRI-17); (c) opportunity for a roadway retrofit in a residential neighborhood (G-RRI-201); (d) proposed location for a bioretention area at a school (E-RRI-34); (e) downspout disconnection opportunity at a school (K-RRI-06); and (f) proposed location for a bioretention area to capture parking lot runoff from a park (G-RRI-38).

Throughout the watershed, a lack of stormwater treatment was observed for many older development sites, as well as several recent development sites (Figure 3.3 (a, b, & c)). At many of these sites, untreated stormwater discharges directly to wetlands, stream channels, or the stormdrain system. Unmanaged stormwater can contribute high pollutant loads to the receiving waterbodies, and can also result in high stormwater runoff flow rates that cause streambank erosion and degrade stream habitat.

Many of the older schools and parks visited during field work had no stormwater management practices. At newer schools, there were often large areas of turf grass or bare soils with very little or no trees. Despite the presence of sandy native soils, downspouts were often directly connected to the stormwater conveyance system. Schools and parks are great places for stormwater retrofits because of the educational and demonstration component associated with projects. An understanding of stormwater and the environment can be incorporated into school science curriculums. Students can learn about the connection between stormwater, Crane Creek, and how they can play a part in improving water quality. Additionally, these sites can serve as good community demonstration projects (Figure 3.3 (d, e, & f)).

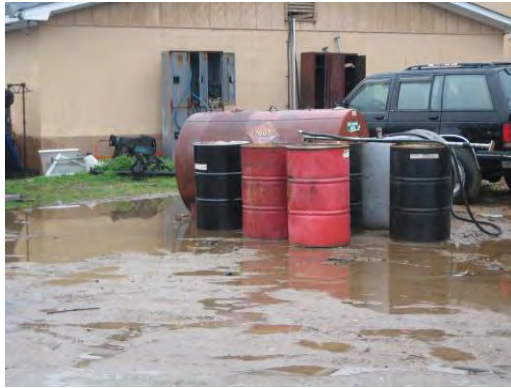
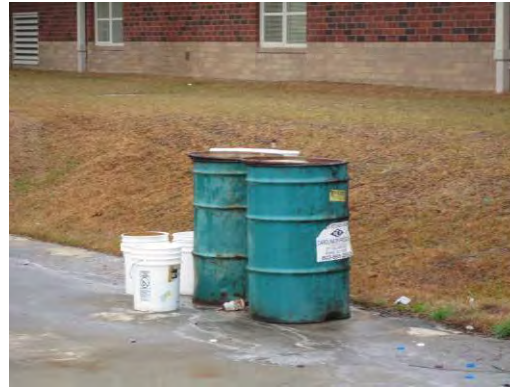
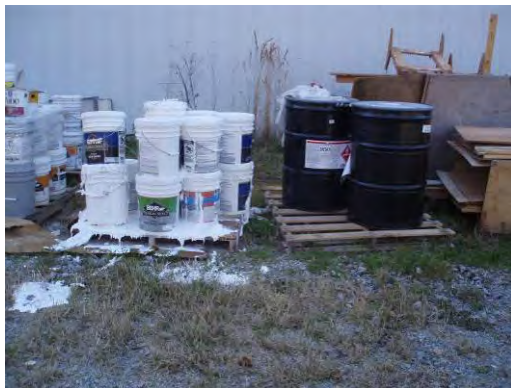
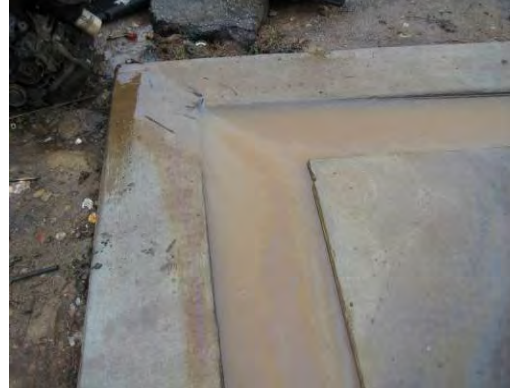
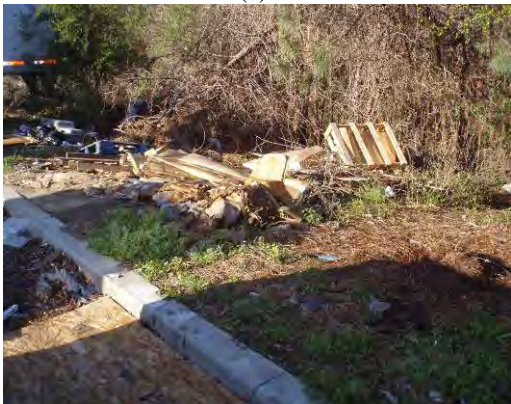
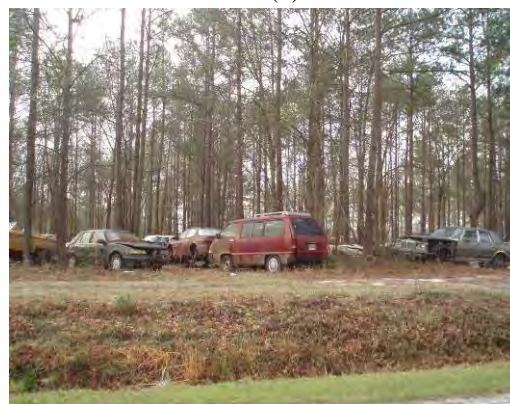
Figure 3.4. Pollution producing behaviors found during the HSI. (a, b, & c) outdoor materials without secondary containment at sites I-HSI-1, E-HSI-2, and K-HSI-4, respectively; (d) automobile oil leaking from an auto salvage yard at site I-HSI-2; (e) dumping site next to a gas station at site M-HSI-1; (f) an automotive salvage site adjacent to a stormwater channel at site H-HSI-22.

The following are general findings from the hotspot assessment that field crews encountered throughout the Crane Creek watershed. Figure 3.4 illustrates some of the field findings.

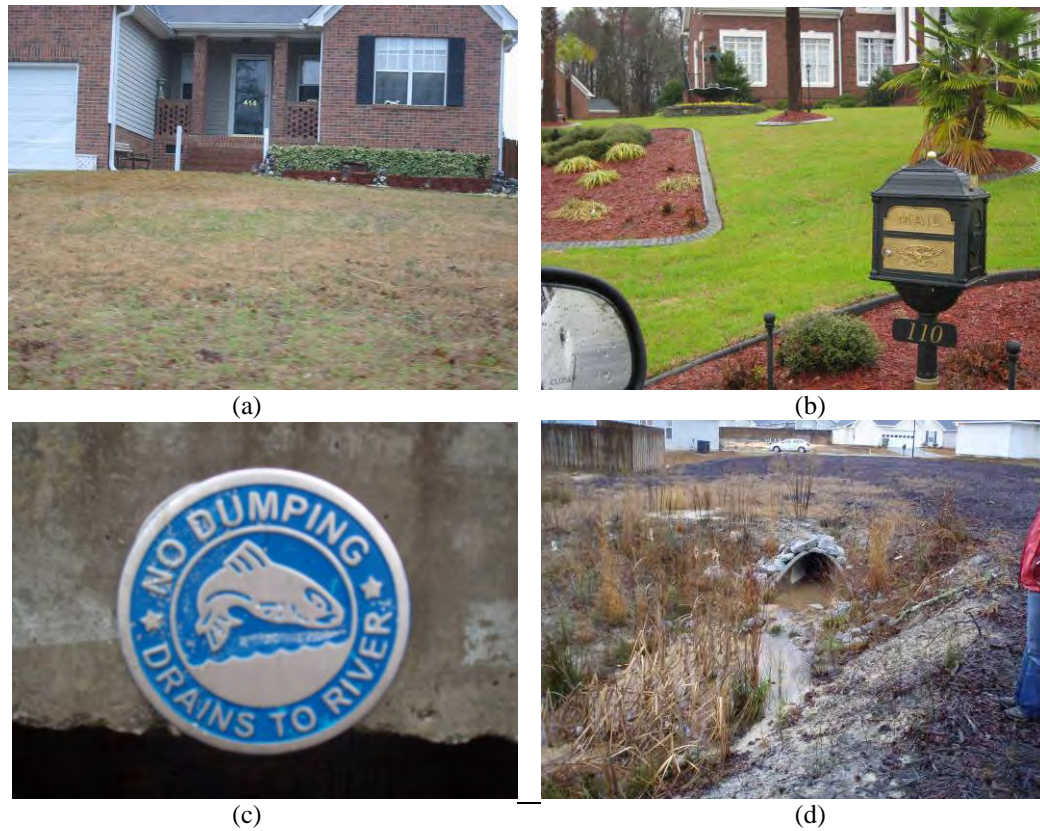
Figure 3.5. Field findings from NSA. (a) bare soils in neighborhood G-NSA-2; (b) over-fertilization in neighborhood I-NSA-3; (c) Stormdrain marker in neighborhood F-NSA-2; and (d) pond modification at neighborhood F-NSA-2 (F-RRI-30).

As noted in Section 3.2 of this report, many neighborhoods were observed to have little or poorly functioning stormwater management practices. Several opportunities for improved stormwater management noted include bioretention in cul-de-sacs, parking lot retrofits, repair of existing stormwater dry ponds, and incorporating stormwater treatment into wide residential roadways.

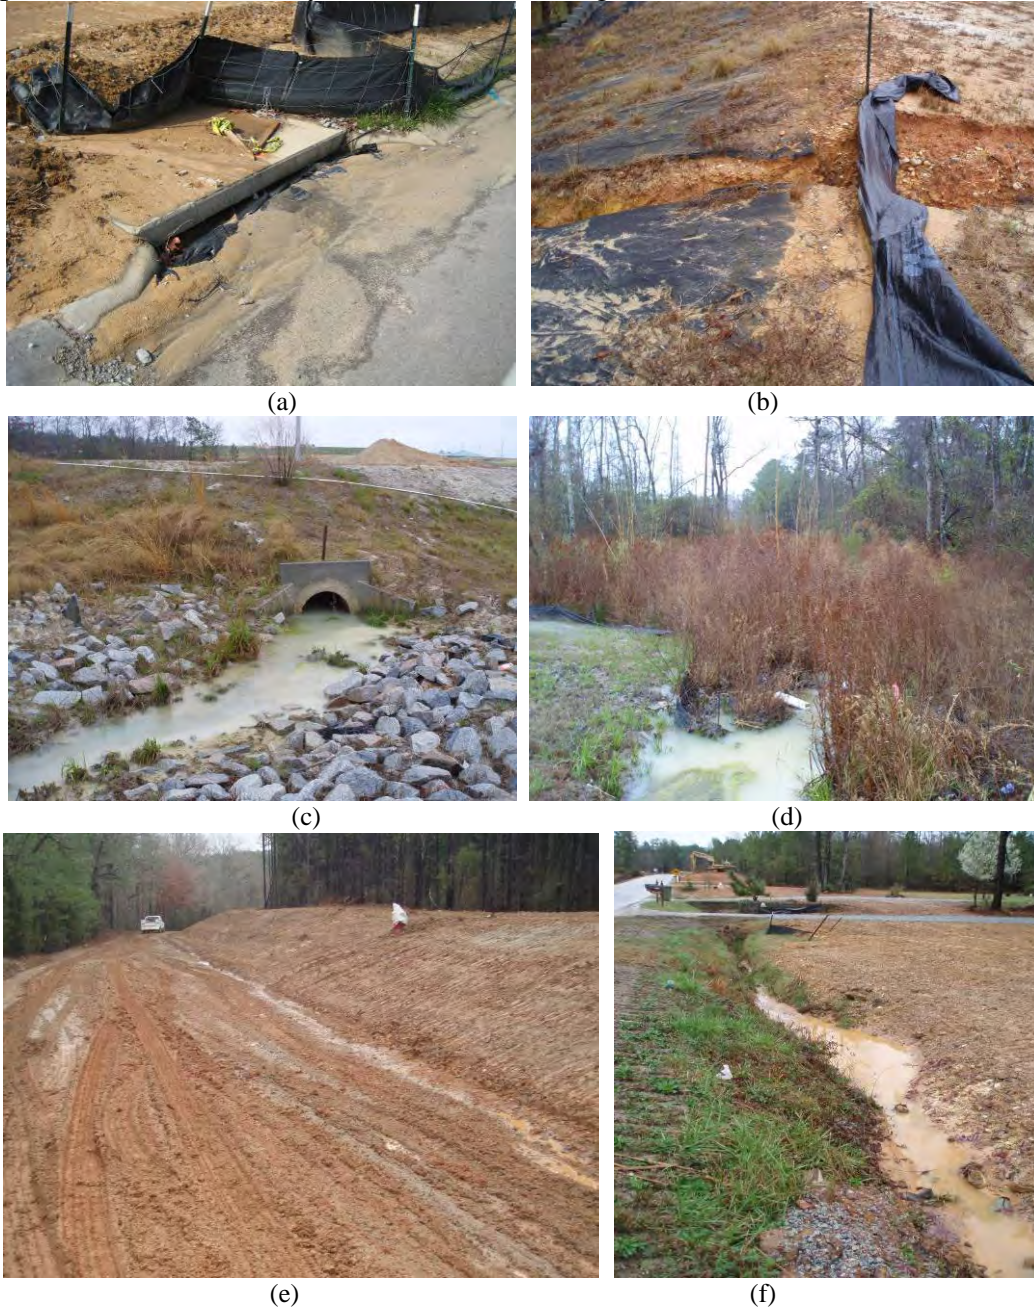
Figure 3.6. Erosion and sediment control problems found during field work. (a) Poor ESC at a subdivision construction site (E-ESC-2); (b) failing ESC at an inactive construction site (H-ESC-1); (c&d) sediment export from an abandoned sediment pond (F-ESC-2); and (e&d) poor ESC along utility line construction (B-ESC-2) and (B-ESC-1).

Field teams identified numerous instances of poor or nonexistent ESC controls at active construction sites. A total of 15 incidences of failing or poorly maintained ESC practices were documented during the week of field work. A list of these sites is found in Attachment E. It should also be noted that additional sites were identified during previous trips to the watershed by the Center, so this is an ongoing problem. Figure 3.6 provides examples of some of the problems encountered by the field crews during the week of field work.

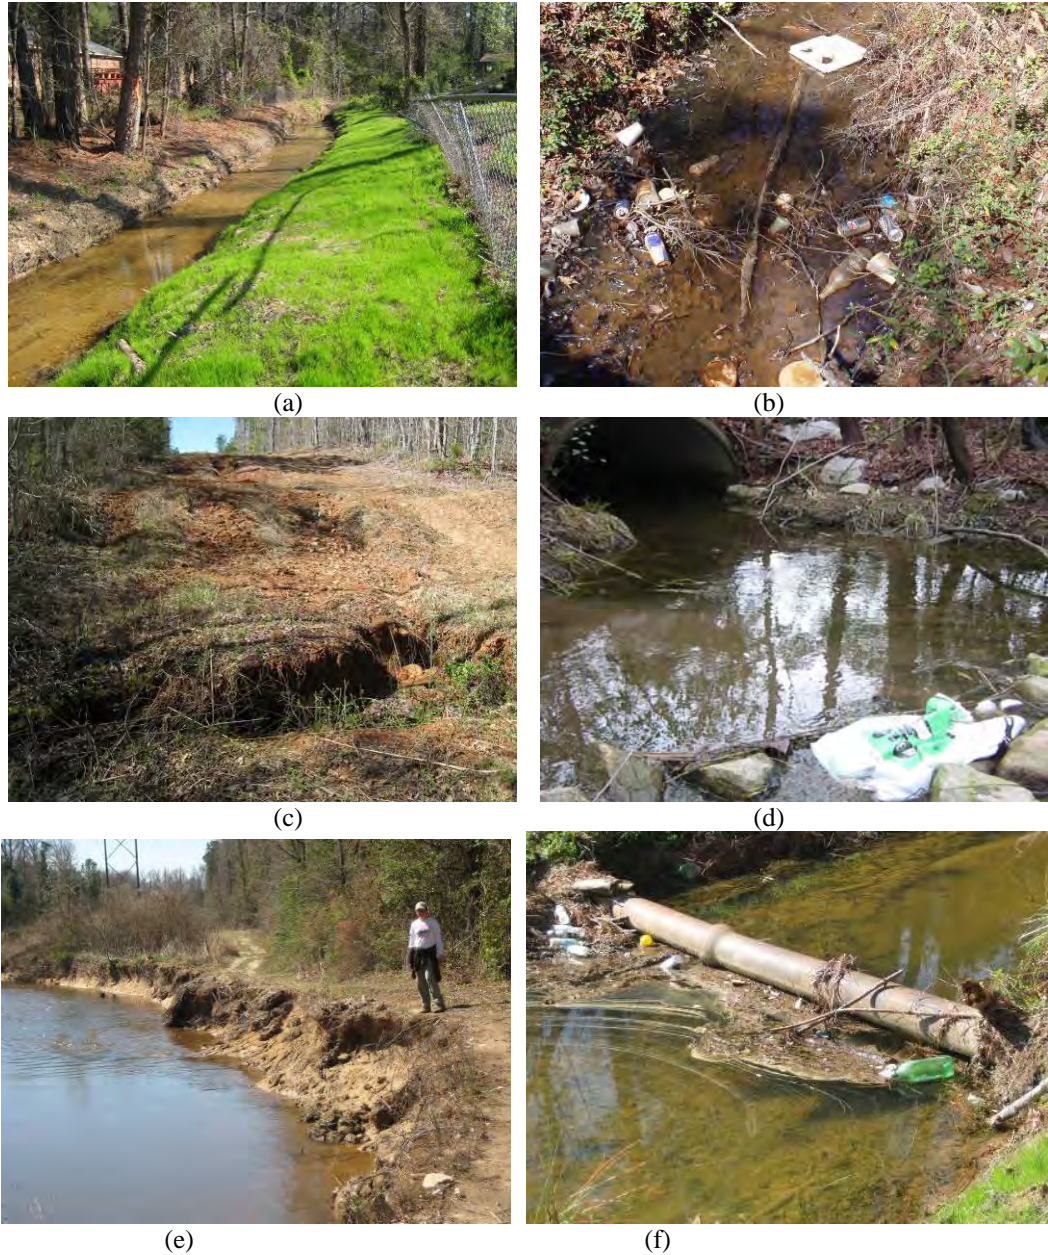
Figure 3.7 Stream restoration opportunities. (a) mowed and fertilized stream edge (L-RCH-5) located in neighborhood L-NSA-3; (b) trash including plastic bottles, wrappers and cups in G-RCH-10; (c) erosion impacts associated with utility crossing (J-ER-11); (d) fertilizer bag in stream in neighborhood G-NSA-2 (G-TR-2); (e) utility corridor located above stream reach K-RCH-13 contributing to bank erosion and impacted buffers; (f) sewer utility across stream acting as trash barrier (L-RCH-5).

Elevated sewer pipes were frequently noted across stream reaches. These pipes cause alterations to the stream hydrology, act as trash racks and are potential sources of sewage to the stream. During field work, illicit discharges were identified and reported to the City (M-RCH-2, M-RCH-10). Repair crews responded to repair the problems.

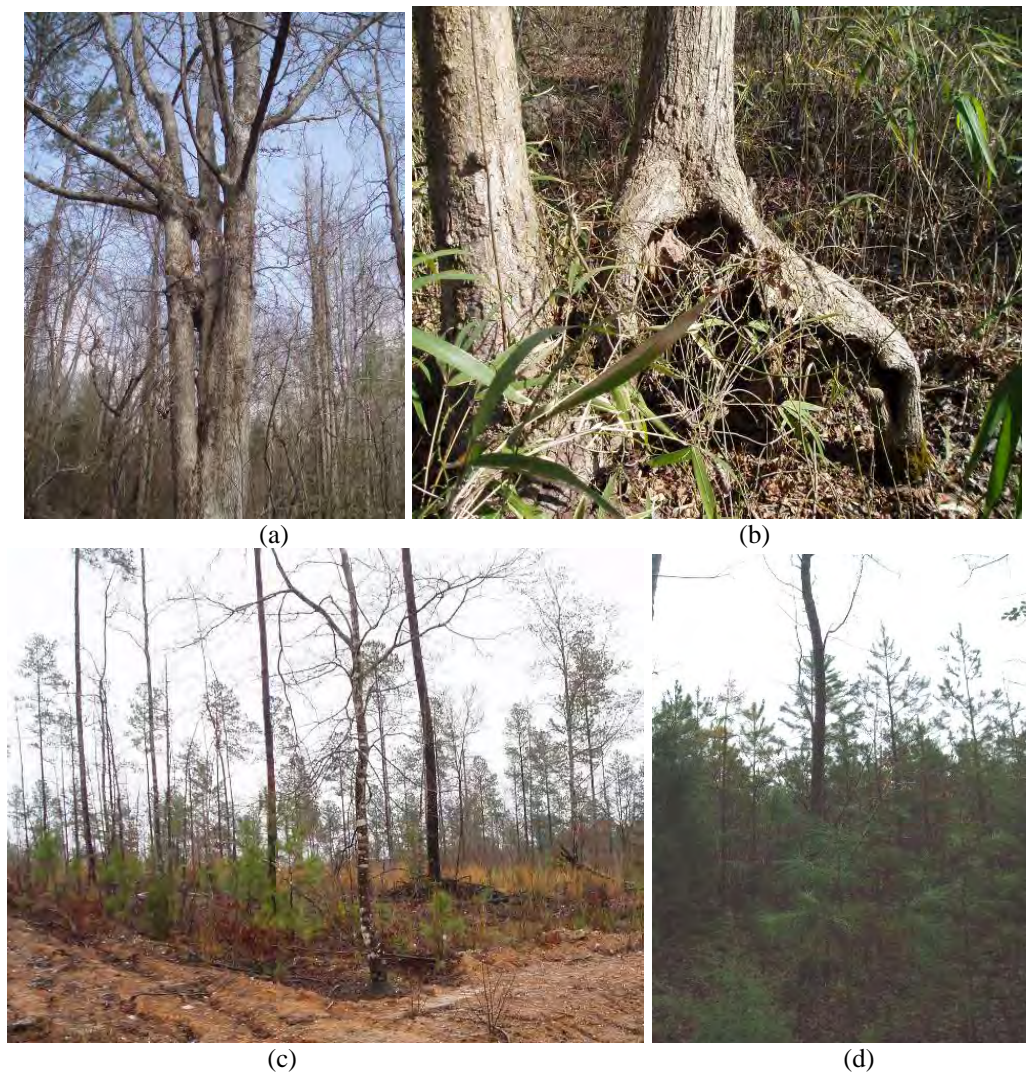
Figure 3.14. Representative forest conditions in Crane Creek. (a) A specimen white oak tree located adjacent to a stream in Subwatershed B (B-RCH-6); (b) a bottomland hardwood forest located in Subwatershed A (A-FP-5); (c) a representative pine forest that has undergone thinning in Subwatershed B; and (d) a clear cut pine forest during regeneration (B-FP-2).

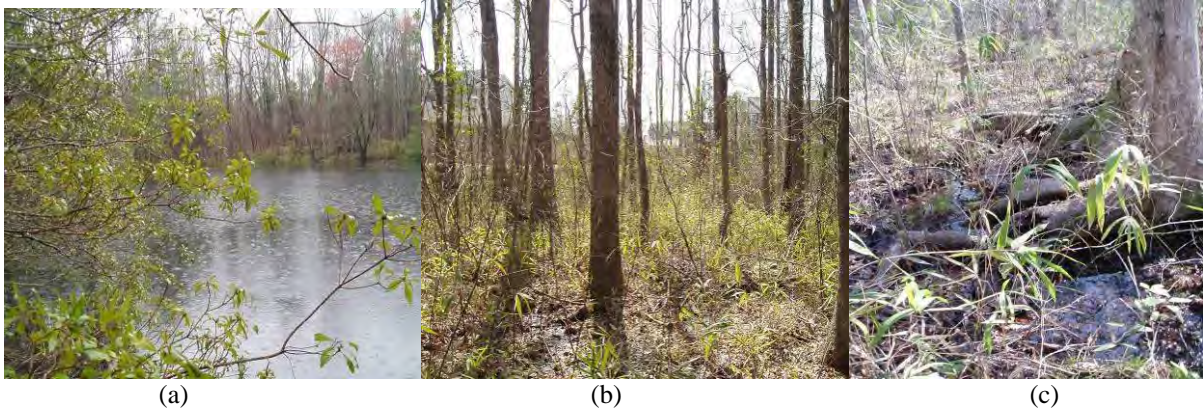
Figure 3.15. Wetland habitats from Crane Creek. (a) constructed pond formed by creating an embankment on a small headwater stream (B-WP-1); (b) headwater stream wetland with nearby development (C-WP-7); and (c) wetland with tulip poplars and a small ephemeral stream (A-WP-4).

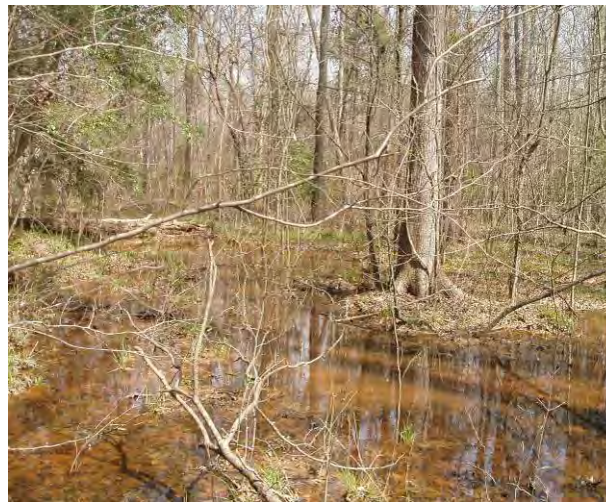
Figure 3.16. A wetland impacted by sediment from a poorly controlled construction site (C-WP-2).

Wetlands assessed in the watershed generally showed very good scores for both water quality and habitat (Figure 3.15). A few wetlands were deemed to have relatively low value due to size or disruption by clearing for power lines or impacts from nearby construction. At site C-WP-2, large quantities of sediment were observed in the wetland bottom due to poor ESC at a nearby site (Figure 3.16).

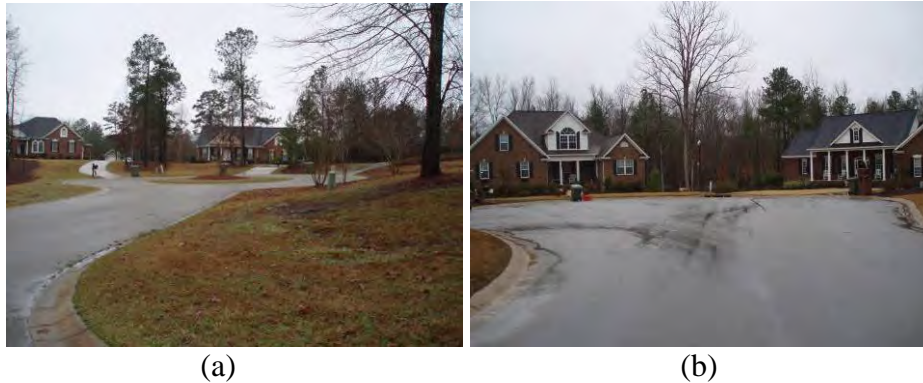
Figure 6.4. (a) Cul-de-sacs with landscaping island at A-NSA-1 and (b) large cul-de-sac at A-NSA-2.

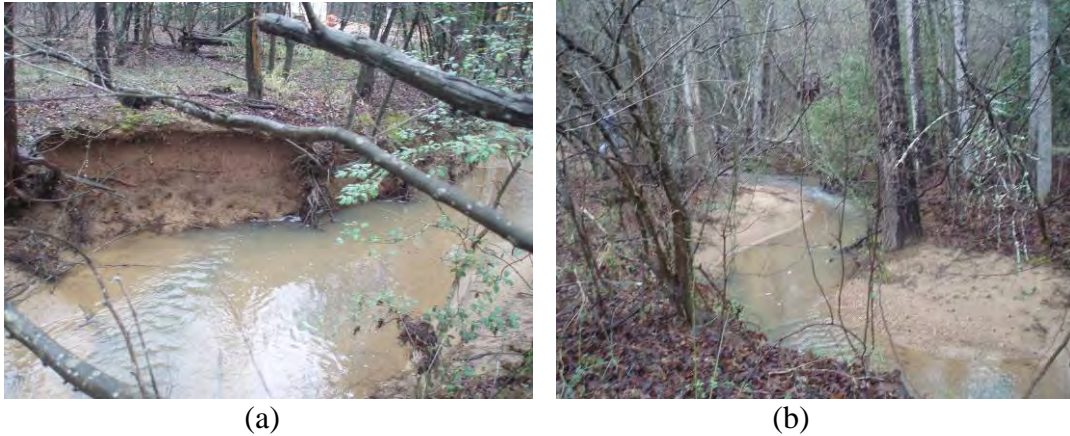
Figure 6.6. (a & b) Bank erosion and sedimentation in B-RCH-4.

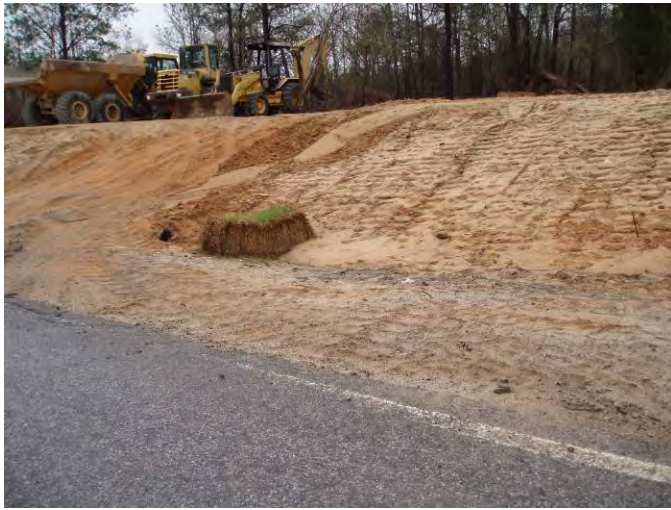
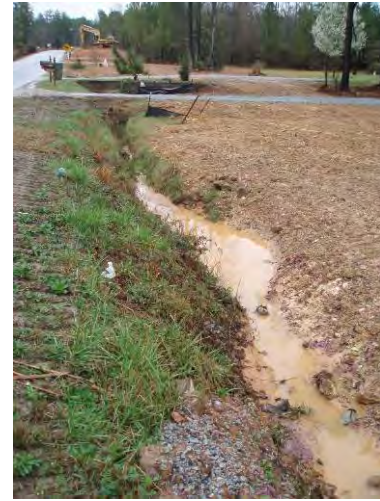
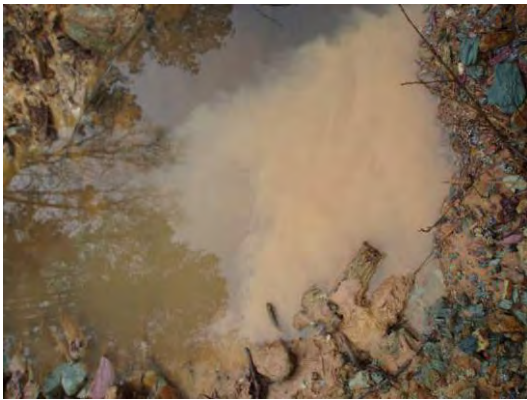
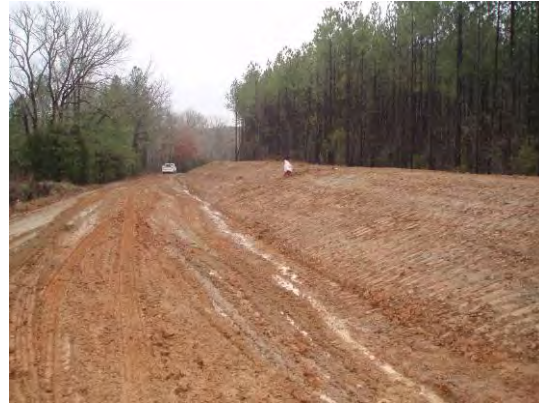
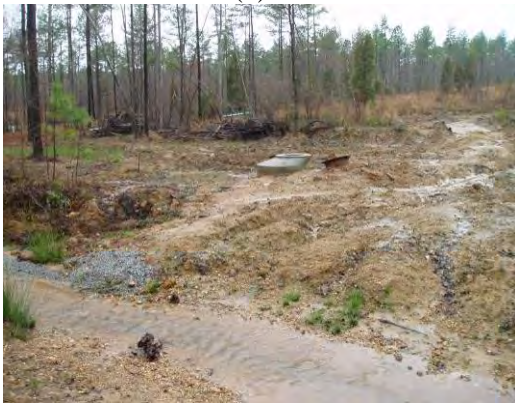
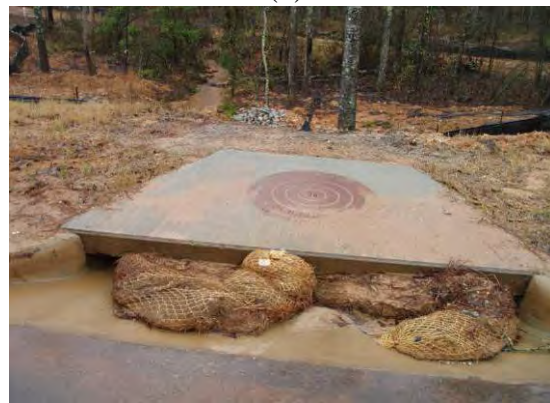
Figure 6.8. Erosion sites in subwatershed E. (a, b & c) B-ESC-1; (d) B-ESC-2; and (e & f) B-ESC-3 adjacent to B-RCH 1.

Several severe ESC problems were observed in Subwatershed B. The ESC problems in this area were especially pronounced due to the presence of the heavy clay soils. Table 6.10 lists the ESC problems that were observed during field work. An observed ESC site associated with the public water-line extension along Mount Valley Road (B-ESC-1&2) was identified as high priority (Figure 6.8). In addition, the construction of a utility line crossing did not appear to have any ESC controls and was resulting in sediment flow to the creek. A neighborhood site (B-ESC-3) had some failure of ESC practices and the site was lacking vegetation. The County should conduct immediate and regular inspections at these sites to ensure that ESC problems have been properly addressed, and that the sites have been stabilized to prevent further erosion.

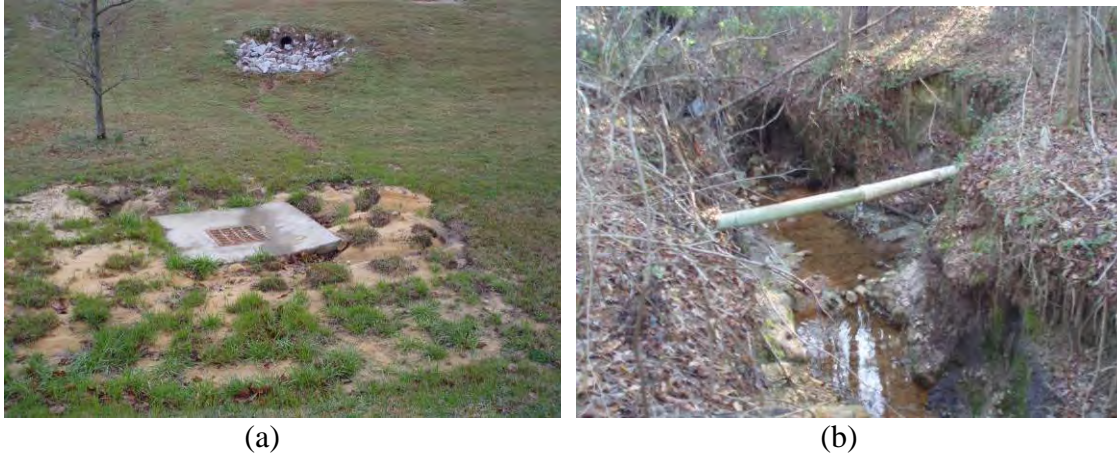
Figure 6.9. (a & b) Retrofit opportunity at site C-RRI-101.

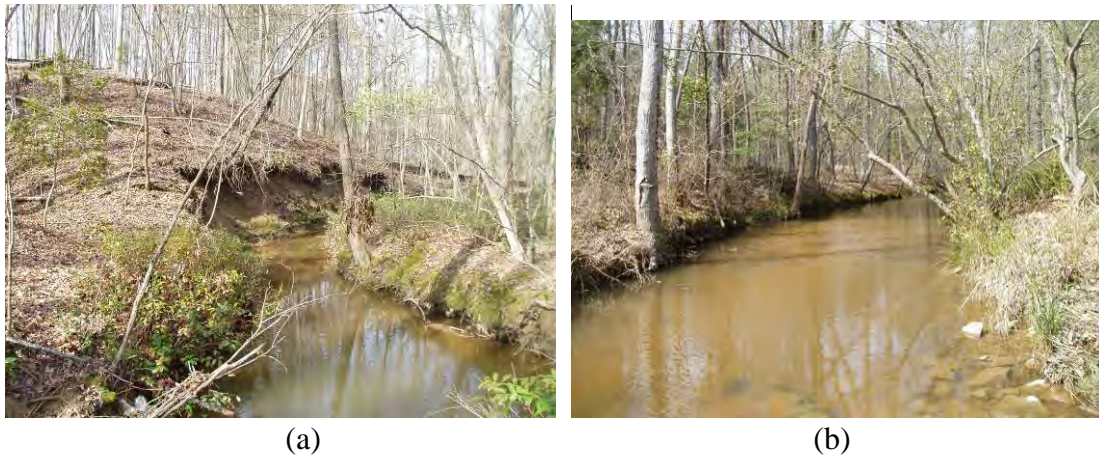
Figure 6.10. (a) Erosion at C-RCH-3 and (b) turbid water at C-RCH-5.

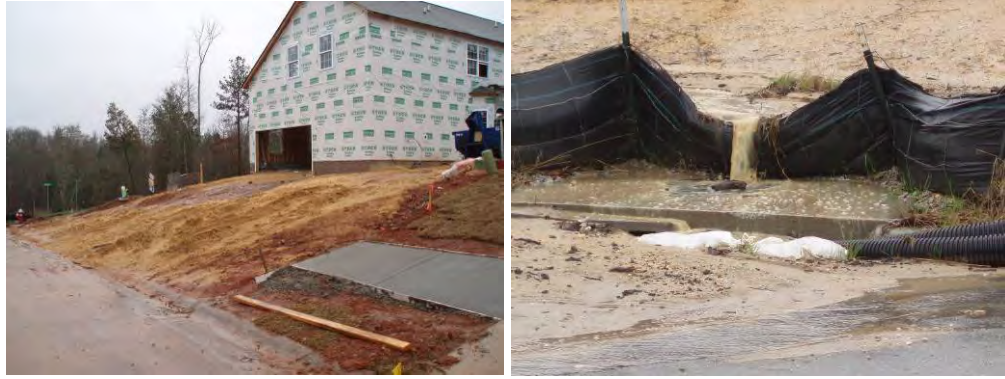
(a) (b)
Figure 6.11. ESC problems at (a) C-NSA-3 and (b) C-ESC-1.

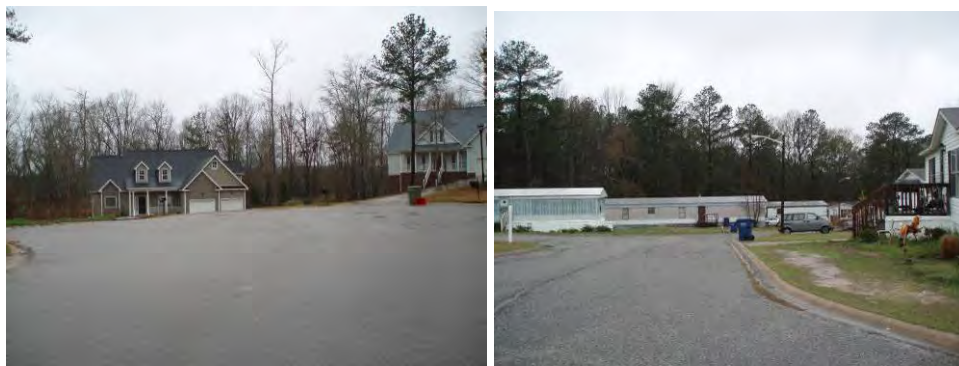
Figure 6.13. Residential neighborhood opportunities include (a) cul-de-sac retrofit at D-NSA-7 and (b) landscaping at D-NSA-8.

Two neighborhood source control opportunities were identified and are shown in Table 6.18. Residential rain gardens, storm drain stenciling, tree-plantings and cul-de-sac retrofit opportunities were observed in the field and are considered the most important areas for improvement (Figure 6.13).

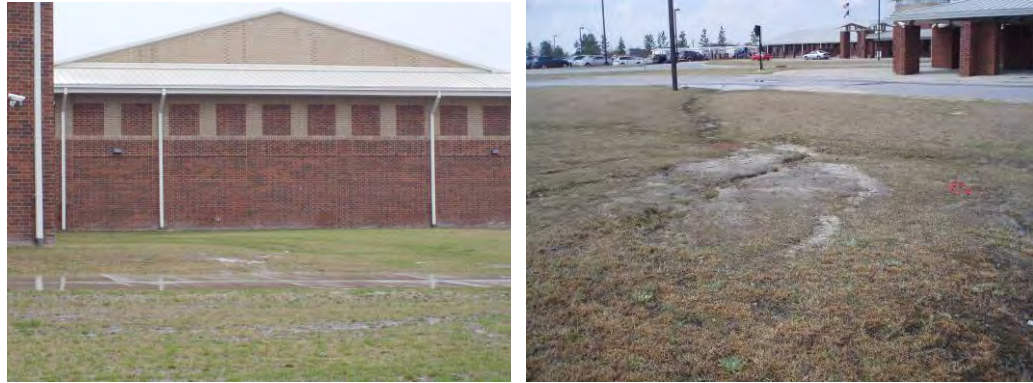
Figure 6.15. (a) Potential for downspout disconnection at E-RRI-31B and (b) creation of a bioretention in the existing traffic roundabout at E-RRI-34.

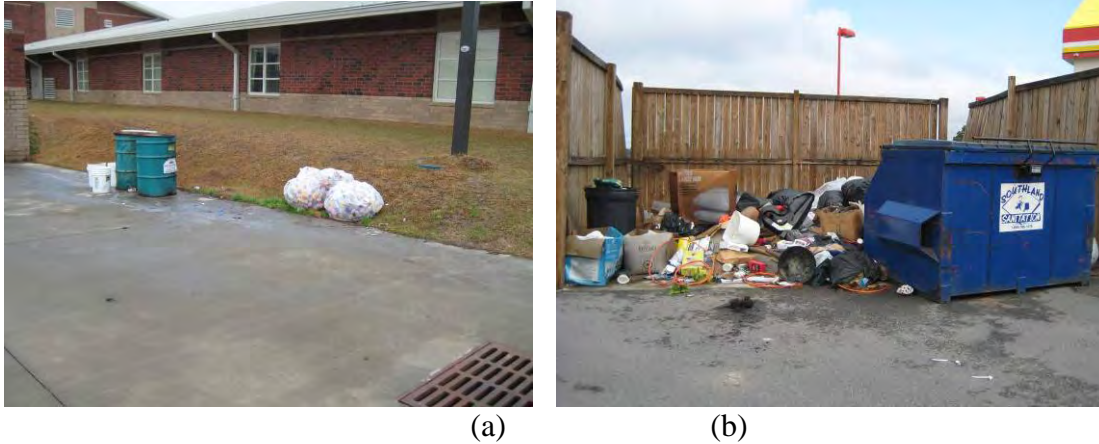
Figure 6.17. (a) Uncovered grease containers at Sandlapper Elementary School (E-HSI-2) and (b) dumping of trash at Dollar General (E-HSI-3).

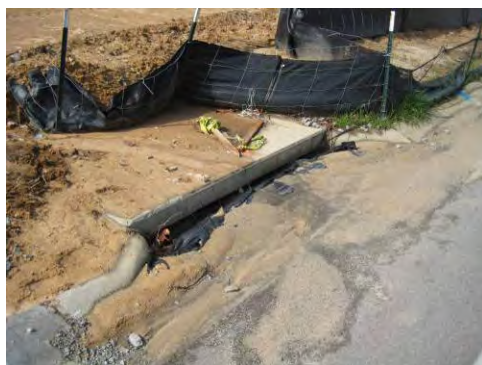
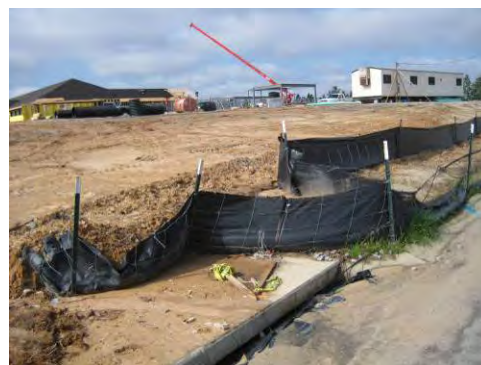
Figure 6.18. (a & b) Failing silt fence at E-ESC-2 allowing silt to enter the storm drain inlet and discharge to the creek.

Two sites with uncontrolled ESC practices were identified (Figure 6.18). Poor storm drain inlet protection and silt fence failure was observed at both sites (Table 6.25). The County should conduct inspections at these sites to ensure that ESC problems have been properly addressed, and that the sites have been stabilized to prevent further erosion.

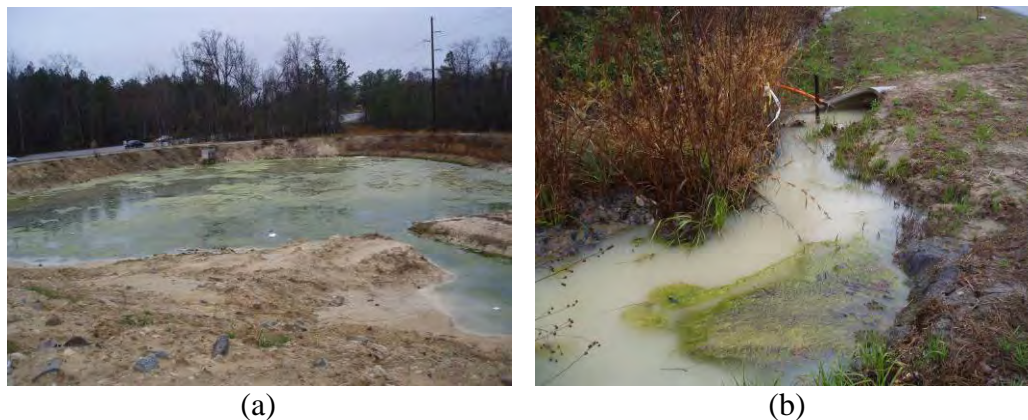
Figure 6.19. Site F-RRI-28 (a) soil needs to be stabilized and (b) sediment laden outflow from the stormwater pond.

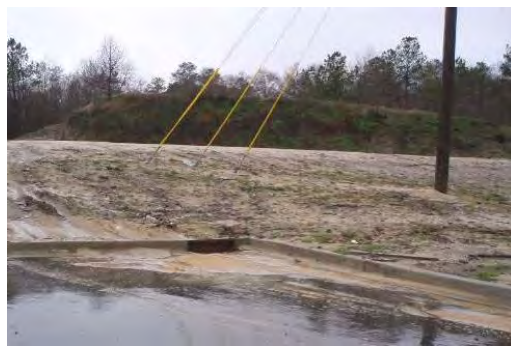
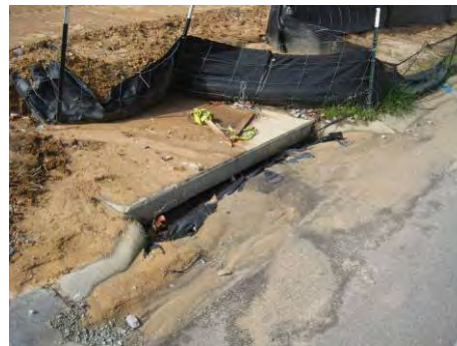
Figure 6.21. ESC problems identified in Subwatershed F. (a) lack of ESC at site F-ESC-1 and (b) failing ESC at site F-ESC-3.

Three ESC sites were identified in subwatershed F. The Killian Lake Apartments (F-ESC-1) were identified as a high priority site as the site was developed with no ESC practices. It is interesting to note that this site was also noted for failed ESC practices in the 2009 Genesis Consulting Group report. Additionally, problems were noted at an inactive construction site with unstable soils at Longtown Commons (F-ESC-2) and at a development site with poor ESC at construction entrances (E-ESC-3) (Table 6.31 and Figure 6.21). Each ESC site should be field investigated and remediated.

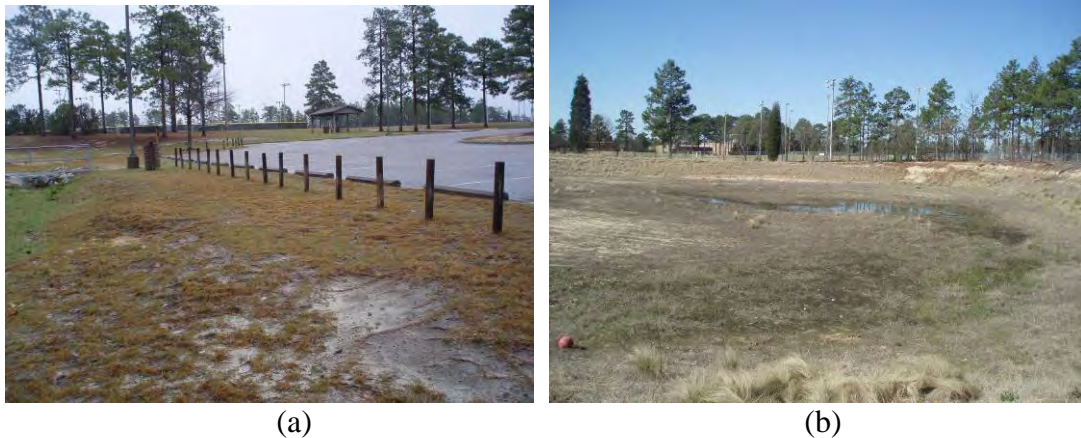
Figure 6.22. (a) Location for a potential bioretention (G-RR1-38) and (b) Location for vegetation planting at an existing stormwater pond.

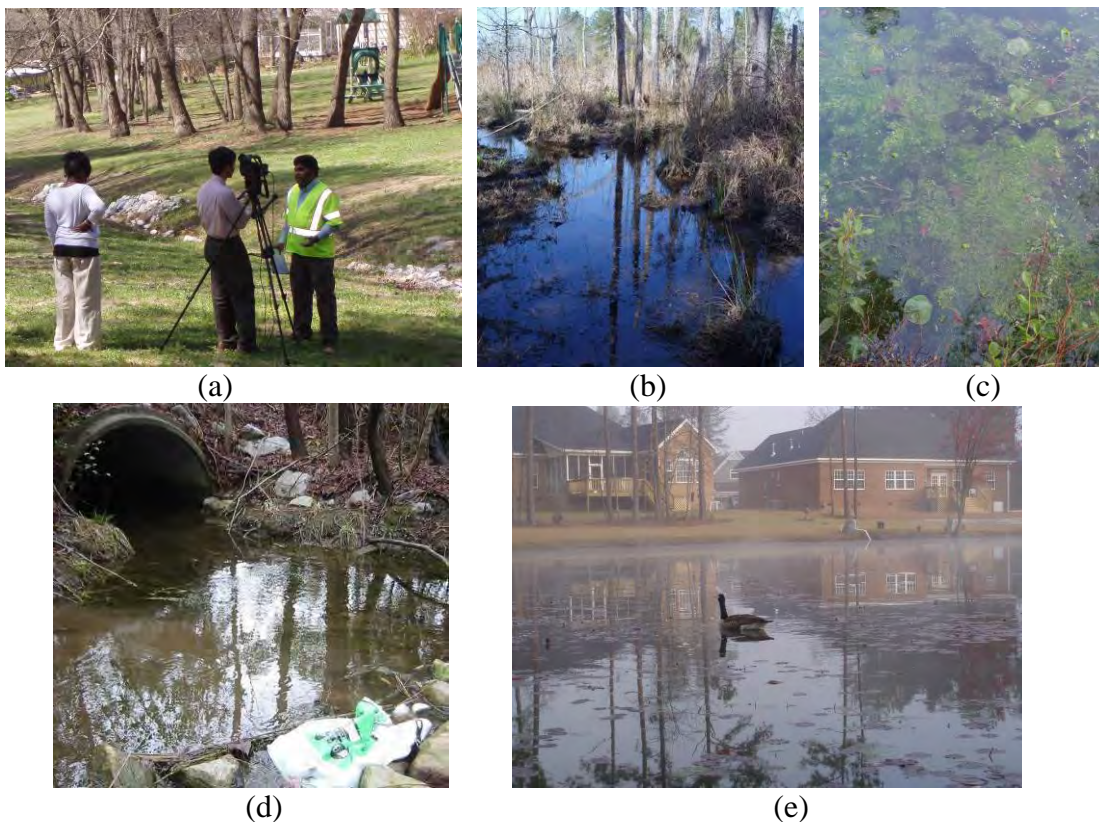
Figure 6.23. (a) Very poor stream reach G-RCH-6 and impacted buffer G-IB-3 in G-NSA-14; (b) wetland associated with excellent rated stream reach G-RCH-12; (c) algae in pond; (d) fertilizer bag found in stream (G-TR-2) in G-NSA-2; and (e) representative pond with geese and algae (G-RCH-7 in G-NSA-2).

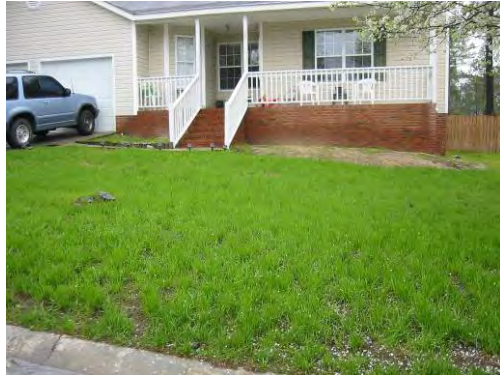
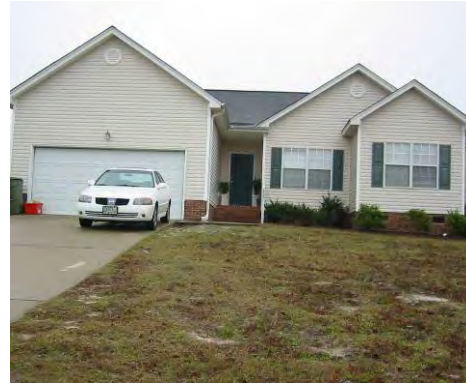
Figure 6.24. (a) High fertilizer use G-NSA-8 and (b) spots of bare soil at G-NSA-2.

Thirteen neighborhoods were assessed for sources of pollution and restoration potential (Table 6.35). One neighborhood was identified as high priority, three medium priority and nine as low priority. All of the neighborhoods except G-NSA-3, G-NSA-1, G-NSA-7, and G-NSA-10 have portions of Crane Creek running through the residential backyards. These neighborhoods present good opportunities for residential education and outreach on stream protection. It should be noted that high lawn care maintenance was observed in G-NSA-2, G-NSA-7, G-NSA-8, and was associated with high algae levels in nearby stream reaches G-RCH-1, G-RCH-7, G-RCH-9 (Figure 6.24). Nutrient management and fertilizer education opportunities for pollution control were noted in these neighborhoods. Residential lawns were also found to be a source of sediment throughout the subwatershed due to the presence of sandy soils. It is recommended that turf matting and/or mixing rye grass with permanent grass is used for stabilization in areas with sandy soils. Also, opportunities for residential restoration projects included planting trees, installing rain gardens and street retrofits, and planting stream buffers.
