DRAFT Crane Creek Watershed Management Plan

PREPARED FOR:

Richland County Department of Public Works
400 Powell Road
Columbia, South Carolina 29203

CENTER FOR
WATERSHED
PROTECTION

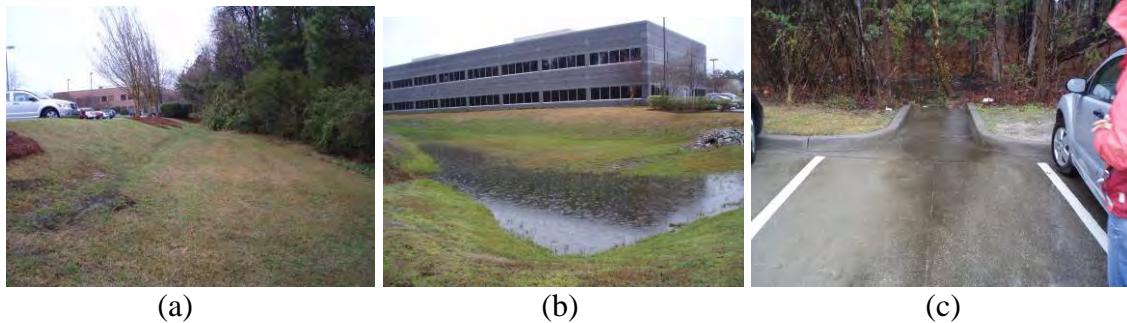
Figure 6.25. (a) Potential location of a bioretention cell at site H-RRI-23. (b) pond retrofit opportunity at H-RRI-200. (c) treatment opportunity at site H-RRI-24A.

Four stormwater retrofit projects were identified in subwatershed H (Table 6.37). Three potential projects involve creating a bioretention area to treat parking lot stormwater runoff (Figure 6.25). Sites H-RRI-24A and H-RRI-24B involve the conversion of existing parking spaces to bioretention and/or permeable pavement. The proposed concept at site H-RRI-200 involves enhancing an existing stormwater pond to provide water quality treatment of the SC DHEC office building and parking lot. Currently, runoff from the parking lot by-passes an existing water quantity pond. The pond outlet can be modified and the pond converted to a wetland system for enhanced water quality treatment and pollutant removal. In addition, a swale can be constructed to direct parking lot runoff into the existing stormwater pond. The projects located on SCDHEC and the HealthPort properties (H-RRI-24A and H-RRI-200, respectively) may provide good opportunities for demonstration projects and education and outreach.

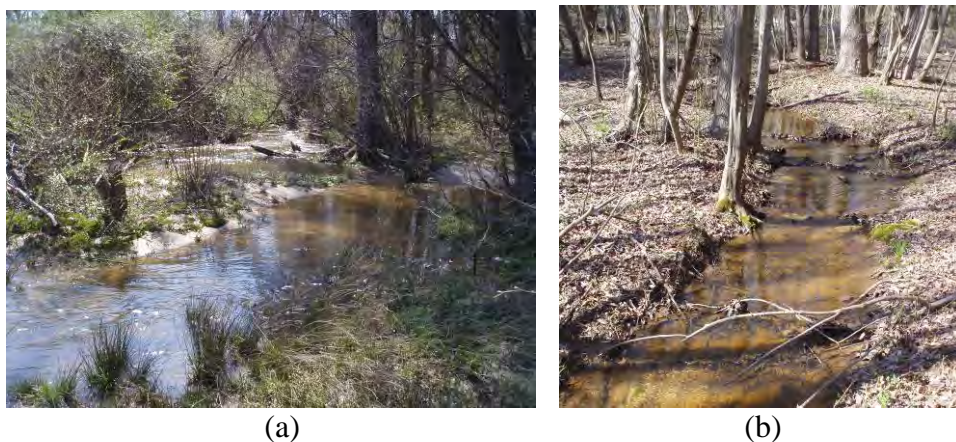
Figure 6.26. (a) Good stream reach H-RCH-30 and (b) excellent stream reach H-RCH-32.

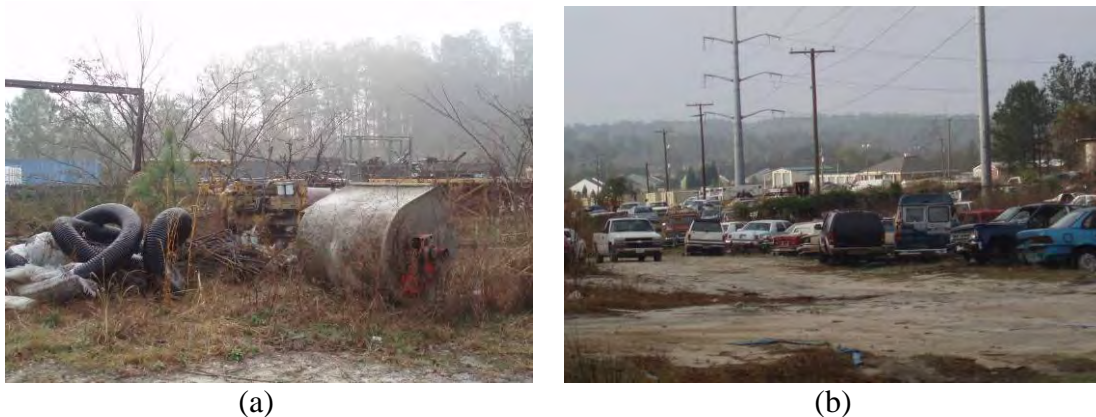
Figure 6.27. (a) Uncovered storage of construction material (H-HSI-20) and (b) auto salvage yard (H-HSI-22).

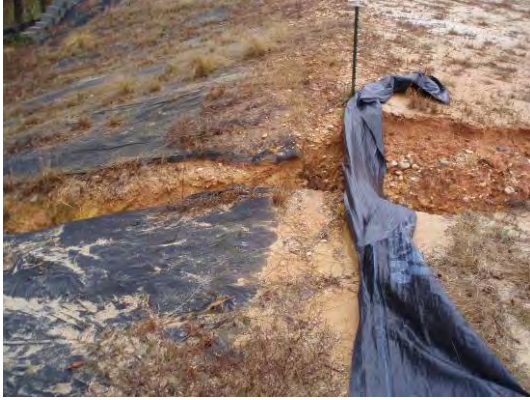
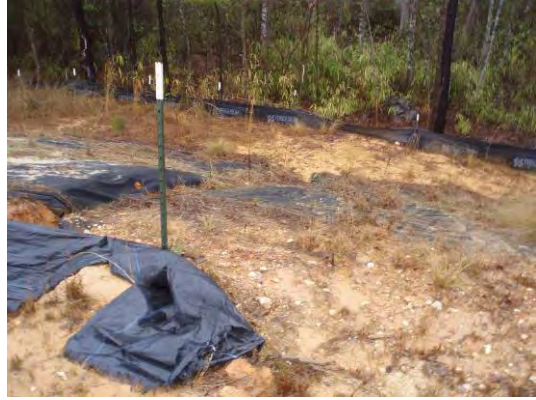
Figure 6.29. (a & b) Failing ESC at site H-ESC-1.

An inactive/abandoned construction site with failing ESC was noted near the Gateway Corporate Park (Table 6.40, Figure 6.29). The site should be stabilized to prevent further sediment from leaving the site and entering the stream.

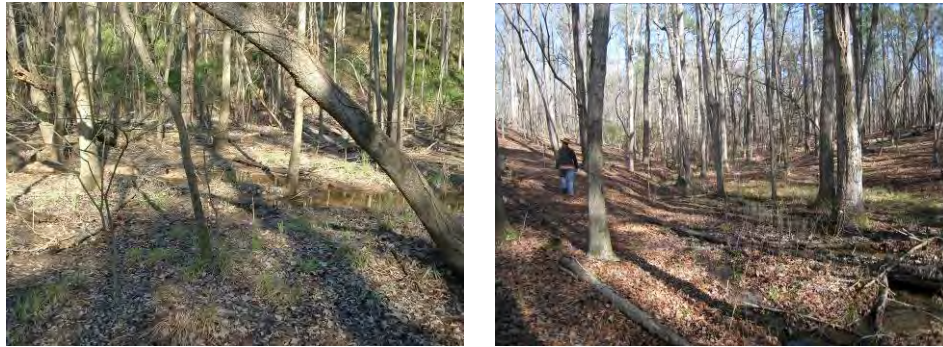
Figure 6.30. (a) High functioning wetland near the mouth of Crane Creek (M-WP-1) and (b) bottomland hardwood forest in Lower Crane Creek (J-FP-1).

Conservation opportunities in the Lower Crane Creek subwatershed are a mix of protection and habitat restoration strategies. The region northwest of the Crane Creek mainstem offers opportunities for protection and reforestation efforts. One forest site was visited (J-FP-1) and was composed of a bottomland hardwood mix (Table 6.41). Two wetlands that were assessed near the mouth of Crane Creek (M-WP-1 & M-WP-2) were determined to have overall high functional values (Table 6.42 & Figure 6.30). These areas, along with the mainstem corridor, are high priority for protection strategies such as acquisition, TDR and easements.

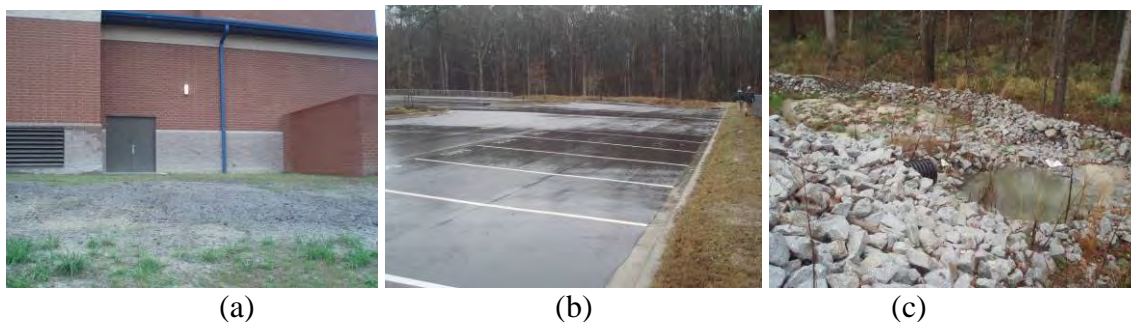
Figure 6.32. (a) Downspouts at site I-RRI-17; (b) southwest corner of lot drains most site; and (c) rip-rapped stilling basin discharging stormwater into nearby forested area.

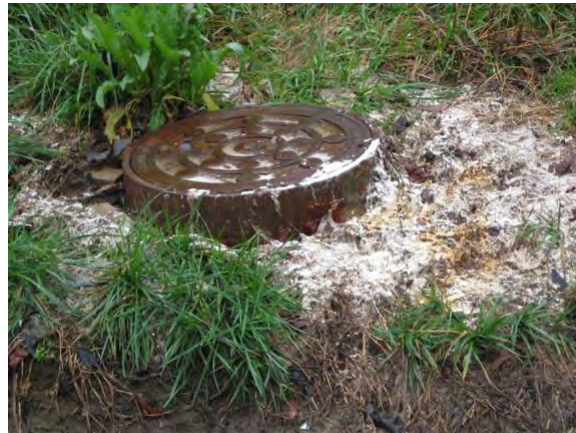
Figure 6.35. Evidence of sewage overflow in the Highland Forest neighborhood.

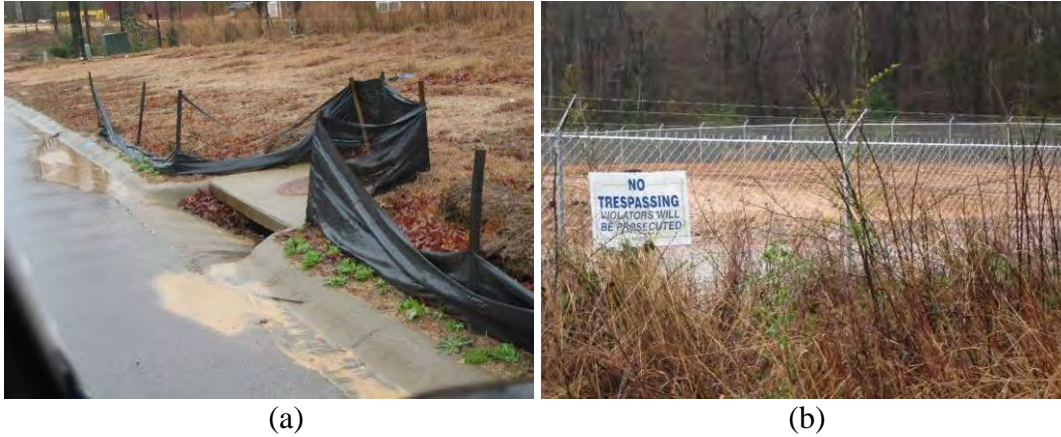
Figure 6.36. (a) Poor ESC practices at Hastings Point development (I-ESC-2) and (b) new development without ESC at Whitaker Container Service (I-ESC-1).

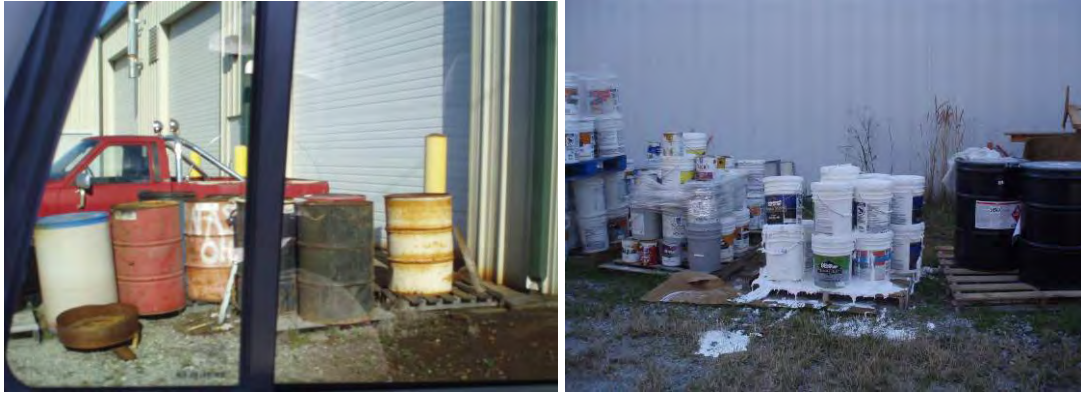
Figure 6.40. (a) Storage of 55 gallon drums at Plinkington Advanced Technologies (K-HSI-3) without cover or secondary containment and (b) leakage and spilling from paint containers at 1 Sunblet Ct. (K-HSI-4).

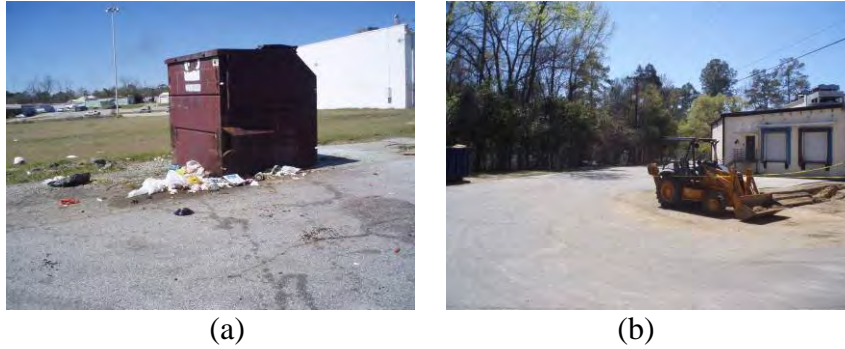
Figure 6.44. (a) Trash collecting outside of a dumpster at the Piggly Wiggly (L-HSI-10) and (b) material stored without cover or tarp at the Dollar General Shopping Center (L-HSI-11).

Three hotspots were assessed in subwatershed L (Table 6.60). All three were determined to not be a hotspot, however, each site should be included in future education efforts. Poor dumpster management was identified as a problem at the Piggly Wiggly (L-HSI-10) (Figure 6.44). Likewise, at the Dollar General Shopping Center (L-HSI-11), material was being stored outside without a cover. Because impervious cover is directly connected to the storm drain system at this location, proper storage of materials can help to avoid accidental inputs of pollutants into the stream system.

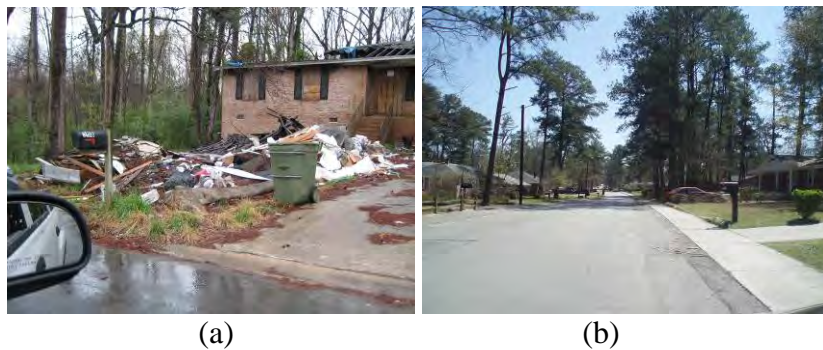
Figure 6.45. Trash accumulation at abandoned house in Hollywood Hills (L-NSA-1 & L-NSA-2) and (b) potential location of retrofit opportunity in the Westmore /Gavilan neighborhood where road ditches could be converted to bioswales (L-NSA-20).

Neighborhoods assessed in subwatershed L would benefit from a broad educational campaign to encourage residents to plant trees and landscape lawns with native materials (Table 6.61). Neighborhoods had generally low tree canopy coverage and some had accumulations of trash (Figure 6.45). In addition, none of the neighborhoods that were assessed had storm drains marked or stenciled, a practice which can help to raise awareness of stormwater in neighborhoods. A potential retrofit opportunity was identified in the Westmore/Gavilan neighborhood (L-NSA-20). Road-side ditches could be retrofitted to biowswales to provide treatment of stormwater before it enters the storm drain network.

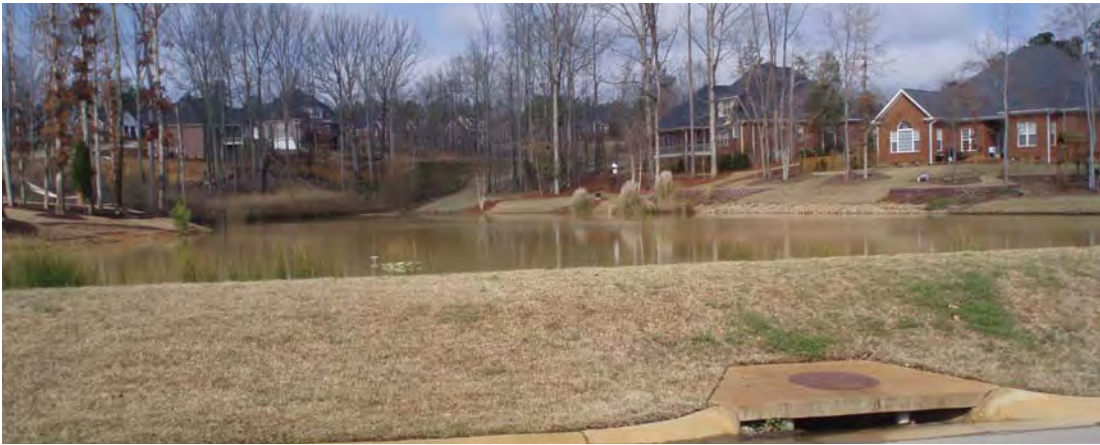
Figure H.1. Wet pond in need of maintenance. Also, a no-mow zone should be established around the pond perimeter.

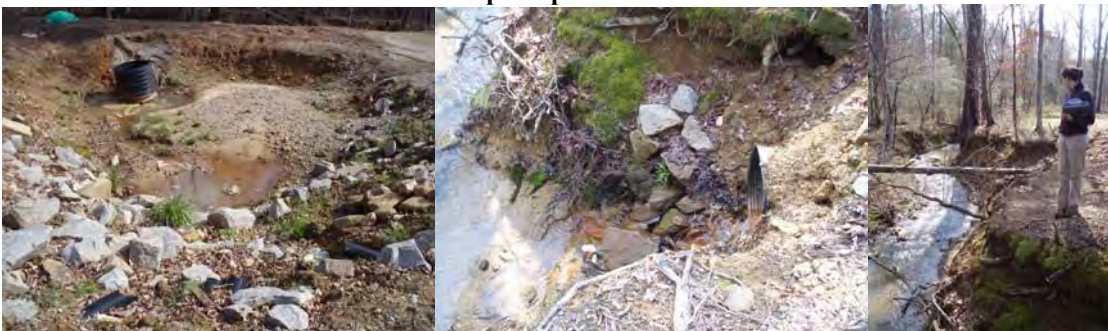
Figure H.2. Third pond in series which is undersized, badly eroded, and on the verge of failure. Stabilization and repair are needed to prevent blow-out of this pond into Beasley Creek.

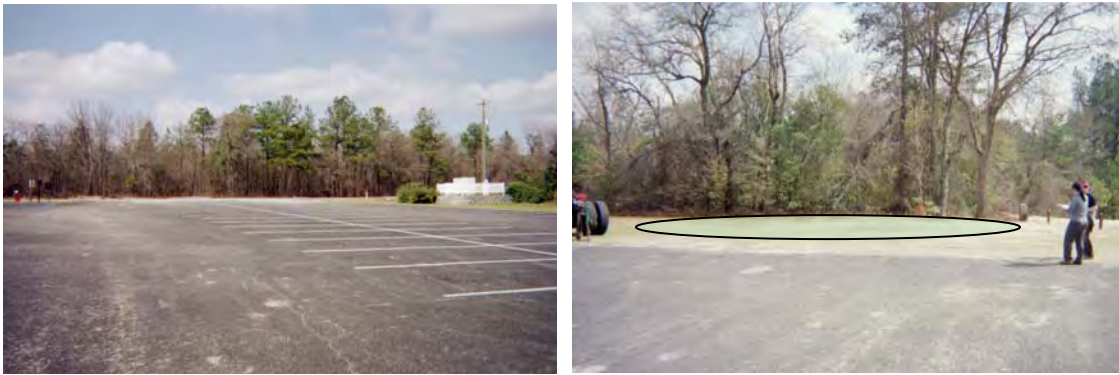
Figure H.4. (a) Killian Park parking lot and (b) proposed bioretention location.

Proposed Practice: Construct a rain garden to capture and treat runoff from the parking lot. The raingarden should have a 6-9” ponding depth and be planted with native plants. Educational signage should be installed adjacent to this project.

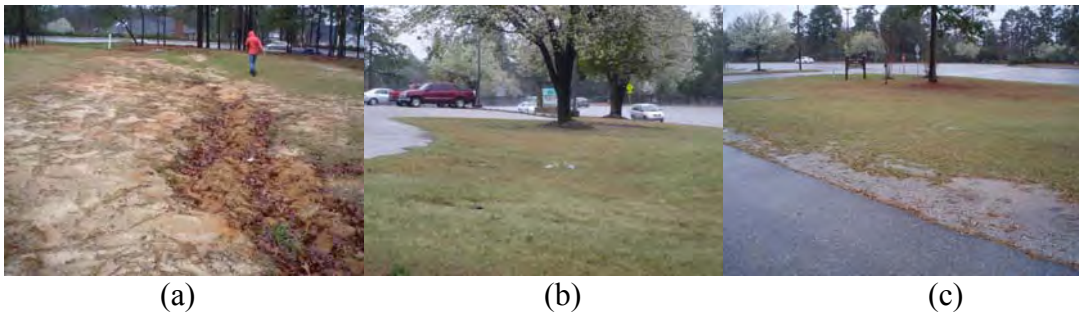
H.5. (a) North Spring Park eroded swale carries untreated stormwater runoff from a parking lot into the storm drain system and (b & c) Proposed locations of bioretention facilities.

Proposed Practice: Construct up to four bioretention facilities in the grassed areas adjacent to the parking lot to capture and treat runoff from the lot, roof of an outbuilding, and tennis courts. The bioretention areas should have a 6-9” ponding depth and be planted with native plants. An existing berm can be modified to provide ponding. The practice overflow should tie back into the existing drainage system.

This project would serve as an excellent demonstration site and would also capture and treat runoff from almost all of the site parking areas. The bioretention areas should be designed around large trees so as not to flood and drown them. Utilities at the site should be avoided.

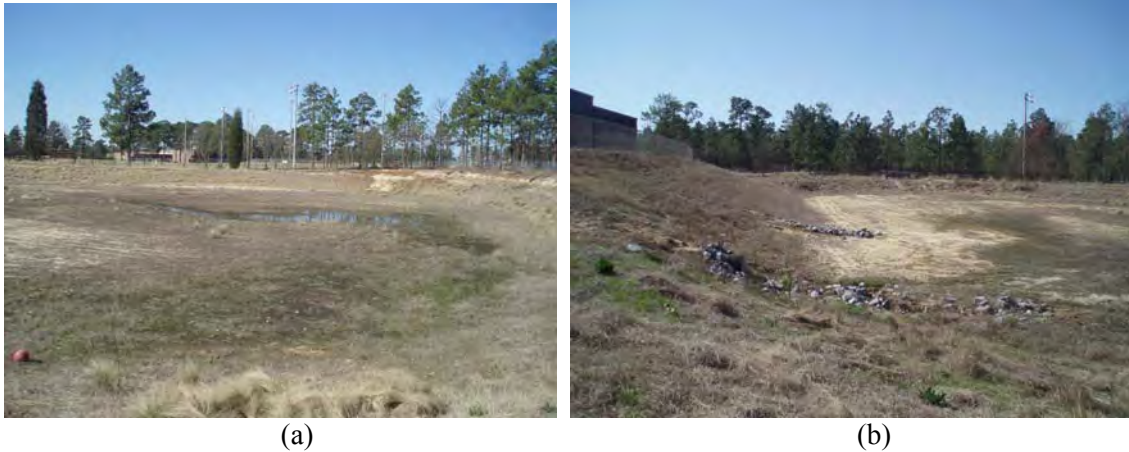
Figure H. 6. (a) Infiltration pond at North Springs Elementary school and (b) Drainage from the school's rooftop (background) and parking lot (foreground).

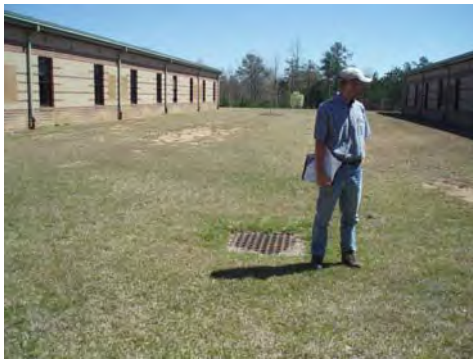
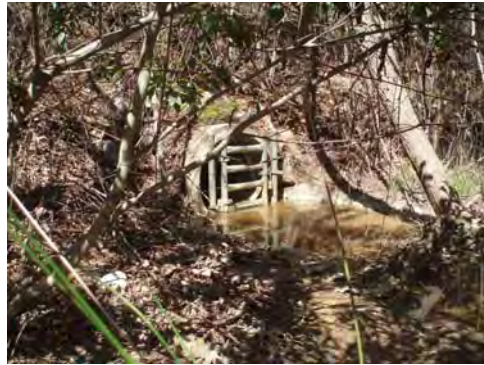
Figure H.8. (a) Proposed bioretention area at Forest Heights Elementary School; (b) outlet from the storm drain system facility that flows to a wetland area. This portion of the site did not appear to receive any stormwater treatment.

Proposed Practice: Two locations were identified for creating bioretention areas on the south side of the school (Figure H.8). Ponding depth would be excavated to approximately 1 foot at the deepest point. Due to the sandy nature of the underlying soils, no underdrain will be necessary for the practice design. Existing catch basins can be used to capture overflow. Additional opportunities for tree plantings exist at this site.

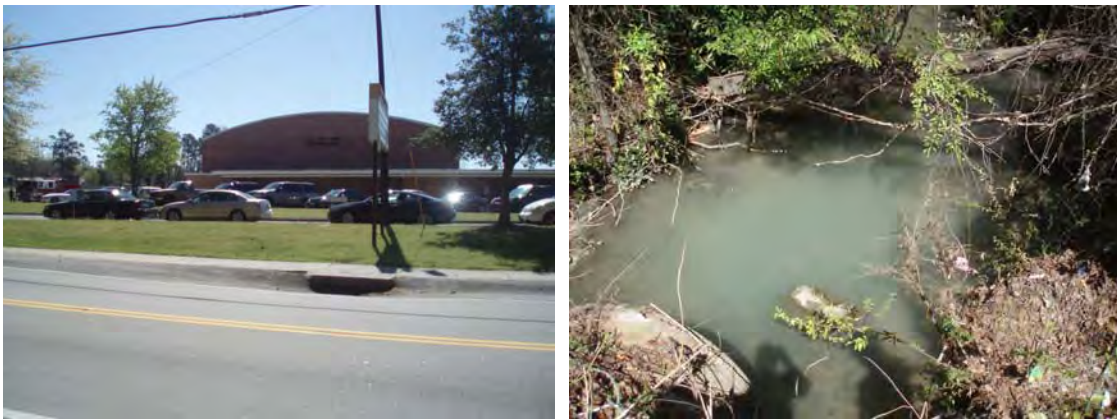
Site Description: A 72” pipe from a nearby subdivision runs under the athletic fields at this site. Runoff from the school enters the pipe via catch basins and yard drains (Figure H.9). Many of the catch basins observed by field crews were partially clogged. The top of pipe was determined to be approximately 1’ below grade at the south catch basin.

Proposed Practice: Numerous opportunities for downspout disconnection and bioretention are proposed, especially on the south side of the school. The entire site could be treated with these practices. A potential opportunity exists to daylight the 72” storm drain pipe in the open field. Because the school was due to close in the summer, 2009, opportunity exists to implement these proposed practices when the lot is converted or sold.

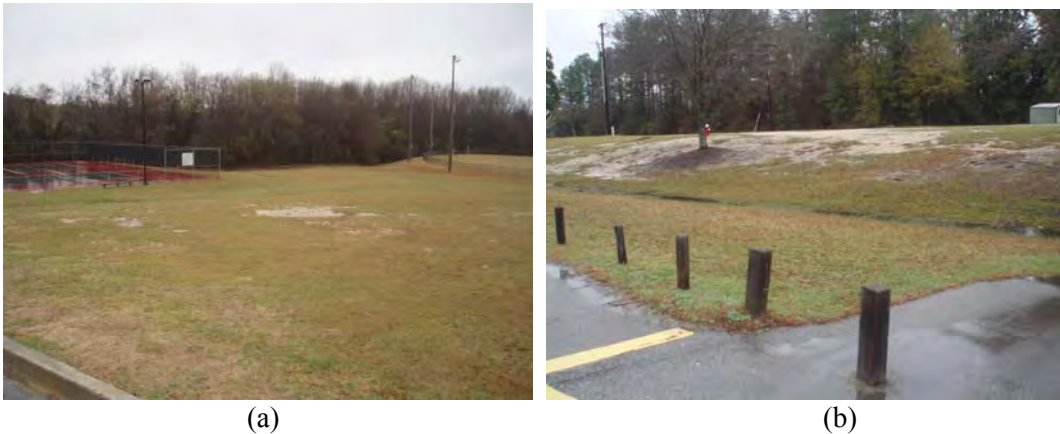
Figure H.10. (a) Much of the runoff at the Medowlakes Recreation Center drains via sheetflow to a nearby buffer and (b) An existing swale at the site could be enhanced with plantings.

Site Description: Much of the runoff from the Medowlakes Recreation Center site drains via sheetflow to a nearby forested buffer area (Figure H.10). Grass channels from the parking area convey the stormwater off-site. The building on-site is essentially disconnected from the stormdrain system.

Proposed Practice: Since the site is largely disconnected already, improvements would be primarily for demonstration purposes. The existing swale near the parking area could be enhanced with a planting of native vegetation. Educational signage can be installed so that patrons of the site are aware of Richland County efforts to improve water quality.

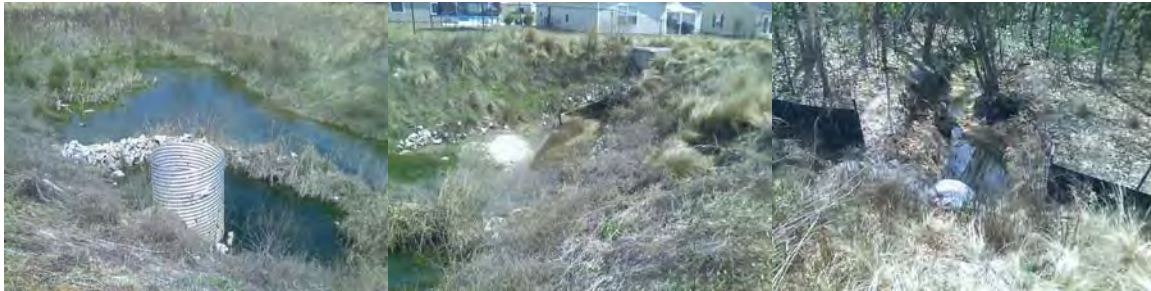
(a) (b) (c)
Figure H.11. (a) Algae in stormwater pond; (b) Sediment accumulation from development in stormwater pond; and (c) Outlet of stormwater pond into wooded area.

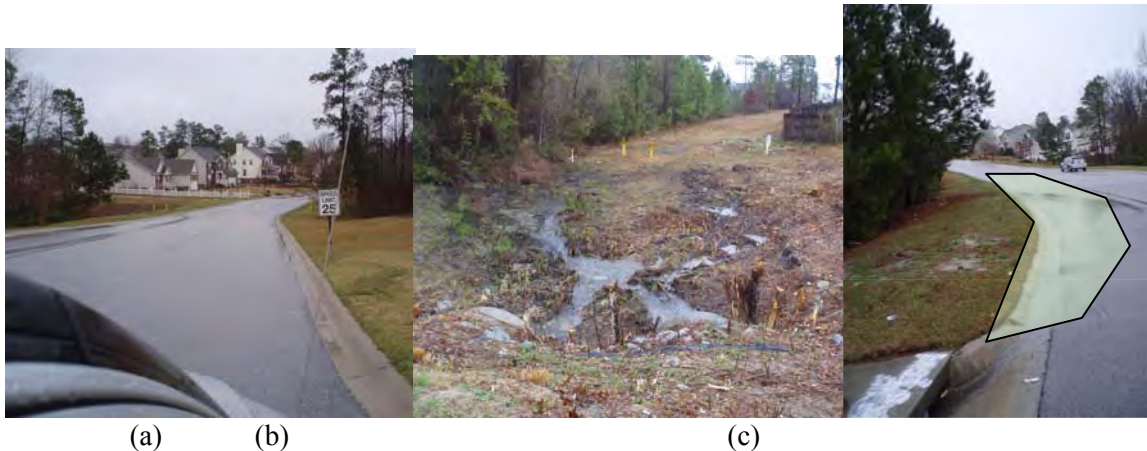
Figure H.12. (a) Alderston Rd. conveys untreated stormwater runoff to (b) a tributary of Upper Crane Creek. (c) Proposed retrofit location.

Site Description: Untreated stormwater runoff from Shamley Green and Alderston Roads drains to a tributary of Upper Crane Creek (Figure H.12). Land use in the drainage area is single family homes on ½ acre lots. Runoff from residential lawns, driveways, and rooftops is conveyed into the street, which drains directly to the creek tributary. The existing roadway is very wide, approximately 40' in width.

Proposed Practice: Create a bump-out bioretention area with a 6-9" ponding depth in the roadway. The bump-pout would be approximately one car-width wide. Construct storm drain berms up-slope, along roadway inlets, to divert runoff from low flows and small storms to the bioretention area. Stabilize the inlet and modify the outlet to provide appropriate ponding. The project has the potential to capture a large area of roadway, residential lawn, driveway and rooftop runoff. The drainage area to the proposed retrofit assumes diverting low flows of four upstream inlets; this volume can be reduced if necessary. This design would serve to calm and slow traffic.

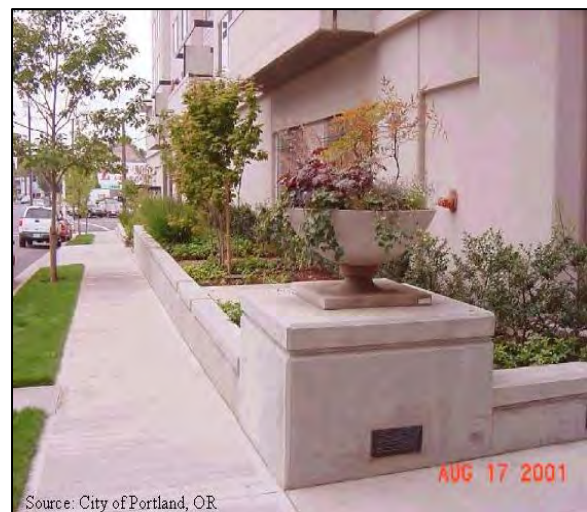
Figure 1: Portland Stormwater Planter

Two basic design variations for stormwater planters are the infiltration planter and the filter planter.

An **infiltration planter** filters rooftop runoff through planter soils followed by infiltration

into soils below the planter (Figure 2). The recommended minimum width is 30 inches; length and shape can be decided by architectural considerations. The planter should be sized to temporarily store at least one-half inch of runoff from the contributing rooftop area in a reservoir above the planter bed. Infiltration planters should be placed at least ten feet away from a building to prevent possible flooding or basement seepage damage.

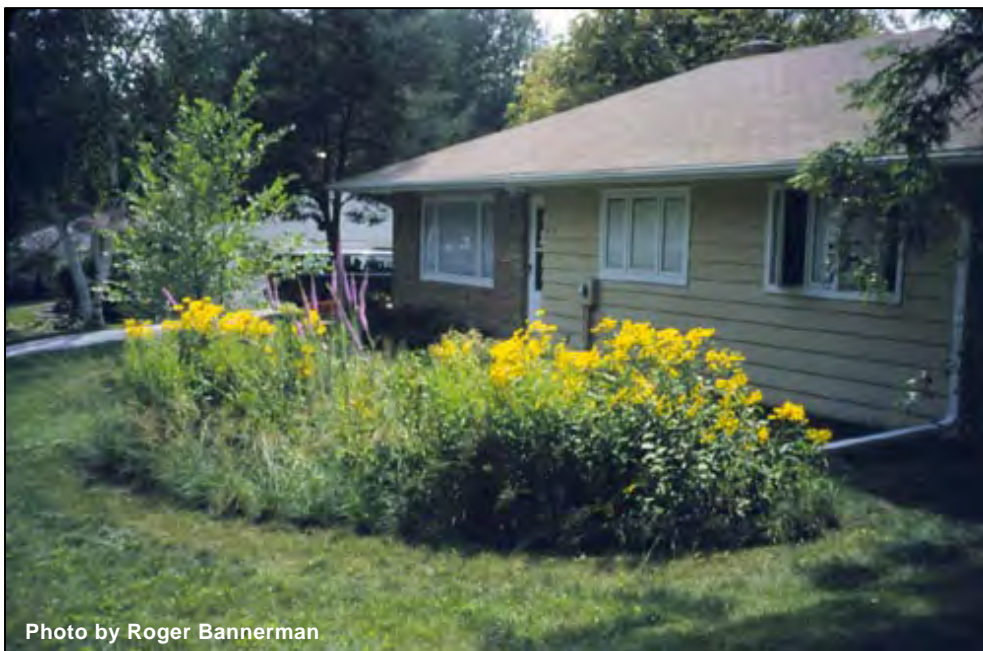
Figure 1: Rain Garden

Rain gardens are essentially a non-engineered form of bioretention that treats rooftop runoff from individual roof leader. (see Profile Sheet ST-4). Because each rain garden treats a rather small area, dozens or hundreds are needed to make a measurable difference at the subwatershed level. Consequently, widespread homeowner implementation of rain gardens requires targeted education, technical assistance and financial subsidies.

To ensure that the water flows from the impervious surface to the garden, maintain at least a 1% slope from the lawn down to the rain garden (a shallow swale can be used). A downspout extension can be used to direct rooftop flow into the garden.

Construction - Construction of rain gardens is simple but requires physical labor to dig the garden, prepare the soil, and plant desired species. Select plants that have a well-established root system and plant them approximately one foot apart (UWEO, 2002). More information on how to install rain gardens can be found online in the Further Resources section.

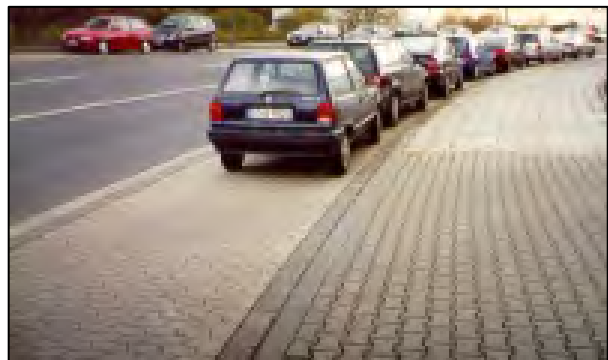
Figure 1: Permeable Pavement

When evaluating a proposed permeable paver retrofit, designers should assess the same constraints for infiltration practices (see Profile Sheet ST-6d in Appendix I). Additional factors to consider include traffic volume and the intended use and ownership of the surface. Permeable pavers are much more versatile, because they do rely less on soil infiltration as compared to surface storage to provide runoff treatment.

Regional and Climate Concerns - Permeable pavers can be applied in most regions of the country, but needs to be adapted to meet the unique challenges of cold climates. Permeable pavers should not be used when sand or other

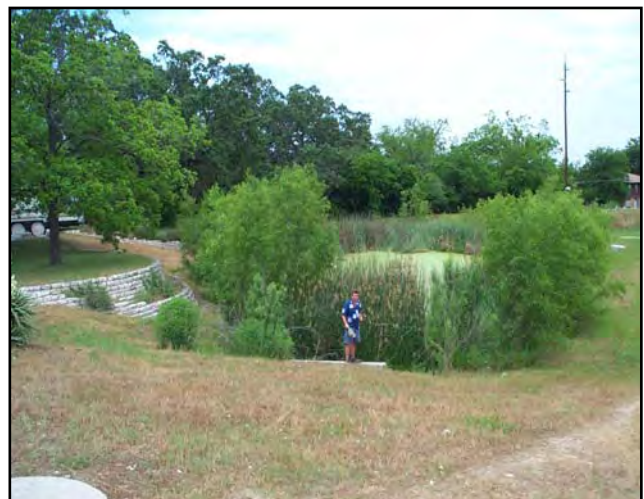
Figure 1: Warm temperatures have led to algal blooms in this wet pond.

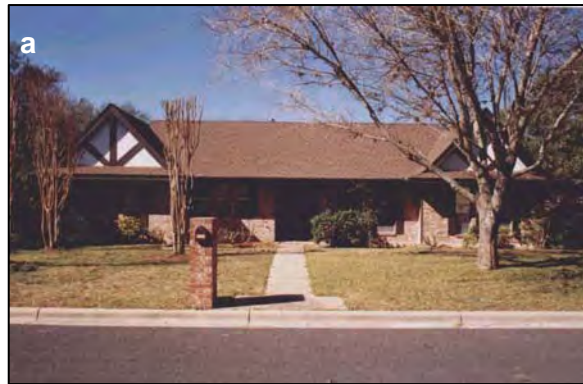
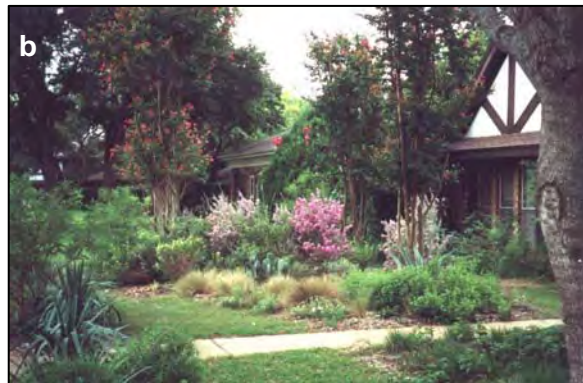
Figure 1: Before (a) and After (b) Natural Landscaping

The cumulative effect of natural landscaping practices on subwatershed quality are hard to quantify, but can provide some clear benefits. First, reduced turf area produces more natural hydrologic conditions in the yard, since mulched beds intercept and adsorb rainfall and can produce less runoff (Figure 1). Natural landscaping also creates native habitats, increases forest cover, and creates a natural seed bank of native plant species in subwatersheds. Natural landscaping can also prevent the spread of invasive non-native plant species into the stream corridor, which is an increasing problem in many urban subwatersheds. English ivy, bamboo, and other fast-spreading non-native species can quickly dominate the plant community of the urban stream corridor.

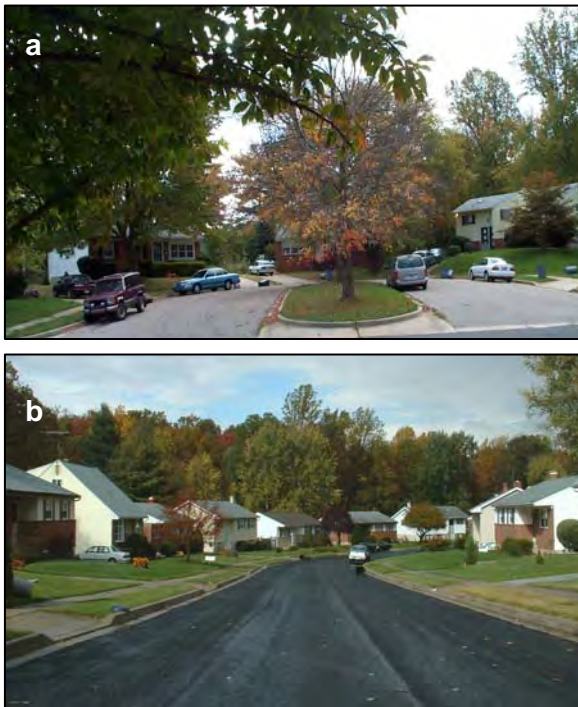
Figure 1: Lots with Extensive Tree Cover (a) and Less Tree Cover (b)

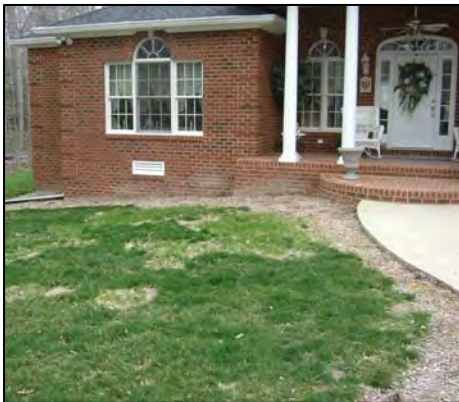
Figure 1: Reseeded Areas on a Lawn

While most yards have extensive vegetative cover, soil erosion can occur on steep slopes, in bare patches, and around driveways. The ideal watershed behavior is to survey the yard for any patches of exposed soils and establish a fast-growing grass or ground cover (Figure 1). The negative watershed behavior is to allow erosion to continue unchecked. In most cases, existing residential yards are exempt from local erosion and sediment control laws, which means that a voluntary approach to erosion control is needed.

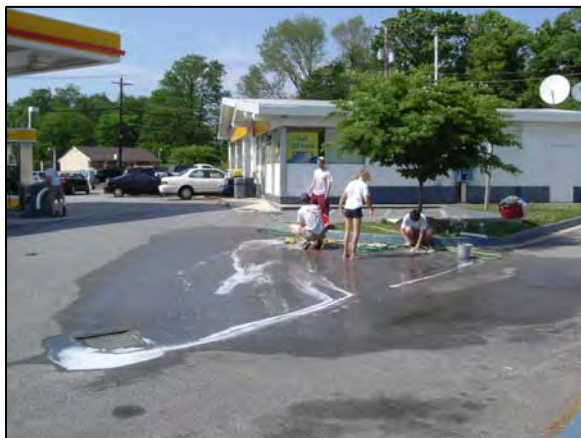
Figure 1: Poor Practices at a Charity Car Wash Event at a Local Gas Station

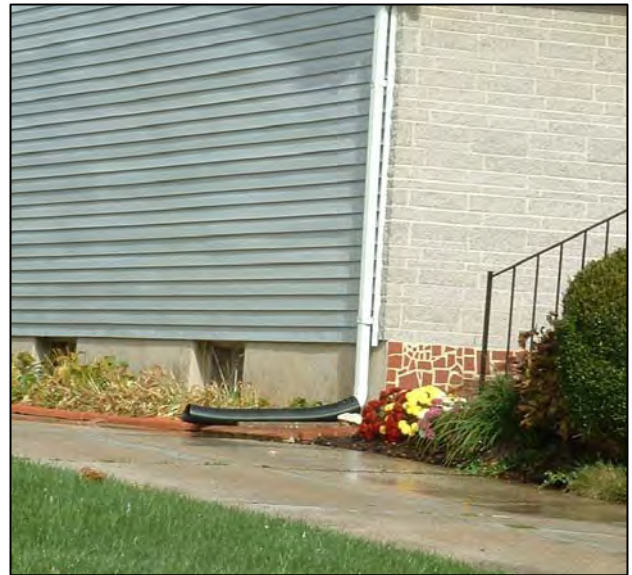
Figure 1: Downspout Intentionally Bypassing Landscaped Area and Draining onto Driveway

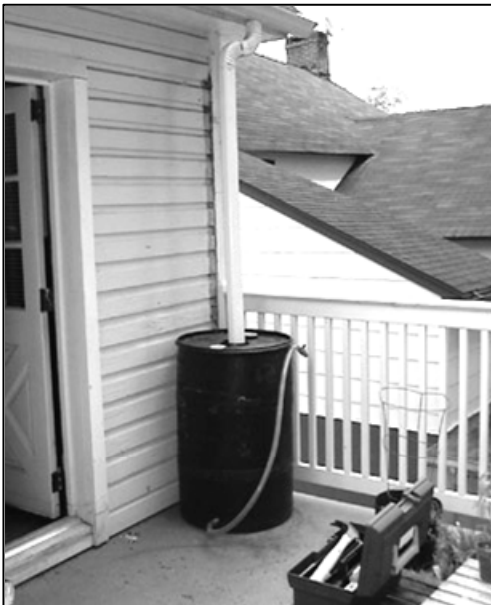
Figure 2: Rain Barrel Used on a Back, Second Floor Balcony

The potential to disconnect downspouts is normally evaluated as part of the Neighborhood Source Assessment component of the USSR survey (see Manual 11). The most important neighborhood factor is the proportion of existing homes directly connected to the storm drain system. Negative neighborhood factors include the presence of basements, compacted soils, and poor neighborhood awareness or involvement. Positive factors are large rooftop areas that are directly connected to the storm drain system, lots with extensive tree canopy, and good neighborhood housekeeping. In general, large residential lots are most suitable for most disconnection retrofits (1/4 acre lots and larger), although rain barrels can be used on lots as small as 4,000 square feet (Figure 2).

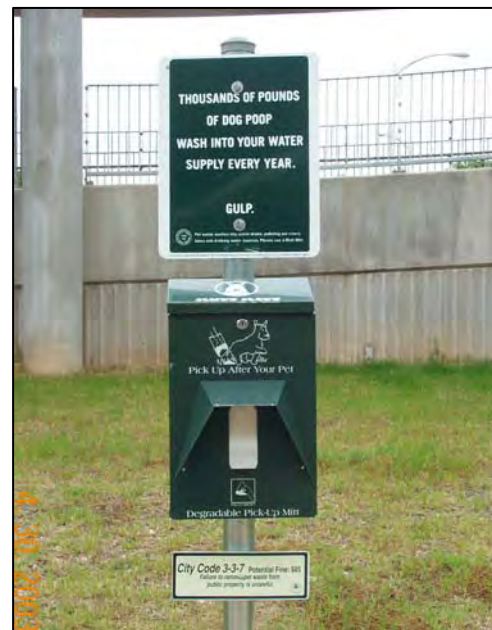
Figure 1: Pet Waste Pickup Station

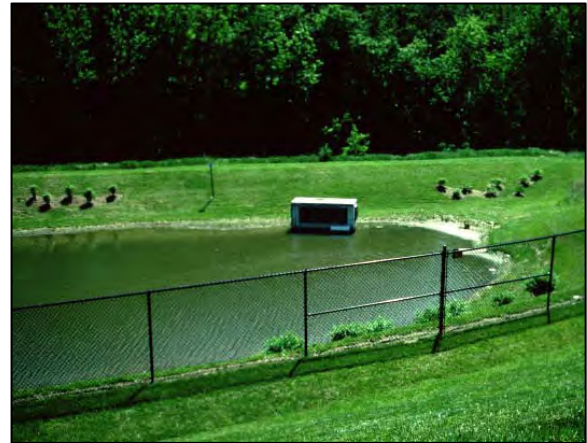
Figure 1: Wet Storm Water Pond

The ideal watershed behavior is to regularly maintain storm water treatment practices, which are normally located in common space managed by a homeowner’s association. The negative behavior is to ignore routine and non-routine maintenance tasks to the extent that the ability of the practice to remove pollutants and protect streams is impaired. Storm water maintenance consists of routine and non-routine tasks. Routine tasks include on-going inspections, mowing, vegetation management, trash and debris pickup, and removal of any obstructions within pipes and riser structures. Non-routine tasks include sediment clean-outs, structural repairs, tree removal, fence repair, and other major tasks performed every five to 10 years.

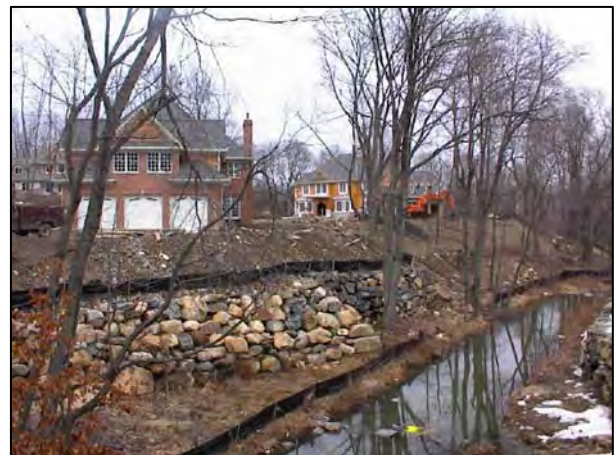
Figure 1: A New Subdivision Encroaching on the Stream Buffer

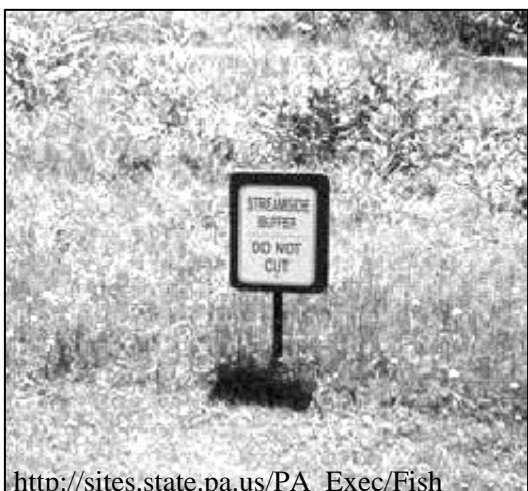
http://sites.state.pa.us/PA_Exec/Fish
Figure 2: Sign Identifying a Buffer Boundary

- Bufferscaping assistance and guides
- Community buffer walks
- Buffer boundary inspections
- Boundary signs (Figure 2)
- Defining unallowed uses in local stream buffer ordinances
- Presentations to community associations
- Adopt-a-stream program
- Financial incentives for bufferscaping

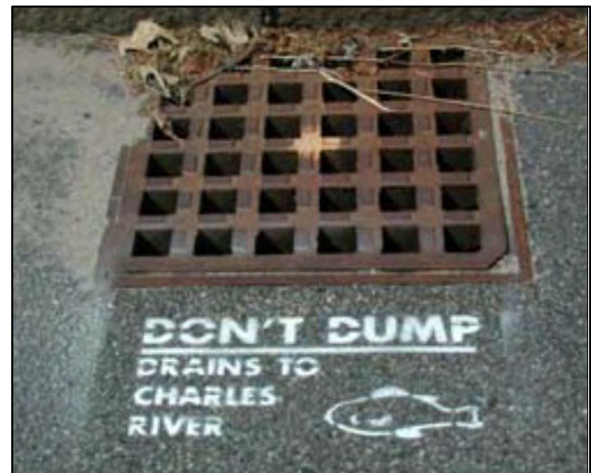
Figure 1: Storm Drain Marking
