Re: Limited Mold and Allergen Investigation Report
Lightsey Bridge II Student Housing, Unit 11C
Clemson, South Carolina 29631
Terracon Project No. 86127158 – Task 87

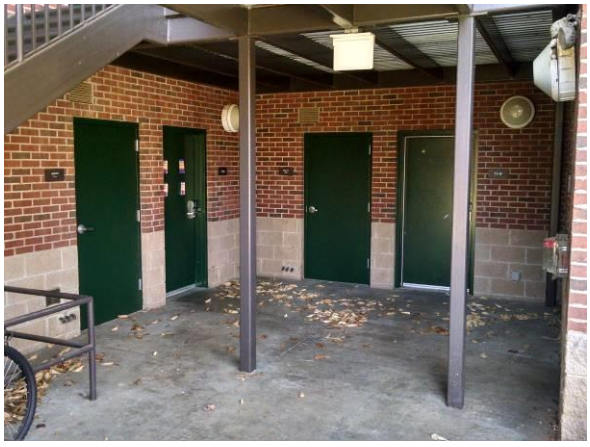
Photo #3 Entrance to unit 11C is on the right

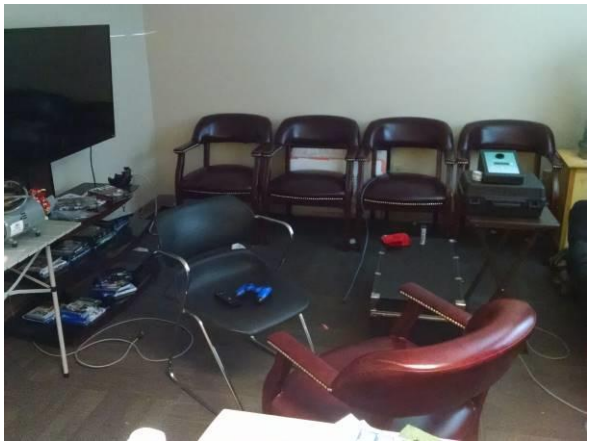
Photo #4 Kitchen area – Unit 11C

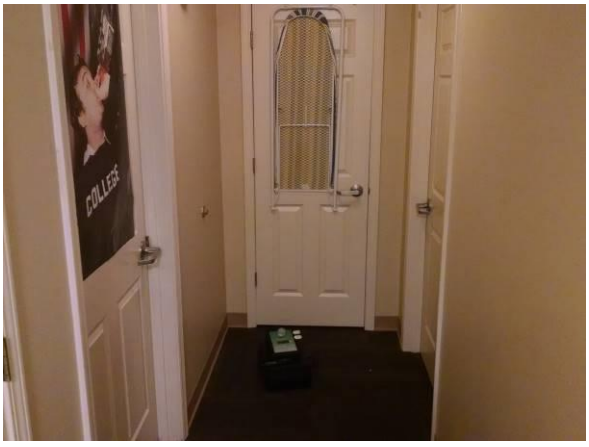
There was no visual evidence of mold growth in the accessible portions of the residence. There was evidence of a previous water leak in the form of a water stain on the ceiling of the common area bathroom vanity. A university-owned dehumidifier was in place and running at the time of our assessment.

Photo #8 Water stain above dehumidifier in Unit 11C

- The source of the water leak should be repaired.

- Confirmation of the drying of the impacted drywall in Unit 11C should be made and if any mold-impacted areas of drywall develop, they should be cut out and replaced. It is not apparent if mold growth has occurred behind the wallboard.

- A similar confirmation and/or repair should occur in the upstairs units where the leak originated. There are two residential units directly above Unit 11C and it is not immediately apparent which of these may have been the source of the water leak.
