March 6, 2018

Re: Limited Mold and Allergen Investigation Report
Manning Hall Student Housing, Unit 8D4
Clemson, South Carolina 29631
Terracon Project No. 86127158 – Task 127

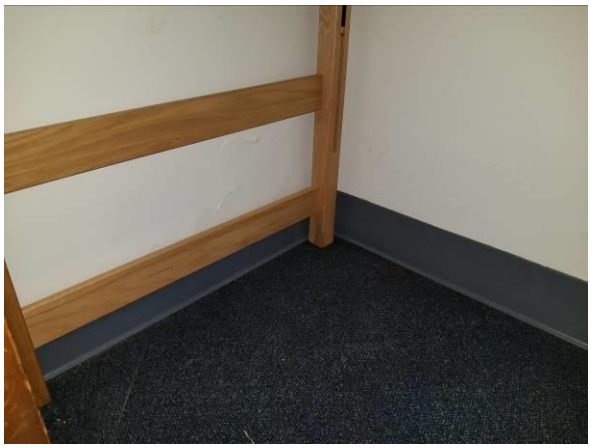
- No evidence of mold growth was observed.
- Damage to an outer wall behind one of the elevated bedframes was observed and appeared to be water-related.
- Water infiltration was also observed beneath carpet square flooring.
- Photographs from the assessment are attached.

There was no visual evidence of mold growth in the dorm room. Wet building materials were observed on the outer wall of the room.

Photo #1 View of water damage on exterior wall in Room 8D4

Photo #2 View of water seepage under carpet squares in Room 8D4

Photo #3 Closer view of exterior wall in Room 8D4

- There was no visual evidence of mold growth in the dorm room at this time. This space should be monitored periodically until the exterior repairs are corrected. In the interim carpeting and the wall should be dried to prevent microbial growth.

- Reportedly, repairs to the curtain wall are scheduled to address water infiltration through the walls during rain events with high winds causing a "driving" rain.
