# KKBE Coming Street Cemetery • Charleston, SC

*Report by Clemson University/ College of Charleston  
Masters in Historic Preservation Program  
Advanced Conservation Spring 2015*

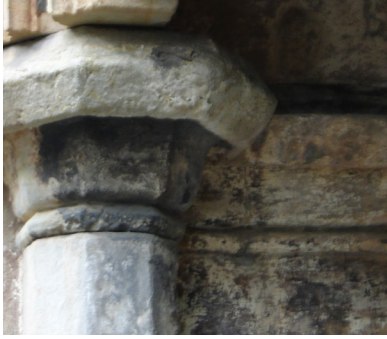
| Black Crust | | An encrustation of the stone that can be either white or black, black crust is caused by formation of deposits on the stone. It is most often found in dense population areas with high levels of pollution. | |

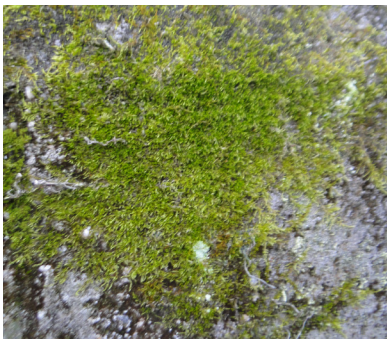
| Biogrowth | | Biogrowth usually occurs in areas of moisture intrusion or poor drainage when biological growth of any kind becomes attached to the surface of the material. Common biogrowth includes mosses, lichens, vines, etc. | |

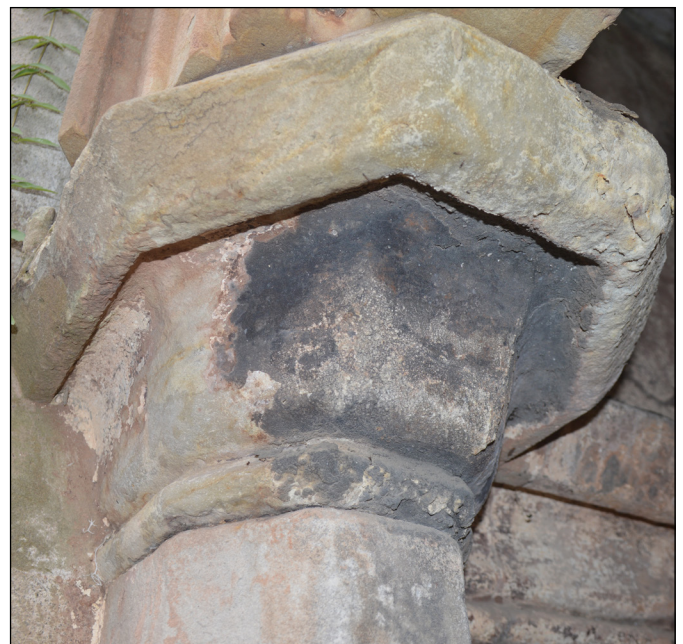
The most interesting deterioration found on the interior of the tomb is the extensive black crust on the inscribed marble slab. Black crust can actually be

white or black. It more commonly occurs in densely populated cities with high levels of pollution. It is an encrustation of mineral deposits that is more concentrated than other soiling patterns. It has caused the marble to become brittle and flake off when touched even very lightly.

Figure 13. Black Crust on the interior of the monument.

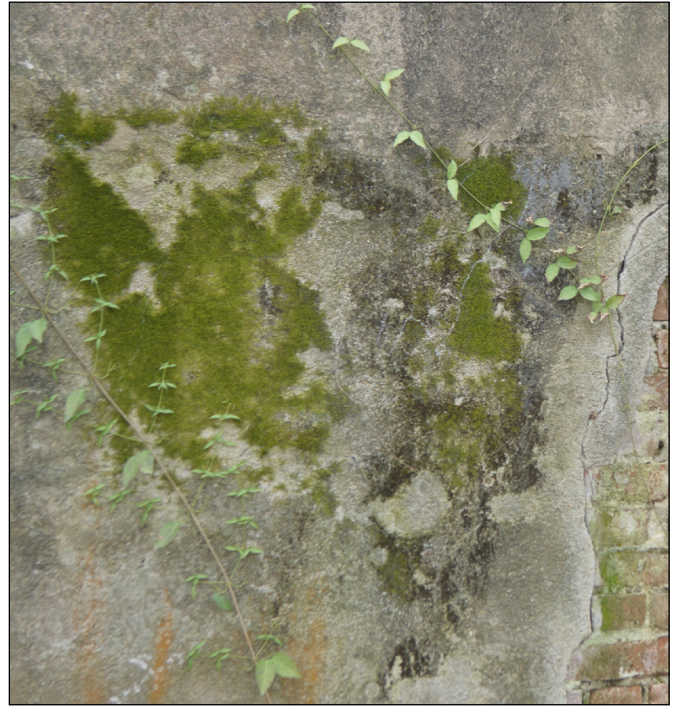
Vines are growing in a few places across the north elevation. The vines reach from the base of the monument to the top. The vines, mostly lie across the surface but they have started to penetrate the lower mortar joints of the section where the stucco has delaminated and left the bricks and mortar exposed. A vine has also grown underneath the slate roofing material into a separation between the roofing material and the masonry structure.

Figure 15. Moss and vines growing on the north elevation

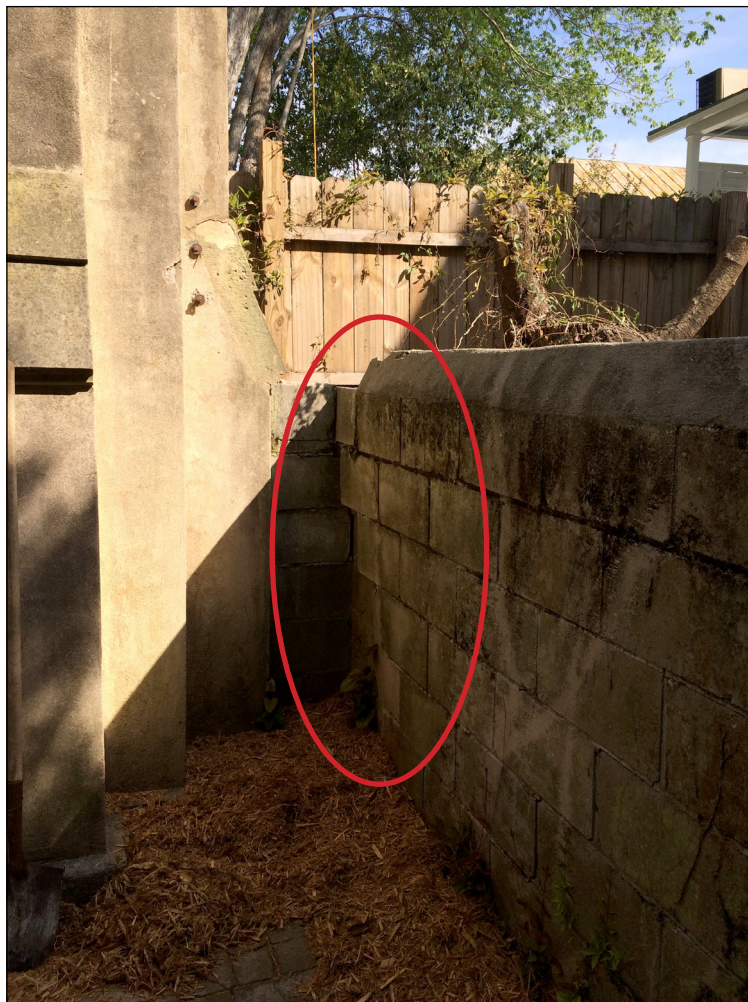
biogrowth is moss and lichen; there are only a few areas of plant growth. Vines at the bottom of the wall have begun to grow up the wall, but have not displaced any material. The biogrowth has stained the CMU. The east wall is bowed in two locations: The northeast corner and in the middle of the wall span. There are deteriorated joints in these areas as well.

Figure 22. Bowing in the northeast corner

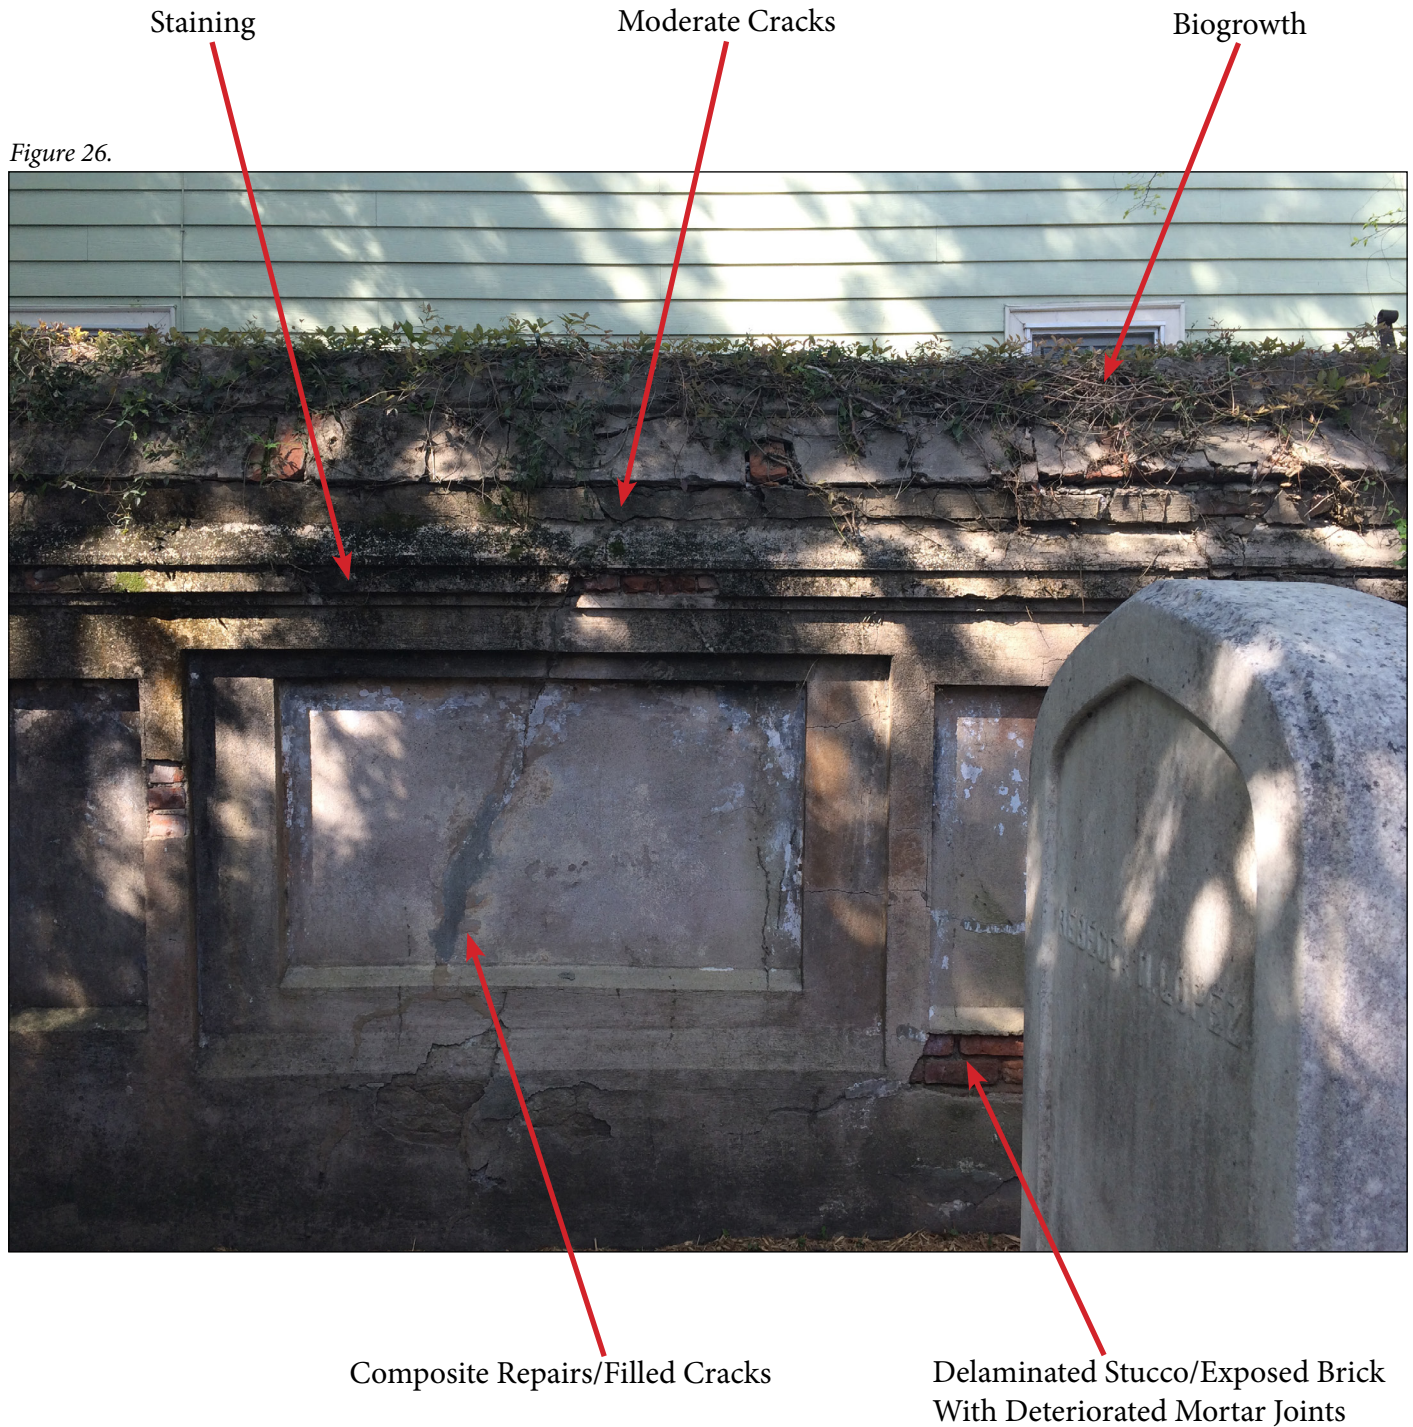
## Typical Conditions of the West Wall

Stucco has delaminated from the brick in many areas. The exposed brick has deteriorated mortar joints and plants that grow in between the bricks. The majority of the cracks in the west wall run horizontally. Some of the vertical cracks have been filled in with portland cement. The entire wall is bowed.

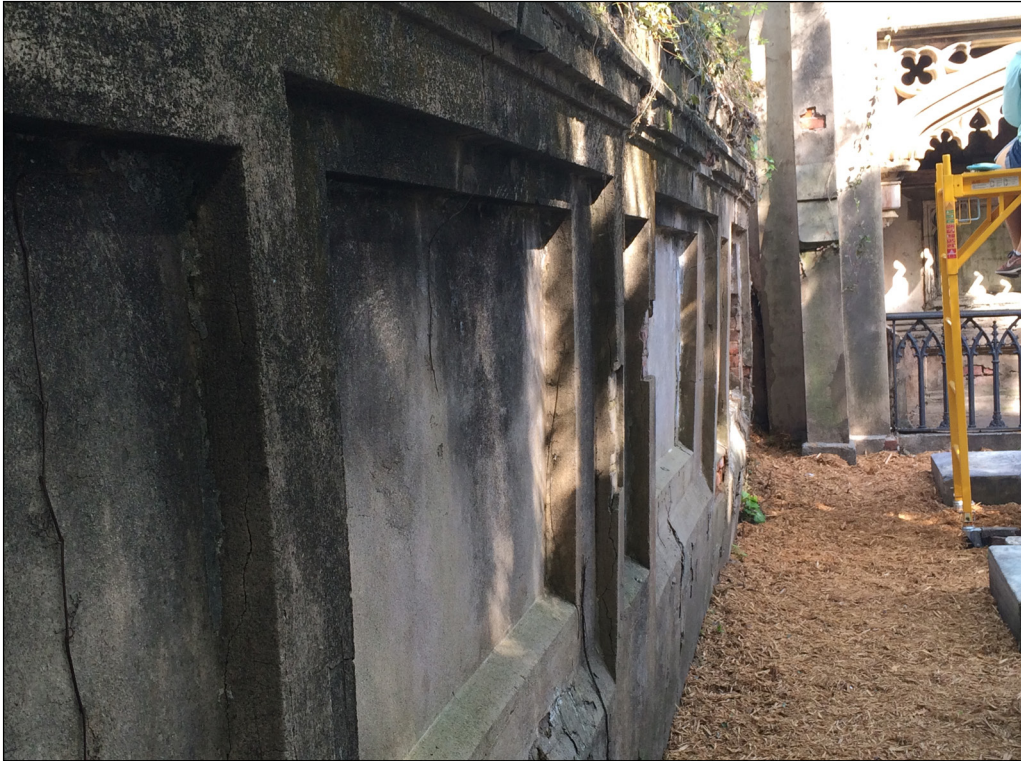
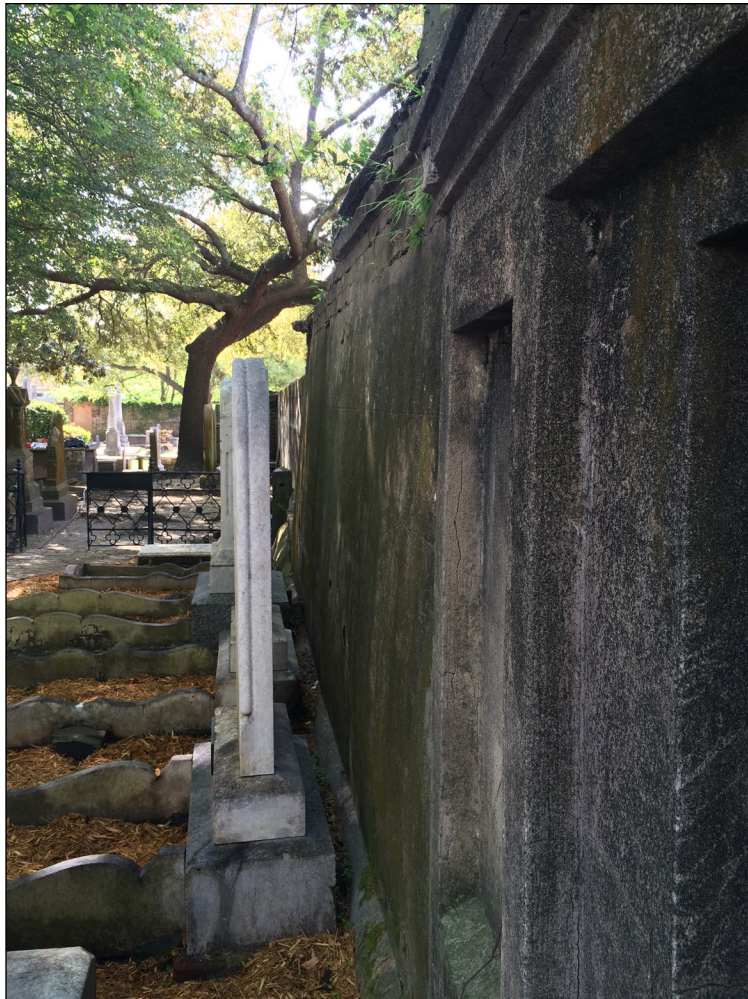
Figure 27 and 28. Bowing on the north (top) and south (bottom) sections of the west wall
