# The Progressive Club

Johns Island, South Carolina

Preservation  
Studio  
Spring  
Term  
2015

Graduate Program in Historic Preservation

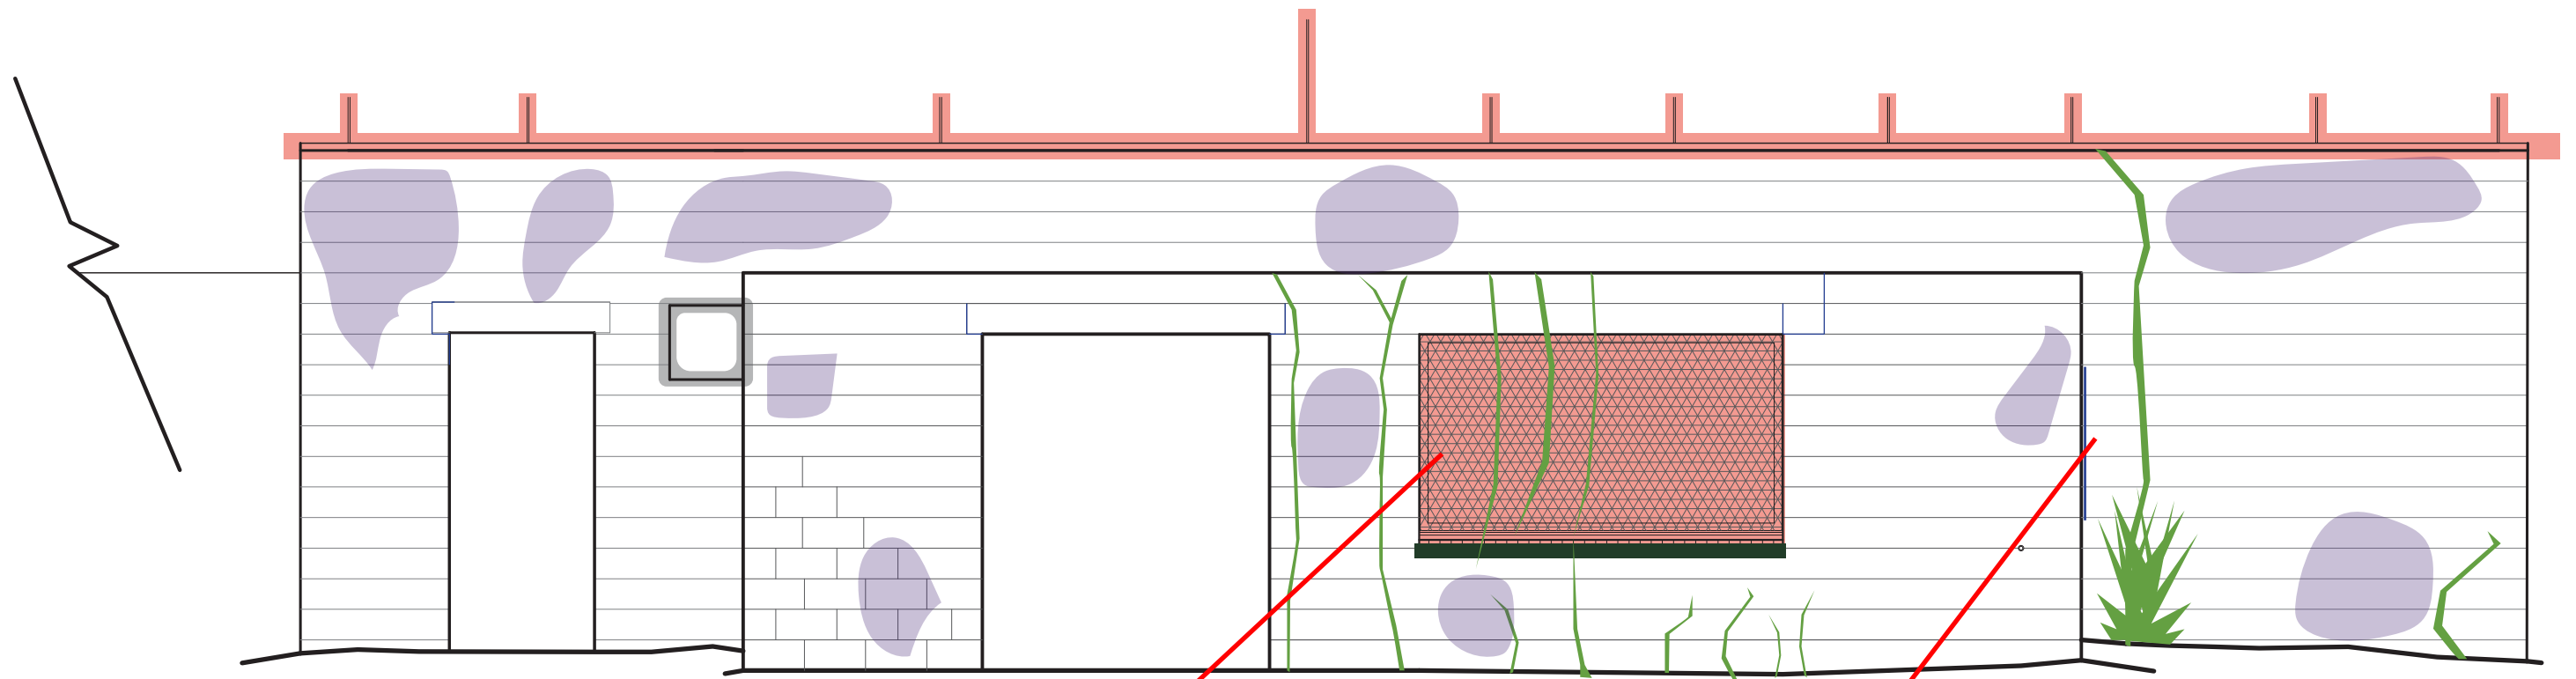
The metal diamond grating that has been inserted into the large window on the northern facade is rusting, causing staining on brick window sill and surrounding CMUs.

This large crack in the northern wall is where the original grocery store area is pulling away from the gymnasium section. The crack is also visible from the interior bathroom space.

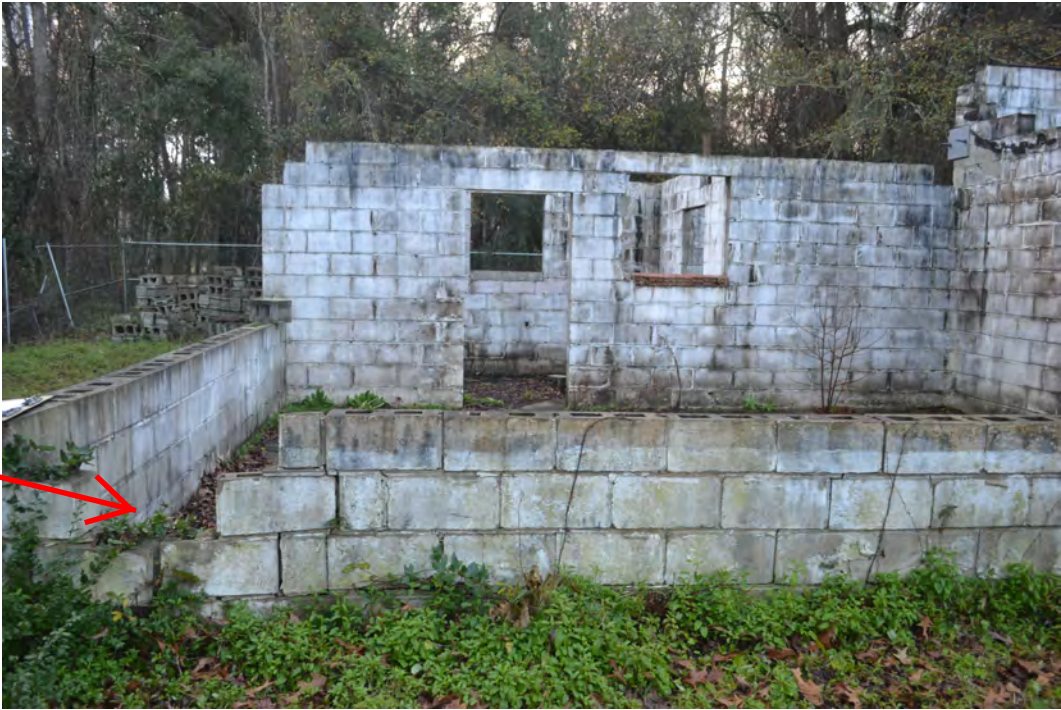
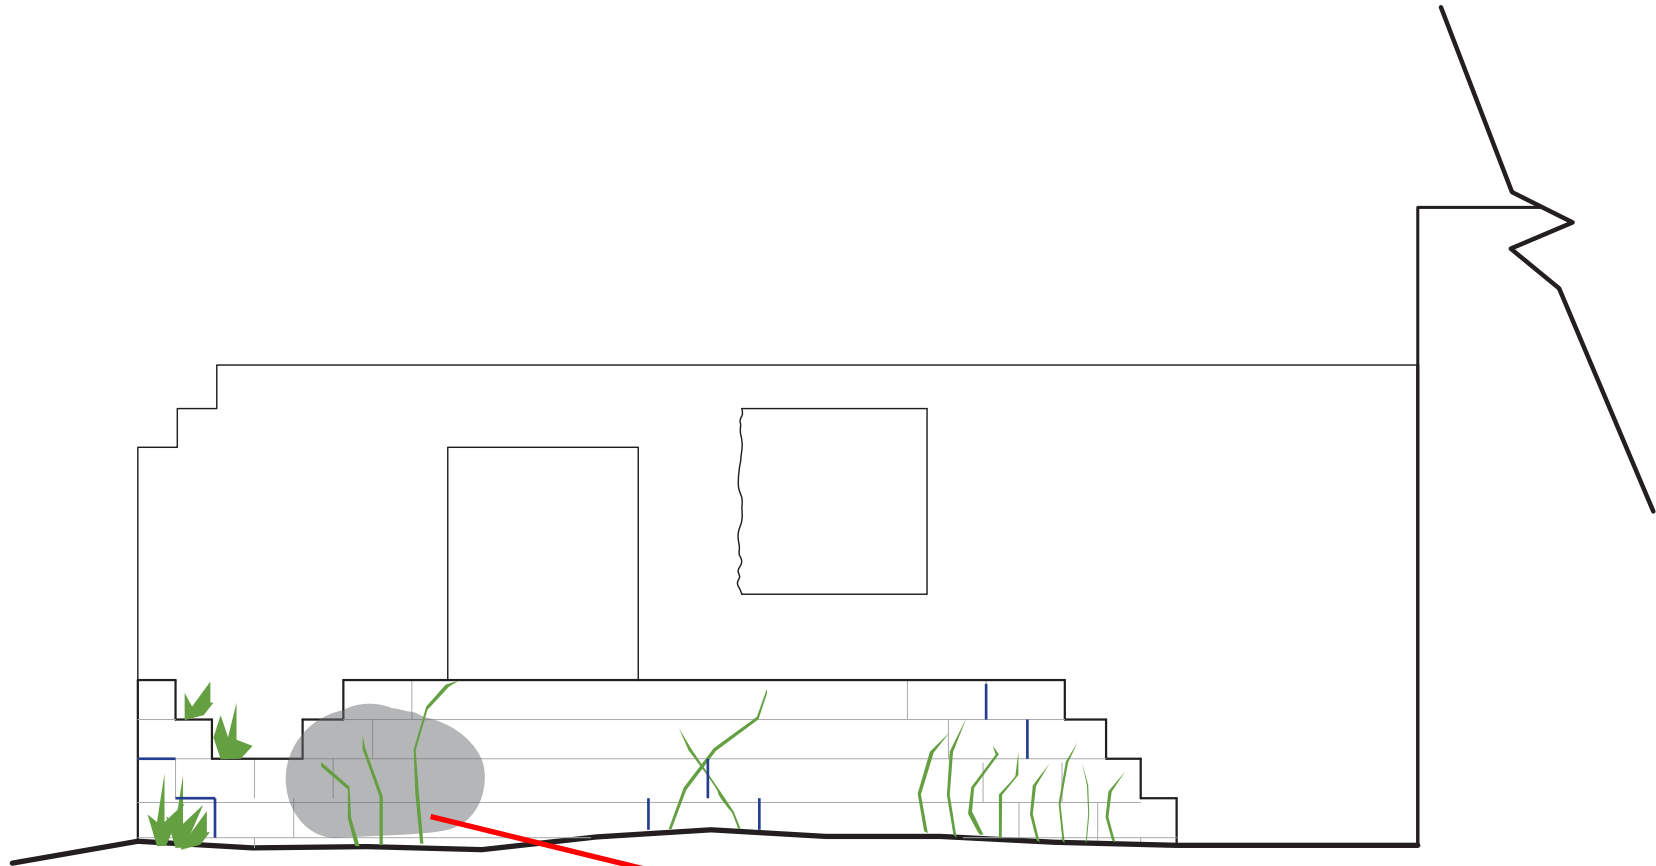
The northeast corner of the sun porch is missing blocks and is severely bowed outward. The structural failure may have been caused when the porch roof fell in, putting strain on the block structure or caused by the plants growing at the foundation of the building and sending roots in through the blocks and mortar.

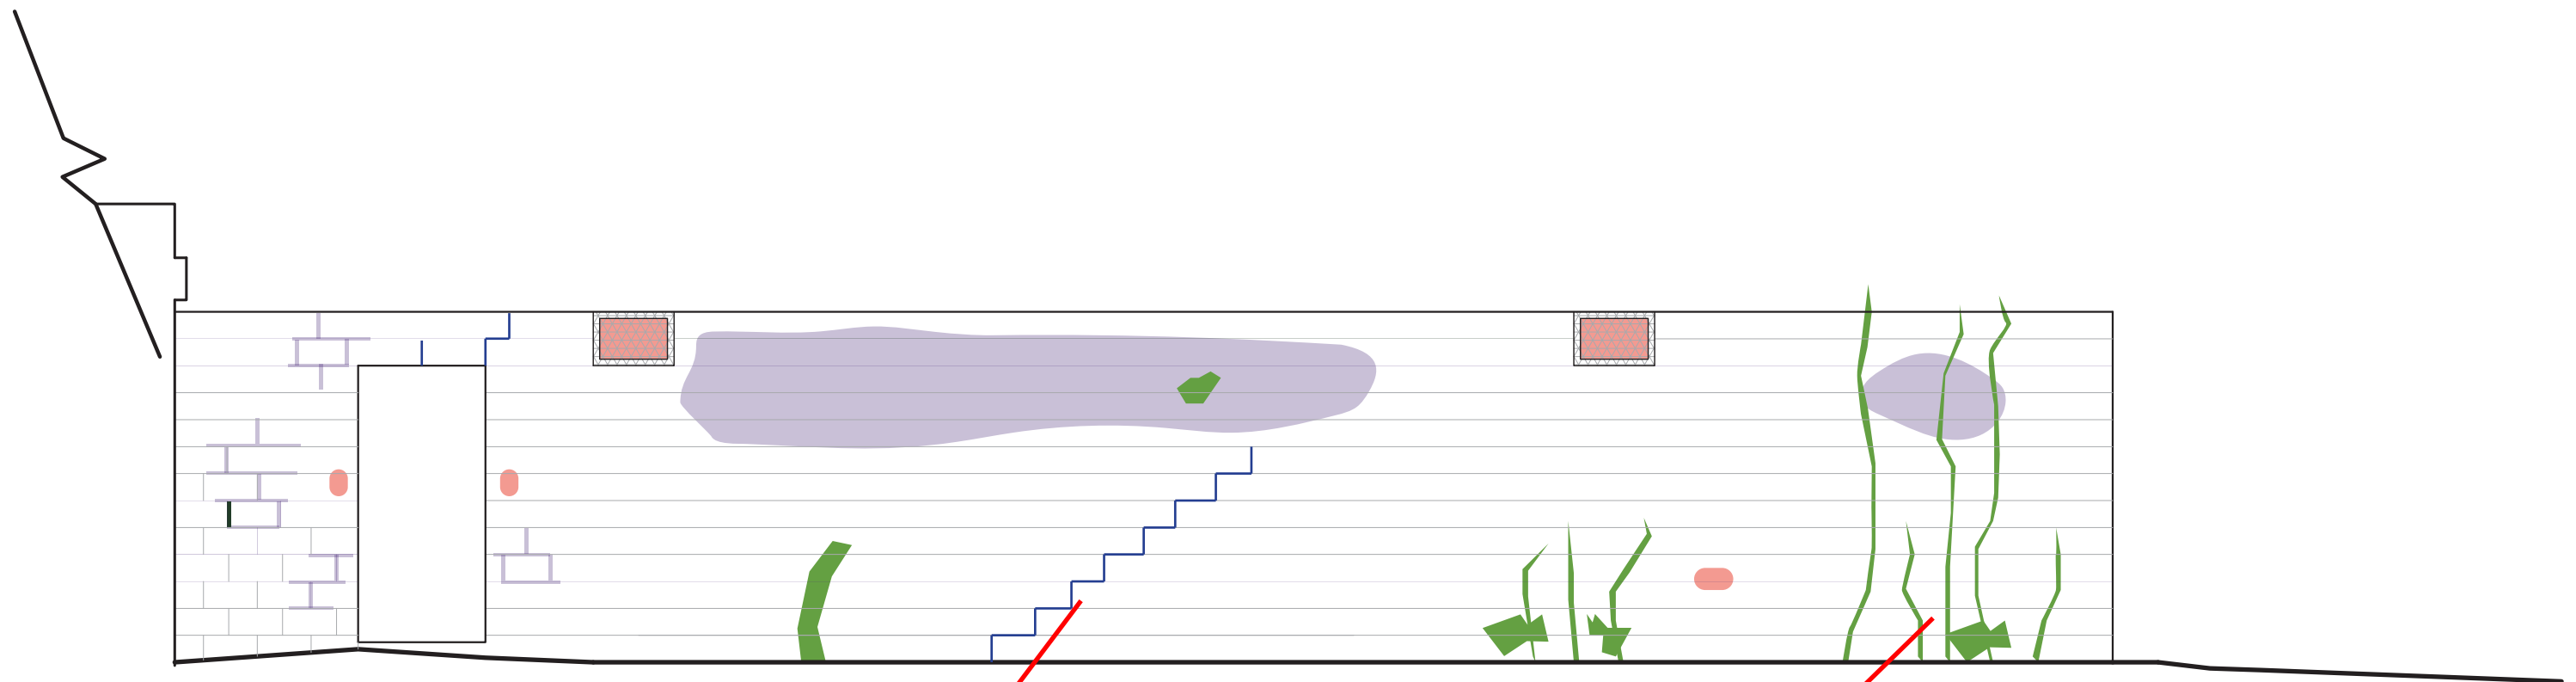
The east exterior wall has a large stairstep crack running two thirds of the wall height.

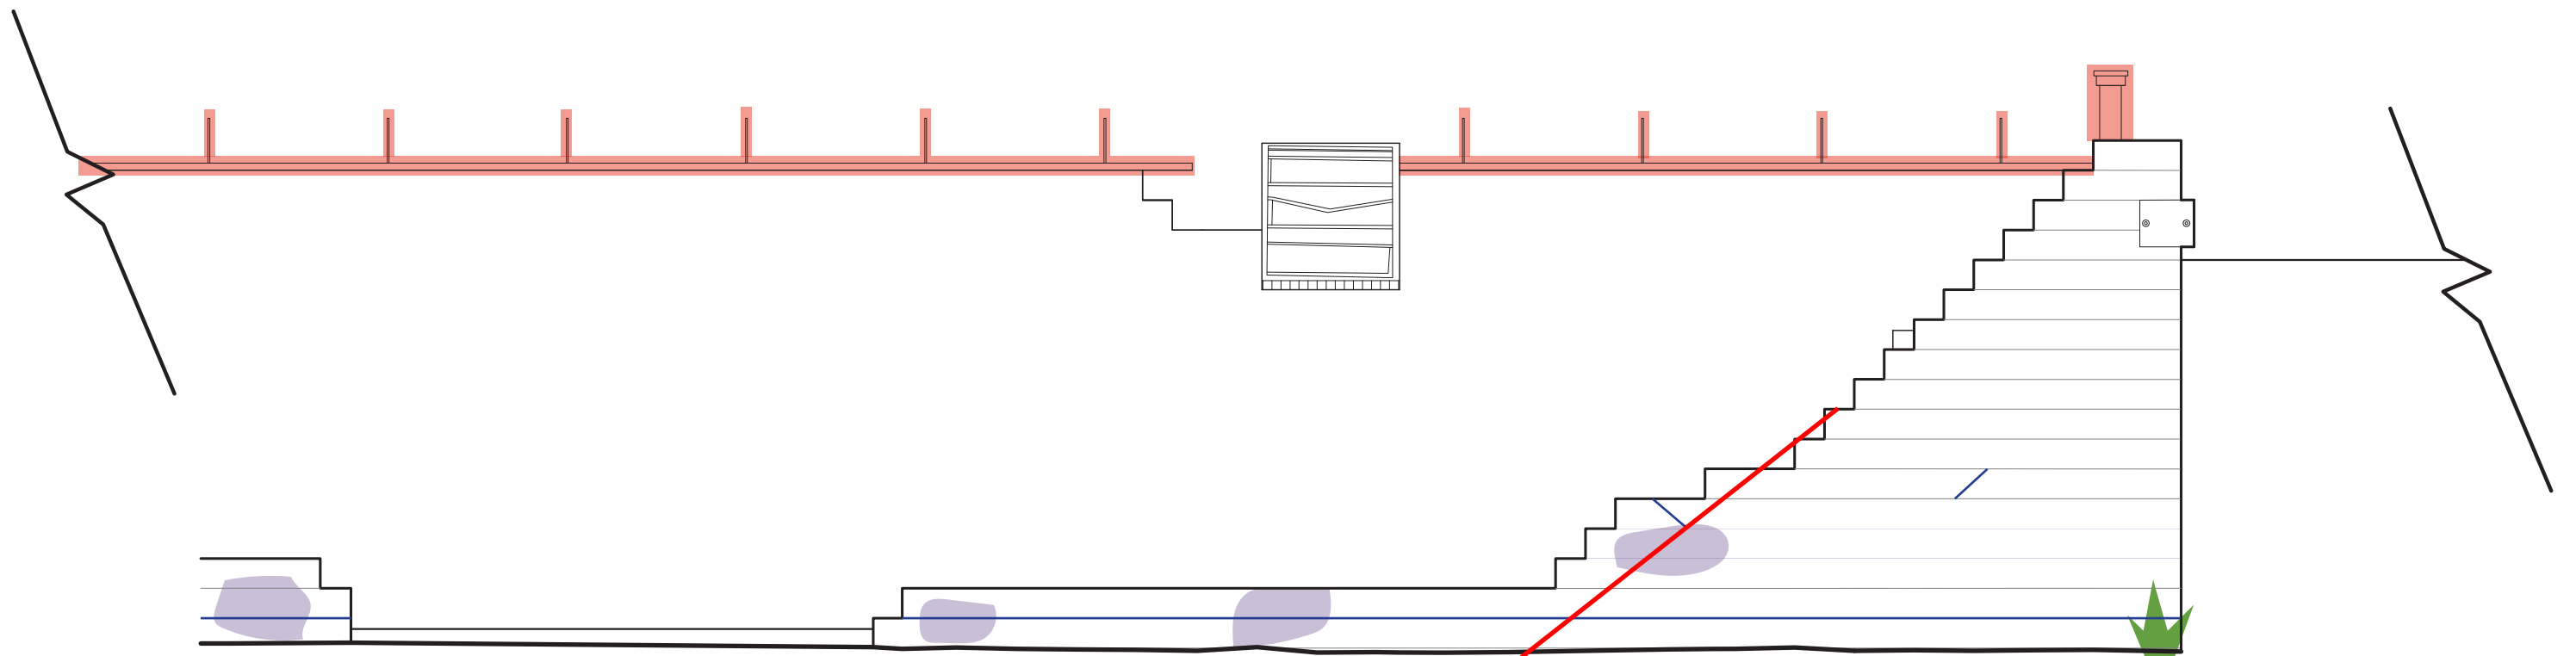
The east exterior wall of the large gathering space has lost all strength after collapsing. The remaining sections of wall are cracked and are susceptible to failure at any time.

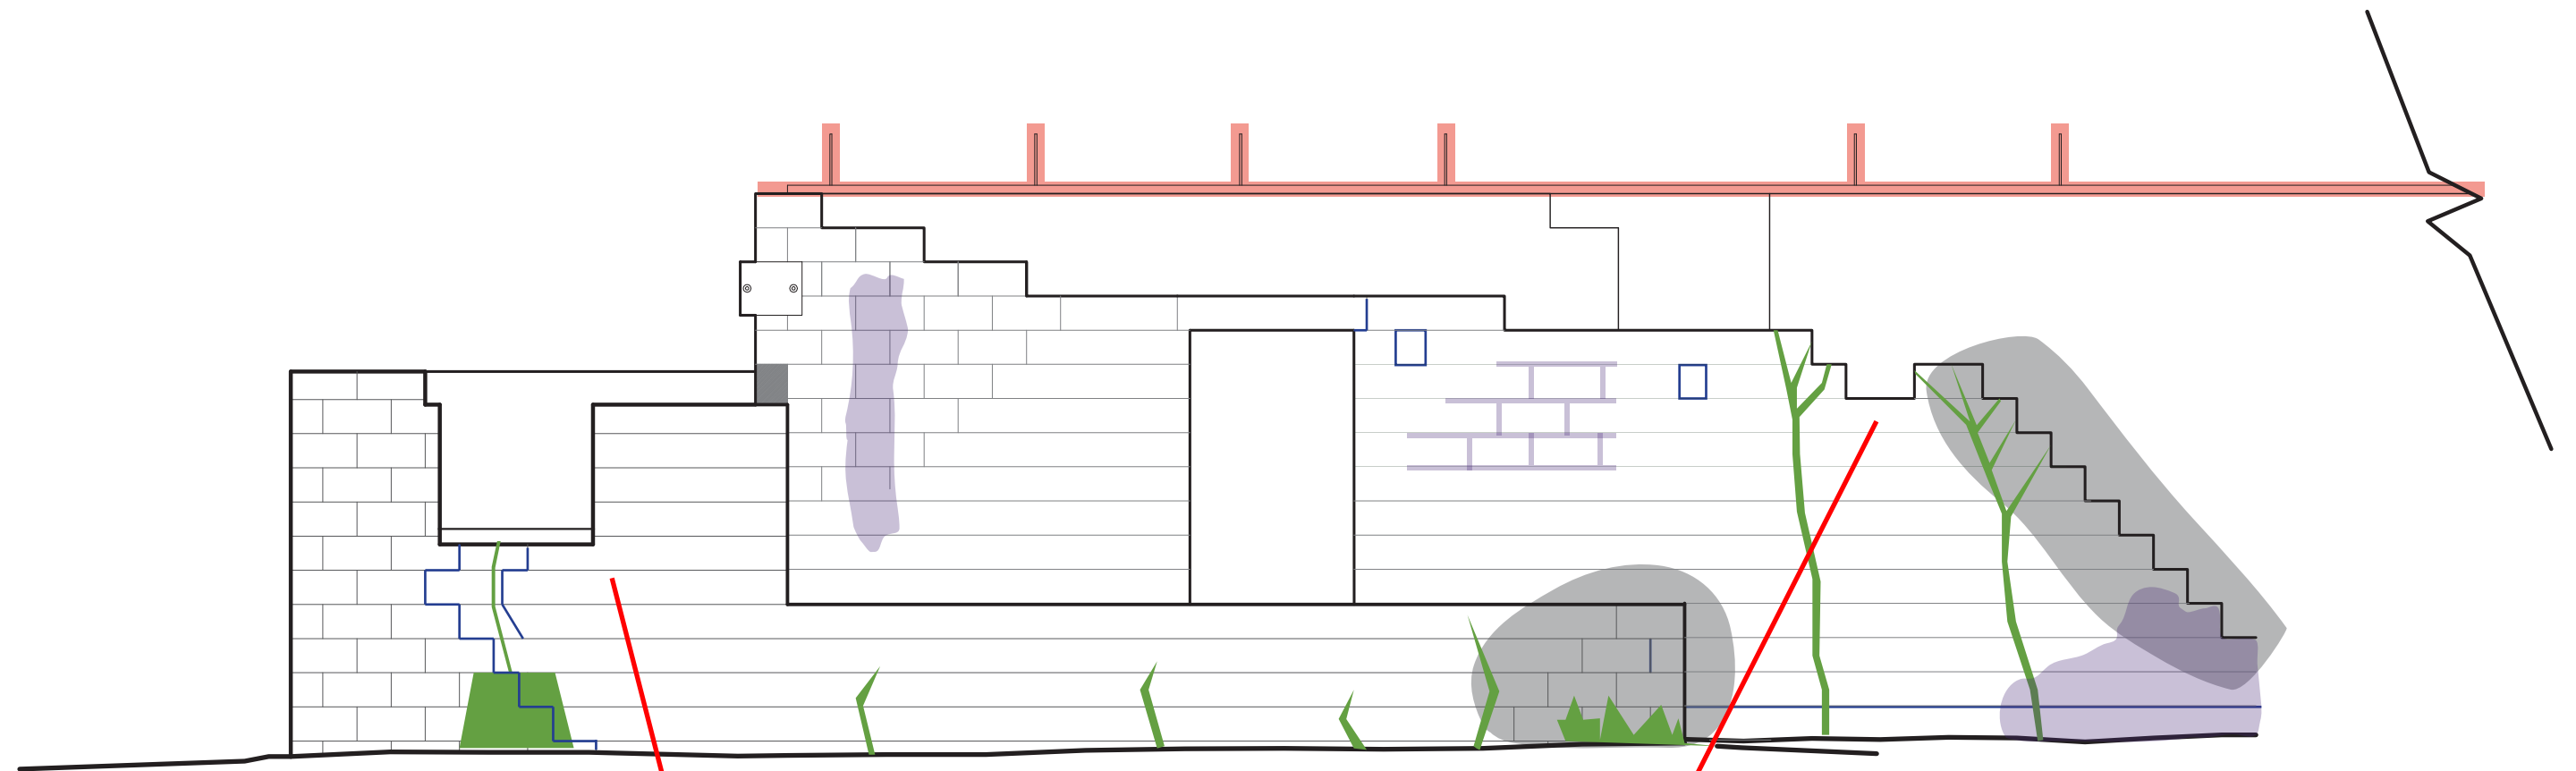
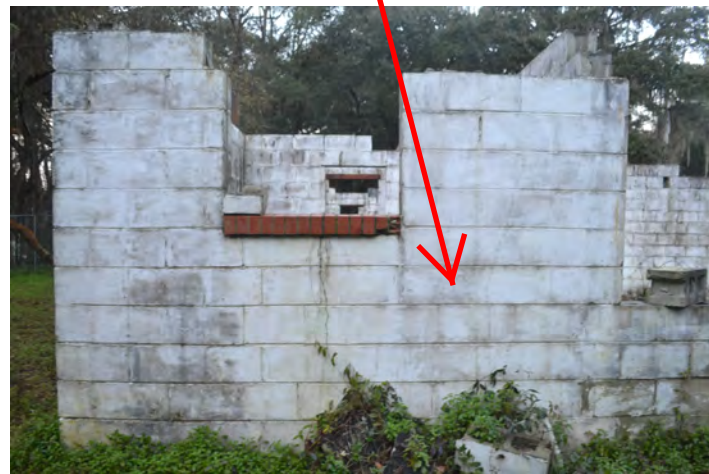
The eastern wall of the dormitory space is cracked under the sill and debris is sitting at the foundation. Portions of this wall have already fallen.

This half of the collapsed east exterior wall has major bowing and biogrowth. This portion of the wall is also susceptible to failure at any time.

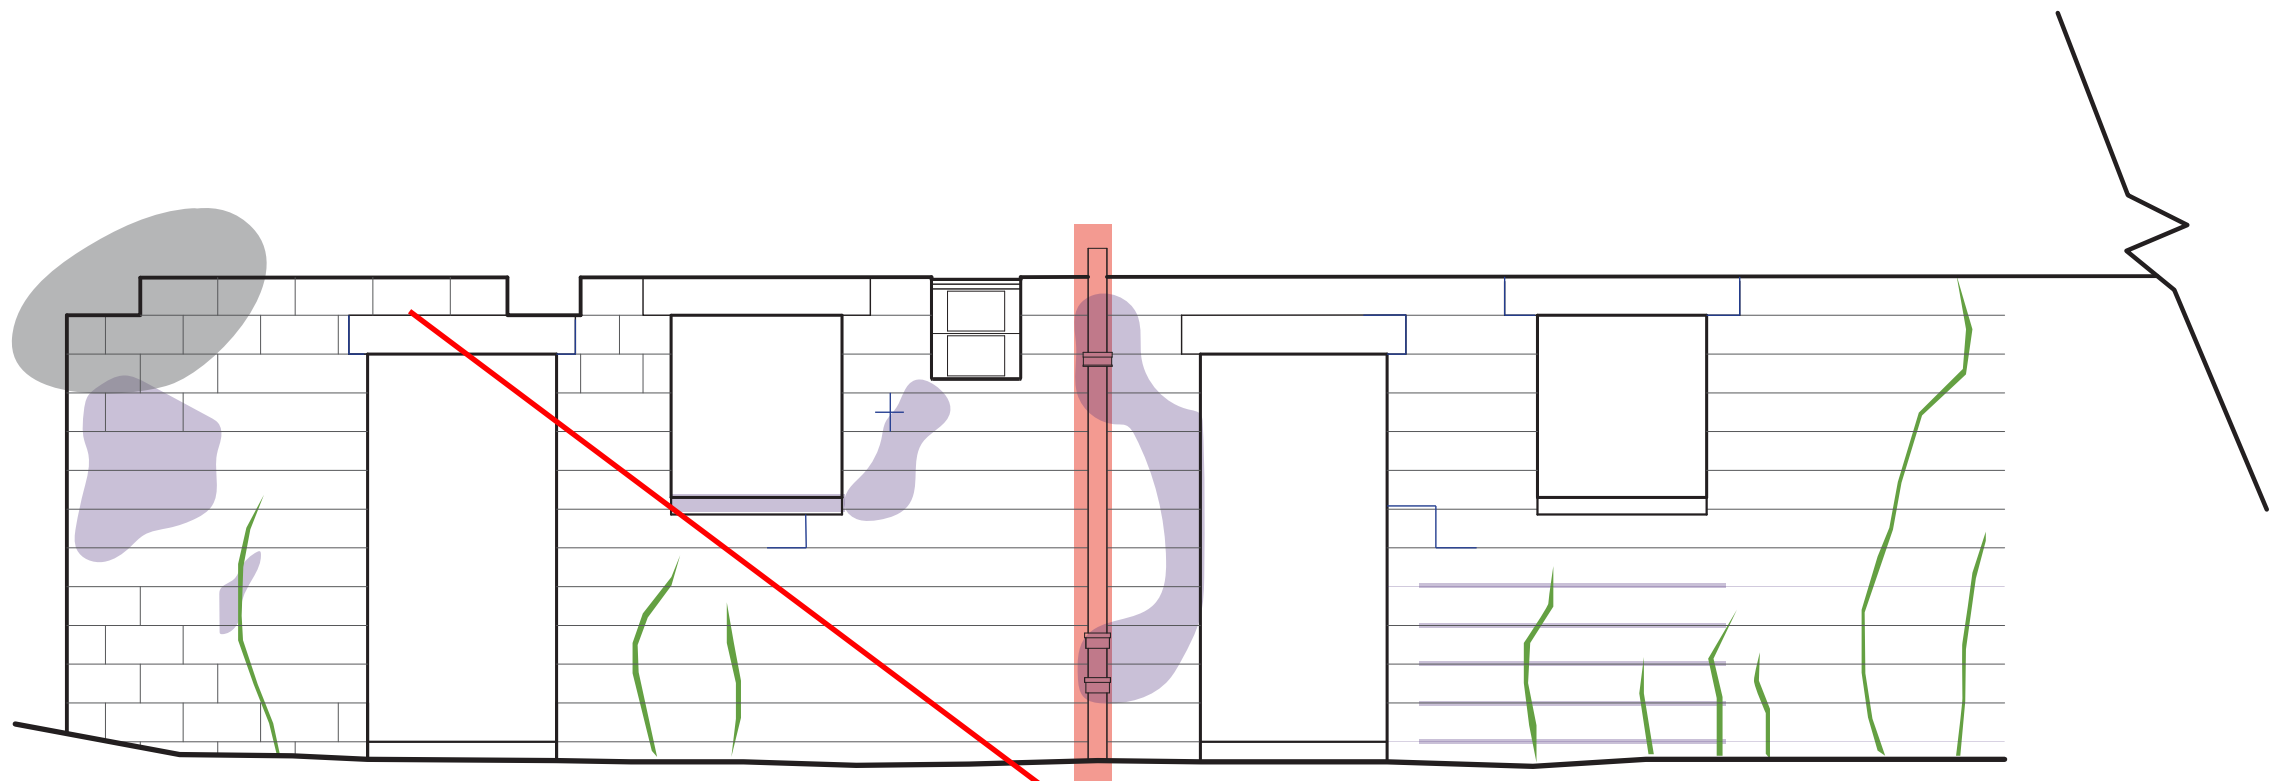
The dormitory walls are not tied in to the main structure and sections of wall are falling off leaving cracks and holes in the interior and exterior walls.

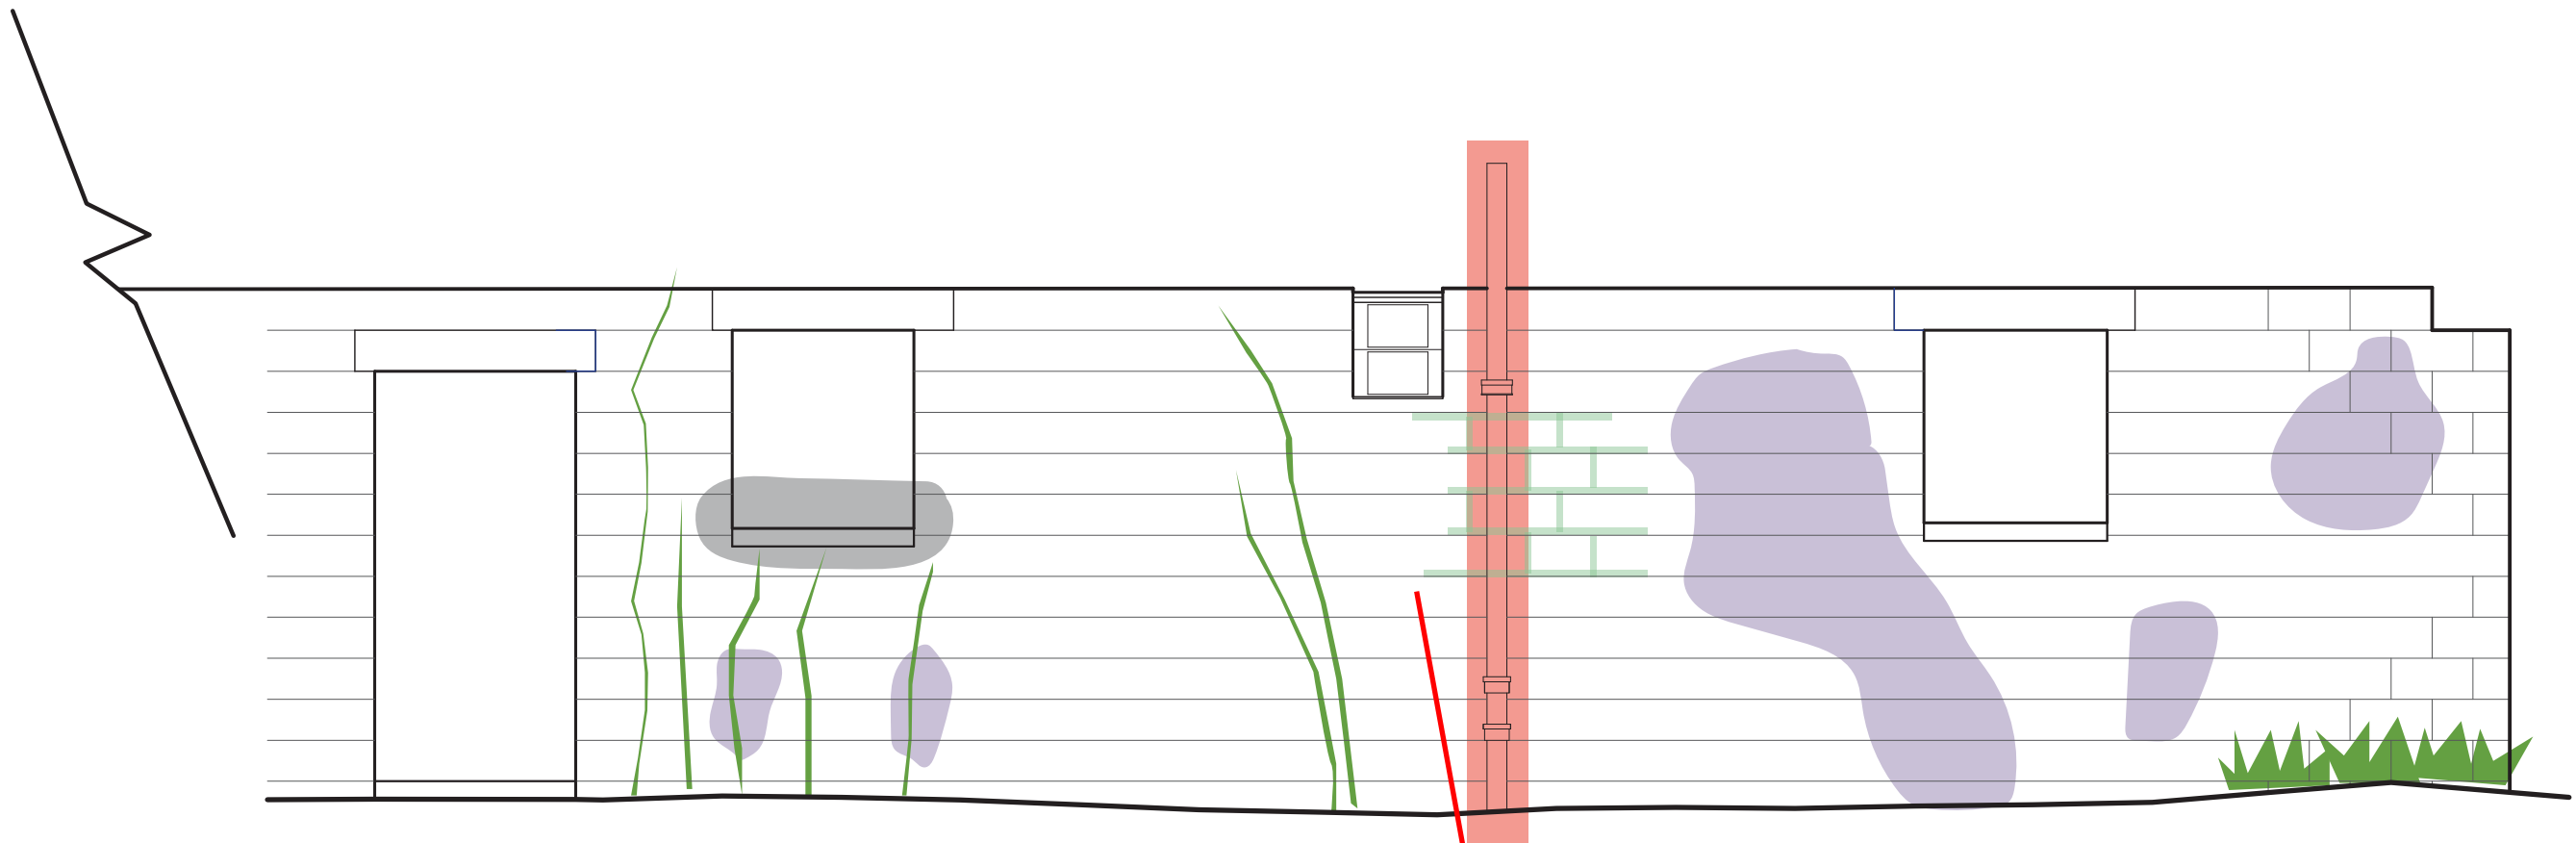
The south exterior wall is not tied in to the main structure and additions of pipes and electrical boxes to the exterior have rusted further weakening the structural integrity of the CMUs.

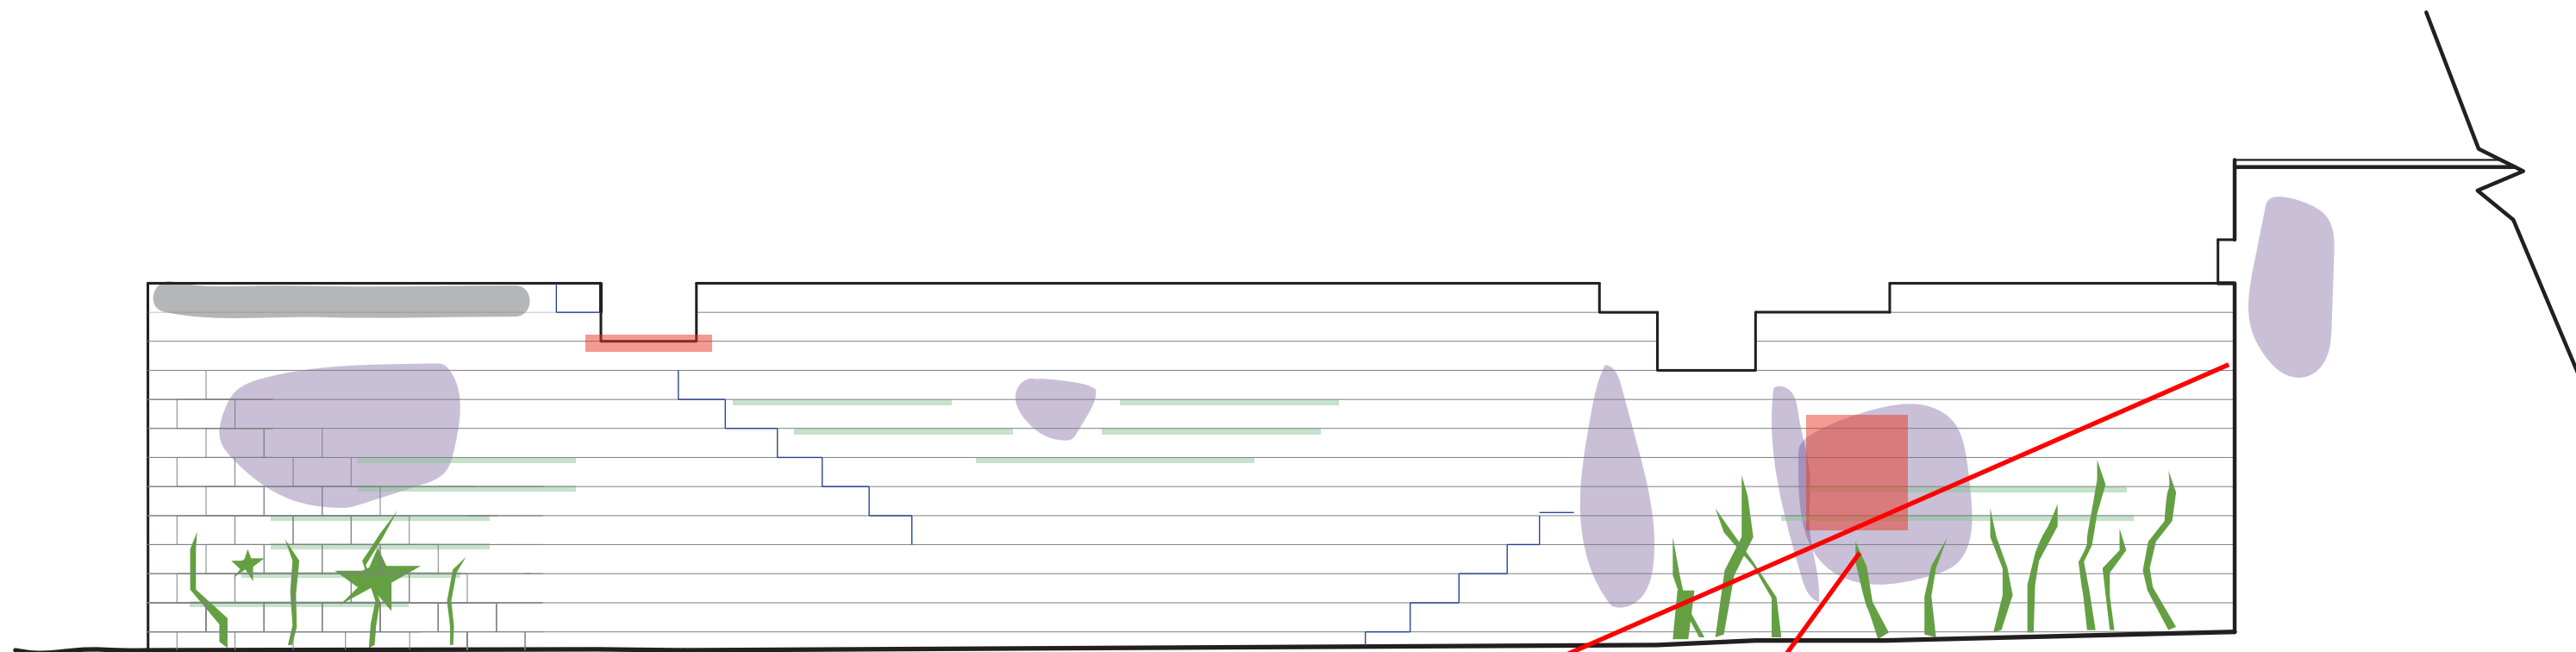
The front store area was not tied into the addition of the gathering space. The walls are separating and a large crack has formed. Although the gathering space wall is held by a tie rod, the wall and intersection are very unstable.

An electrical panel attached to the wall weakening the CMUs and causing staining. This wall gets very little sun and black mold is prominent along the west wall.

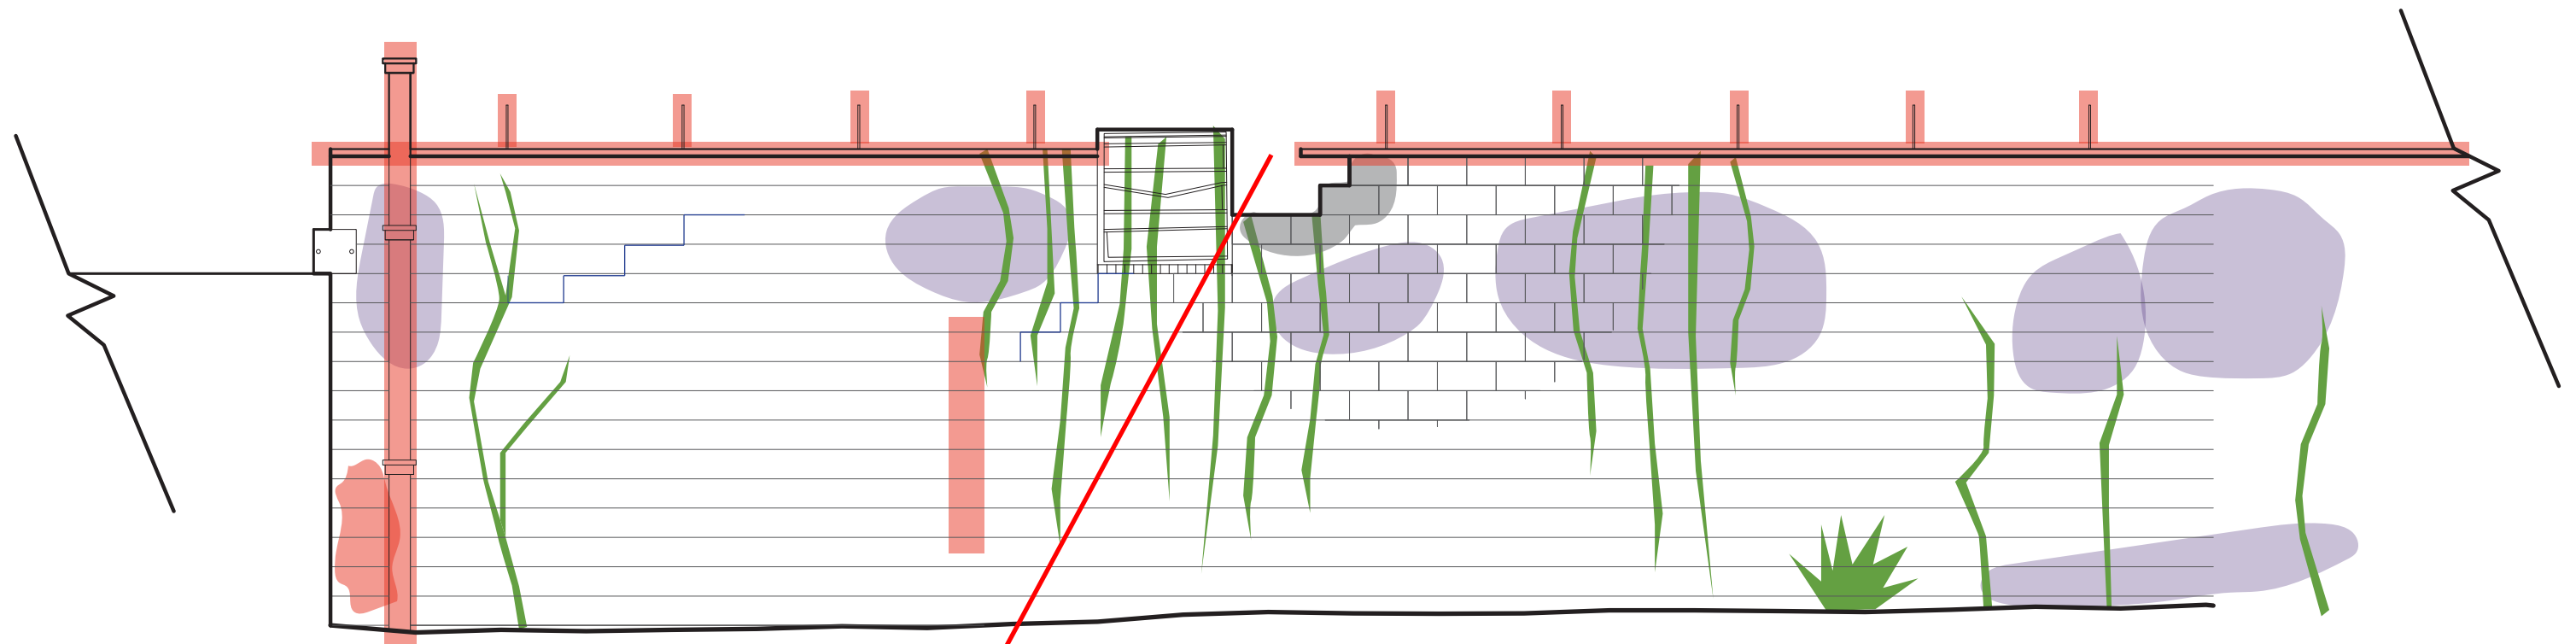
The west exterior elevation is bowed outward. This was likely caused by the collapse of the roof, leaving nothing to support the wall. Tie rods were added in two areas in 2008 to aid in supporting the wall, however, the invasion of vines along the wall and soft ground have added to the instability of the wall.

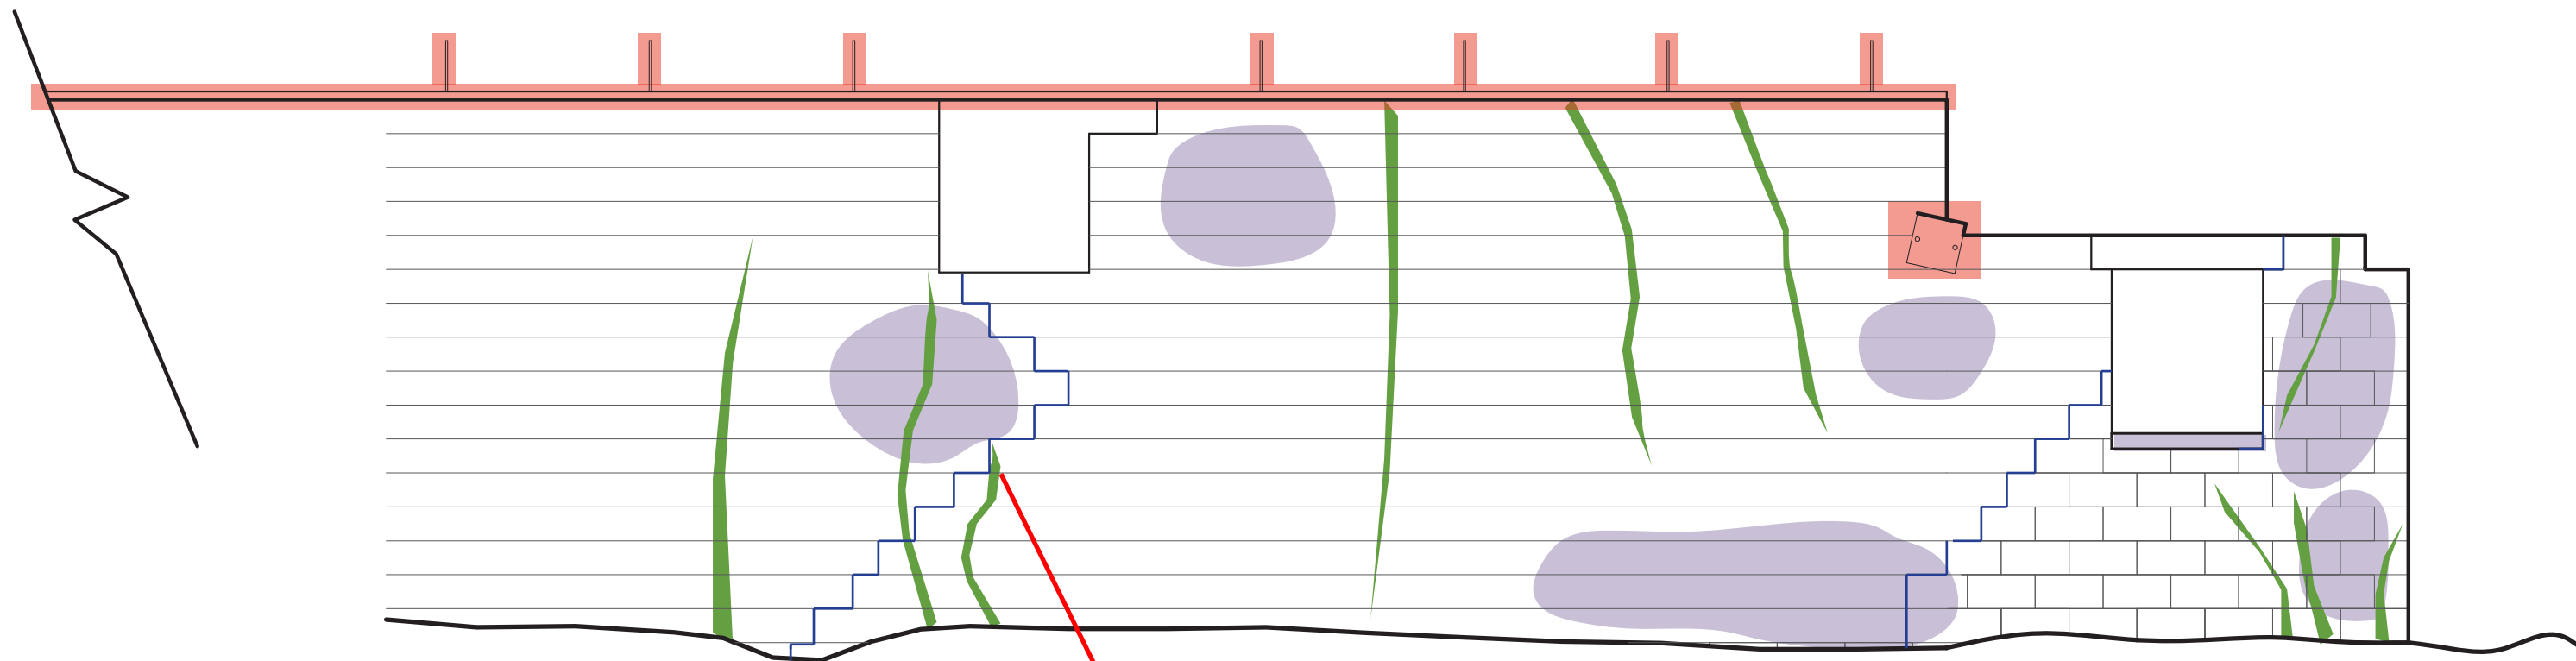
Low point in ground plane that is exposing the foundation and likely a source of the crack under the window.

Large stairstep crack extending from the window to the foundation. Vines growing near the crack help it spread and allow for water intrusion.

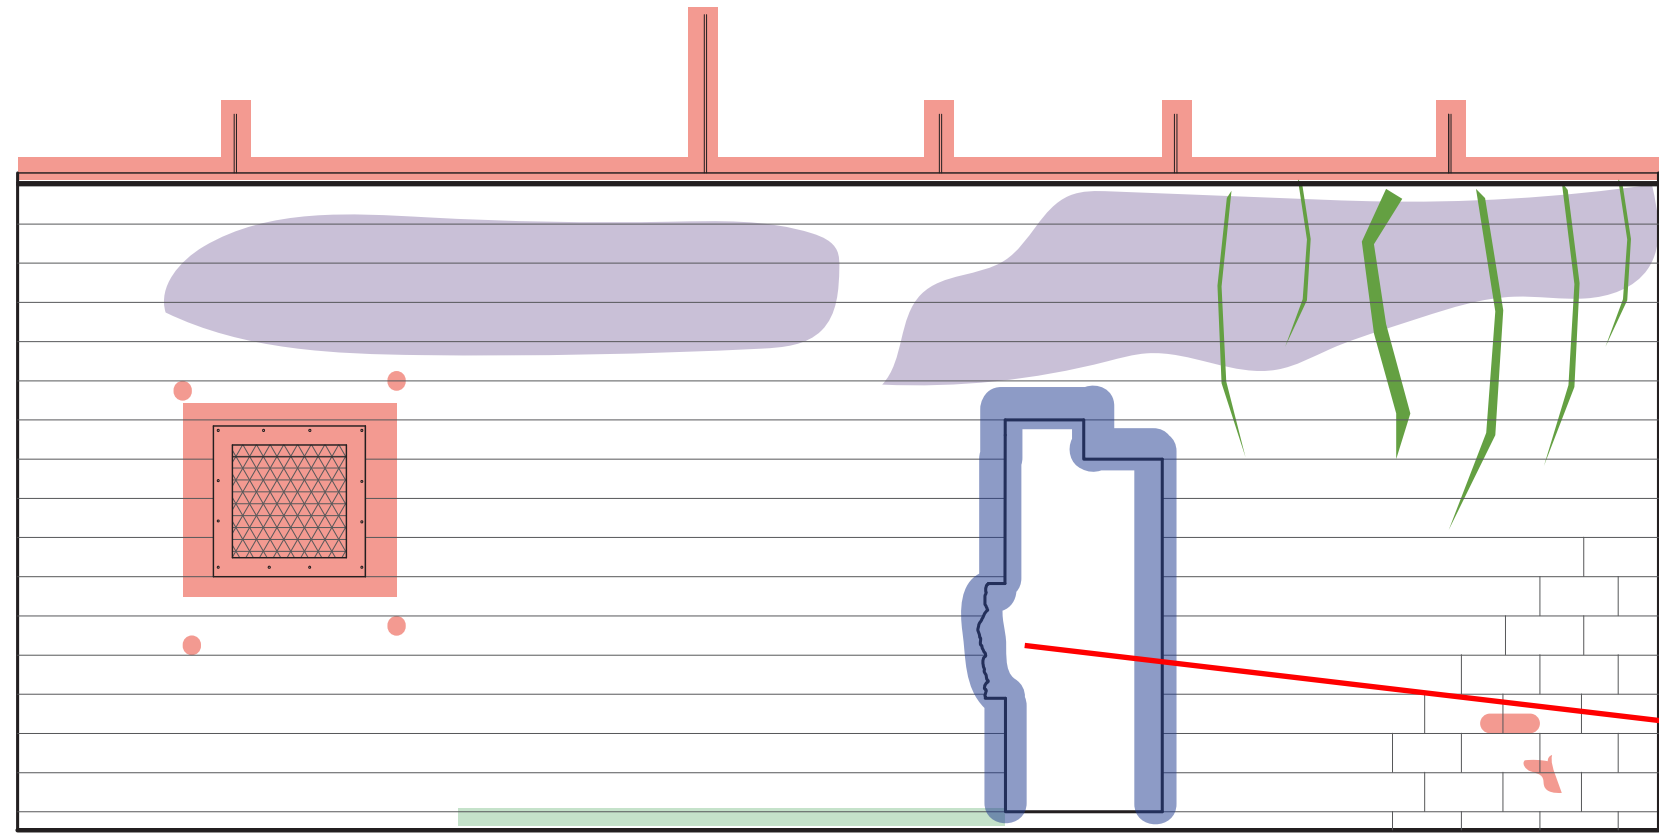
Opening between store and gathering space that was cut through the CMUs after original construction. The opening has no reinforcement and CMUs are starting to come loose creating both a structural and safety hazard.

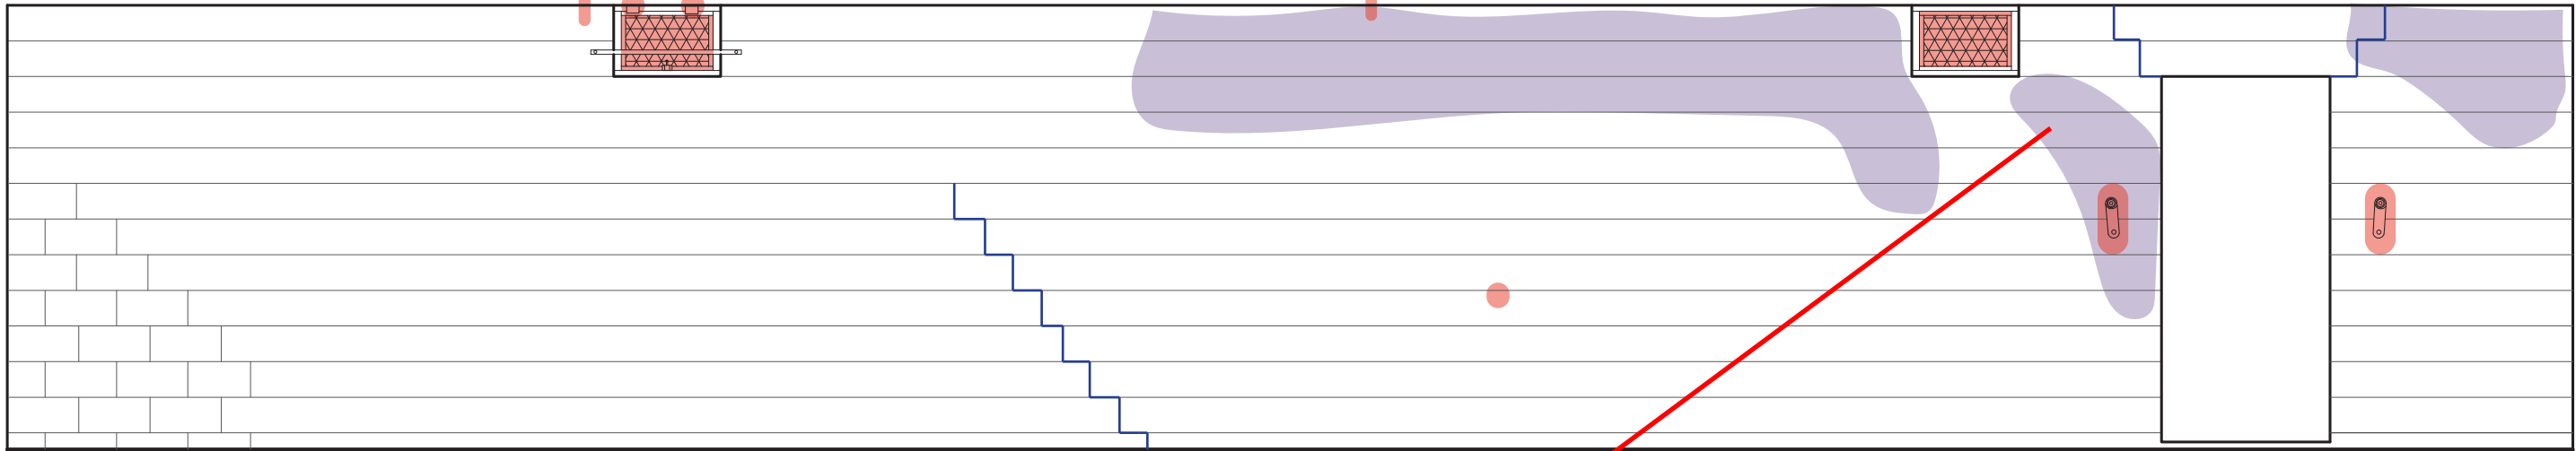
Metal diamod grating in original window opening is rusting and causing staining on the wall. The adjacent oak tree is starting to send branches through the grating.
