# The Progressive Club

Johns Island, South Carolina

Preservation  
Studio  
Spring  
Term  
2015

Graduate Program in Historic Preservation

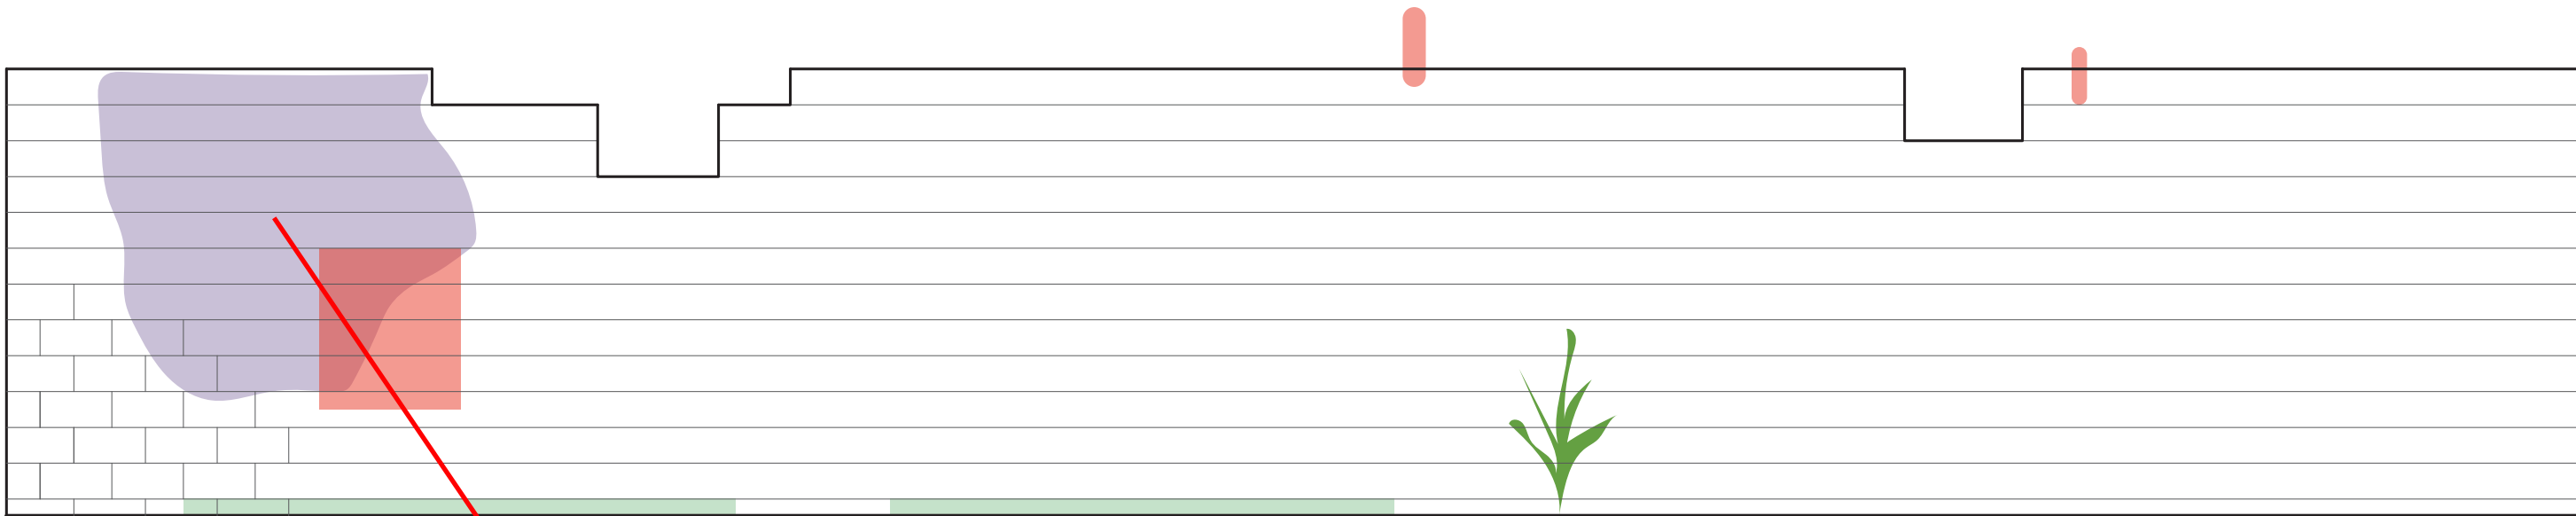
This wall of the store is not tied in to the wall it shares with the gathering space. There is a large crack where the two walls meet and this wall is beginning to bow outward.

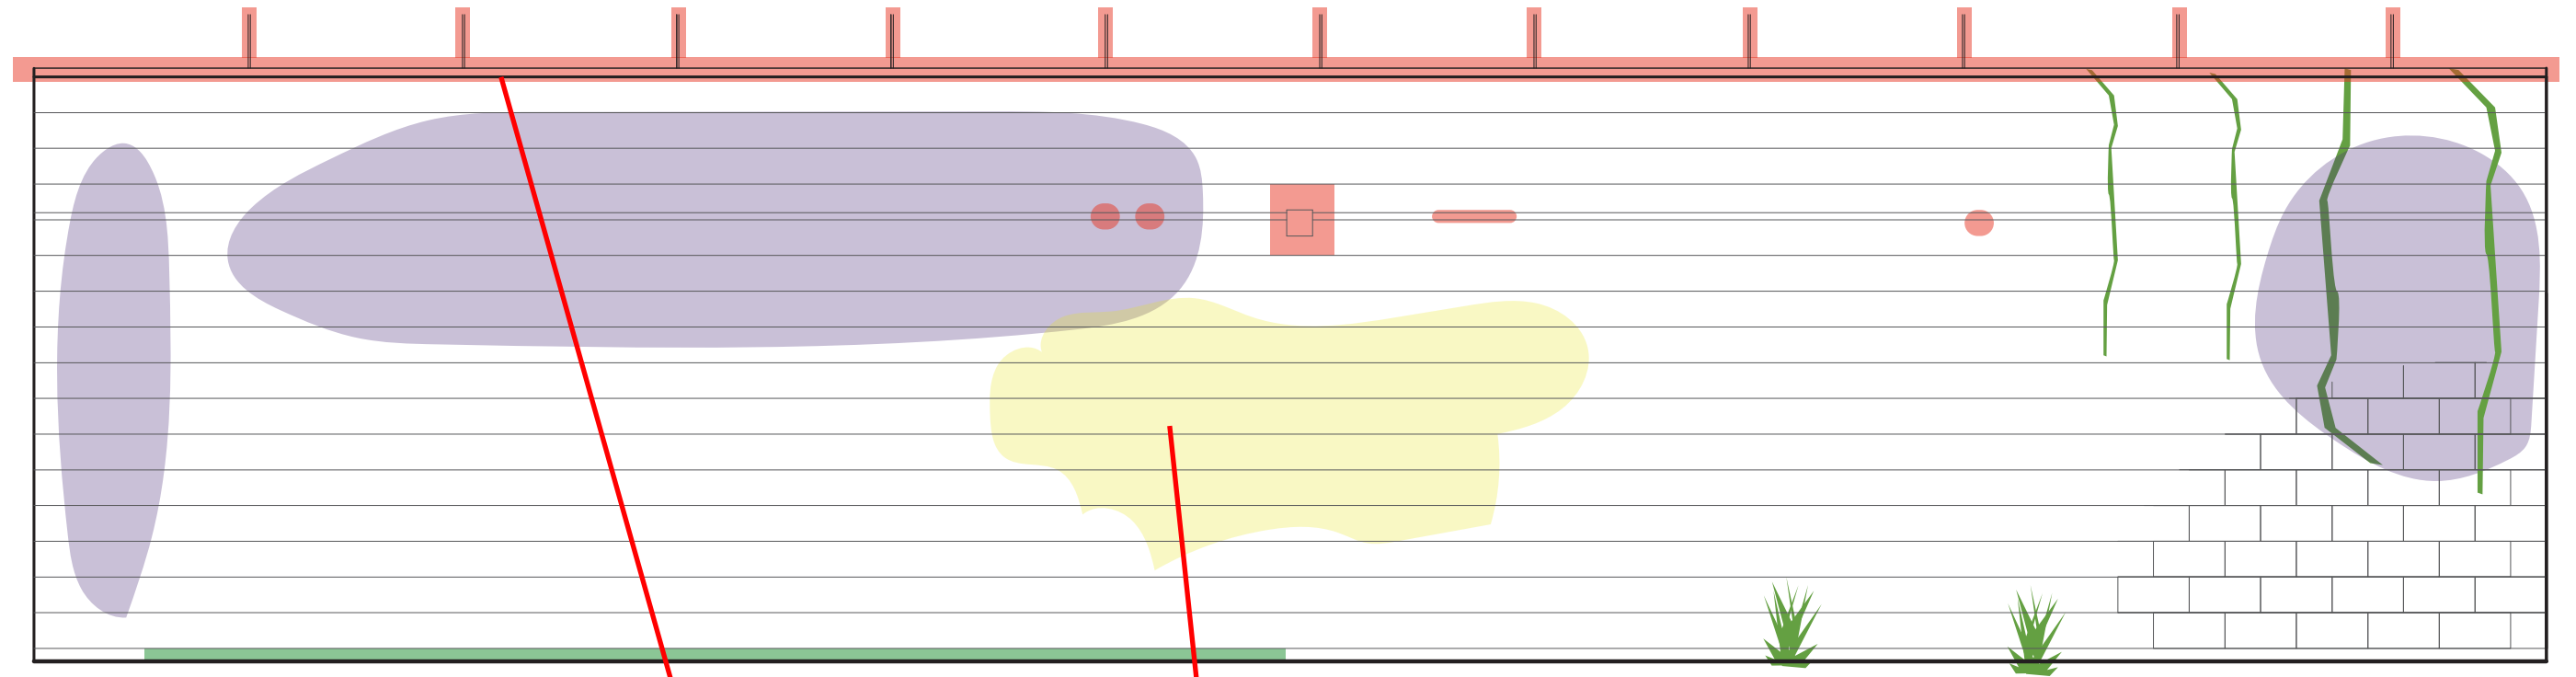
An attempt to clean former graffiti off the wall has left a residue and washed out stain resembling sand blasting. Additionally, the rebar placed along the top of the wall is rusting and causing stains.

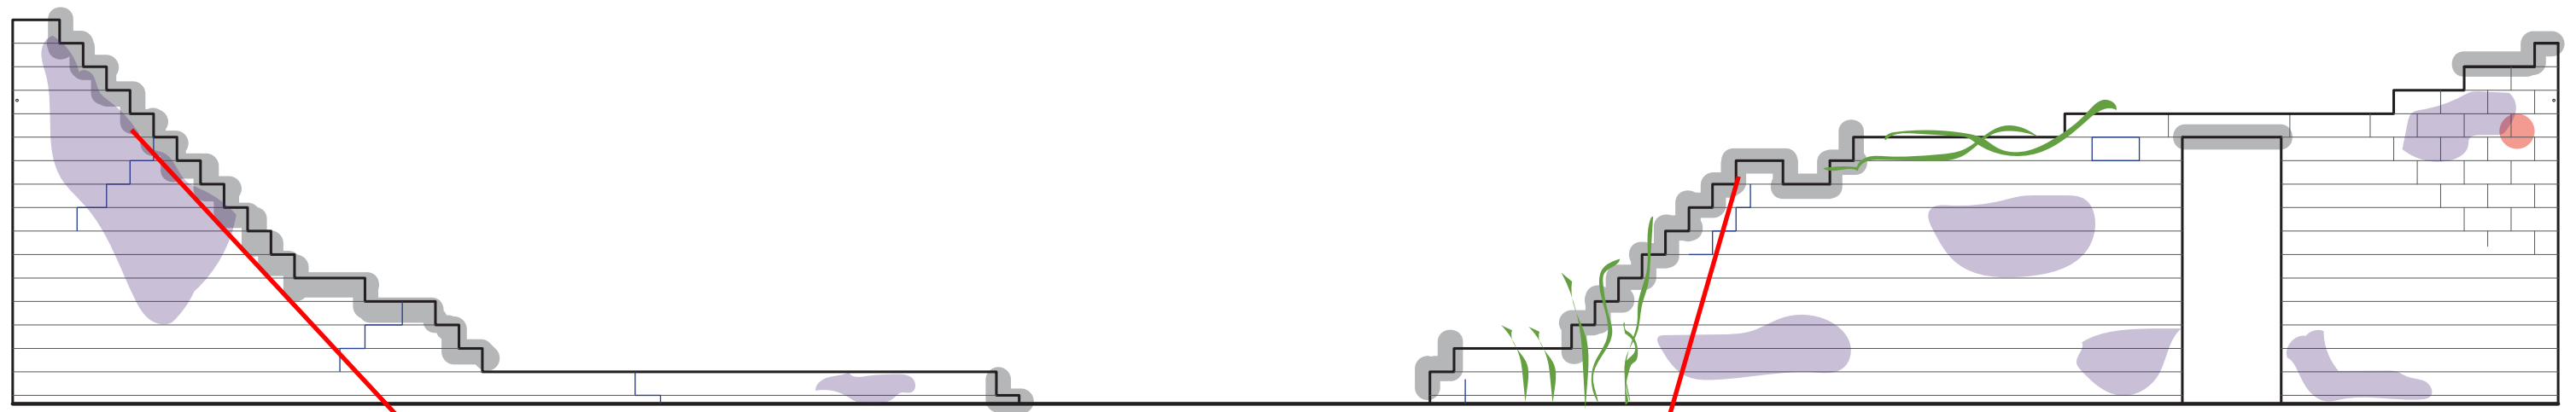
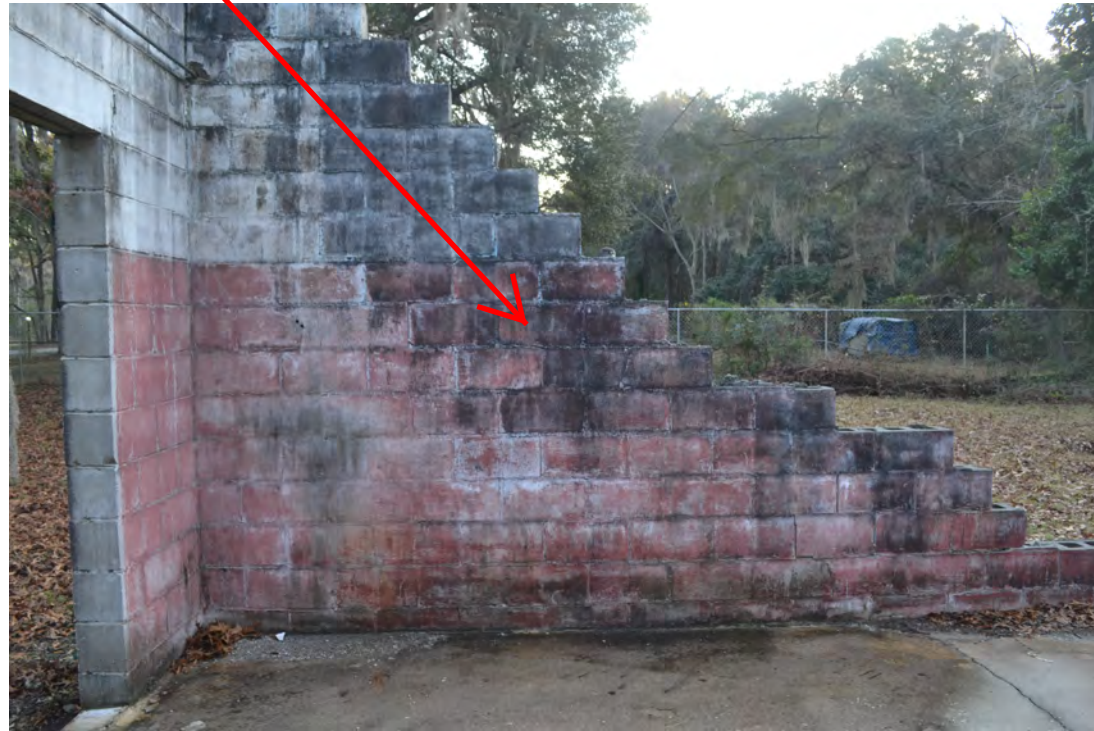
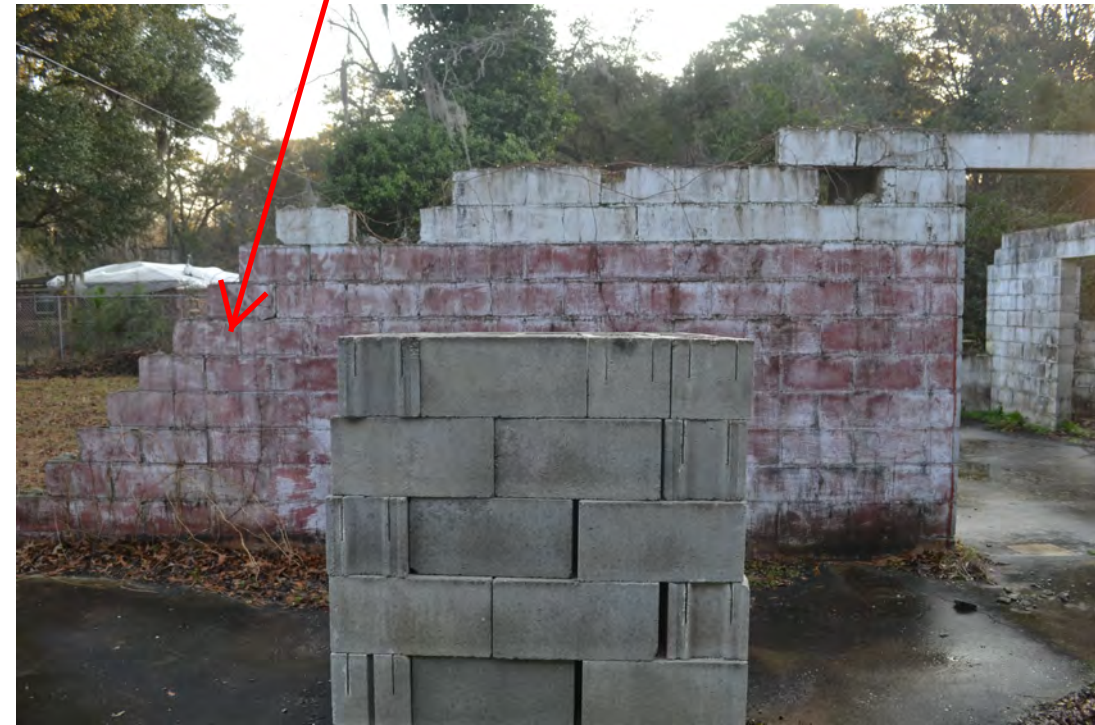
The structural integrity of the east wall has been compromised through the loss of a large portion of CMUs. The stairsteps and missing CMUs pose a severe threat of safety. Additionally, biogrowth and vines are further degrading the wall, and are a constant source of moisture.

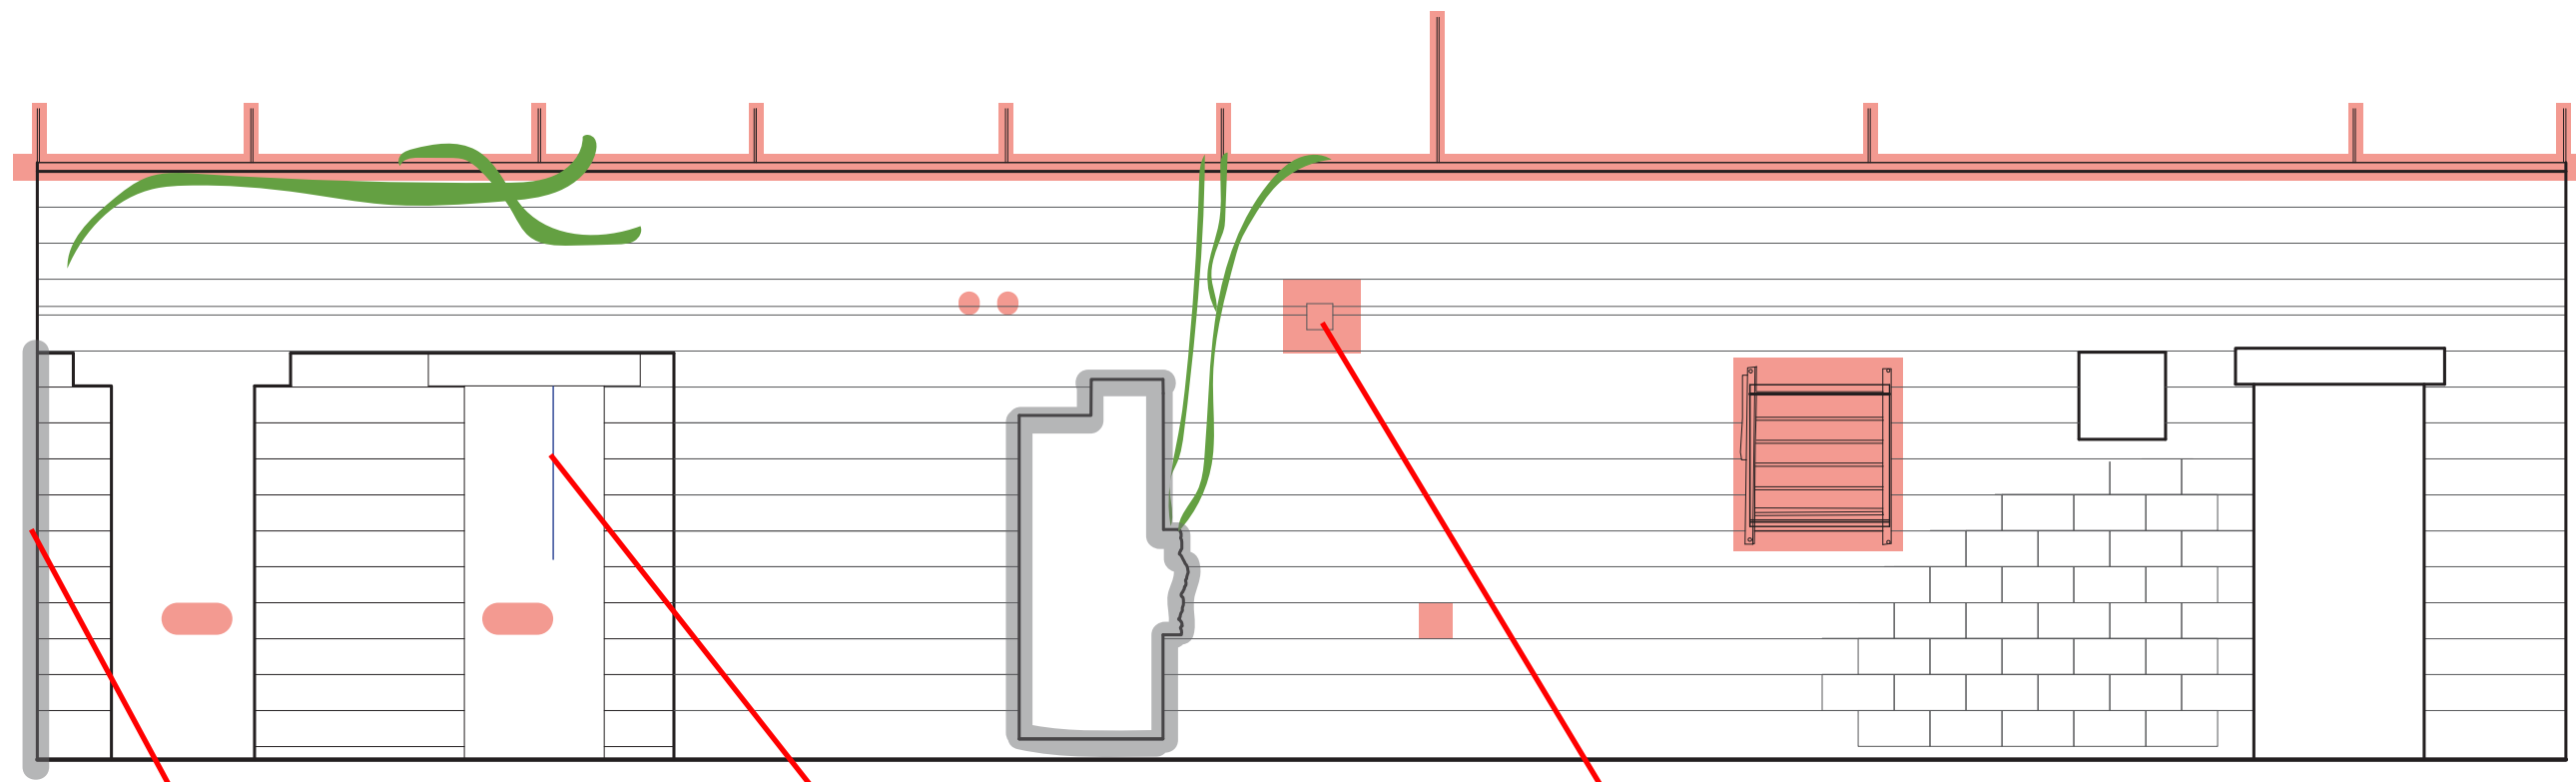
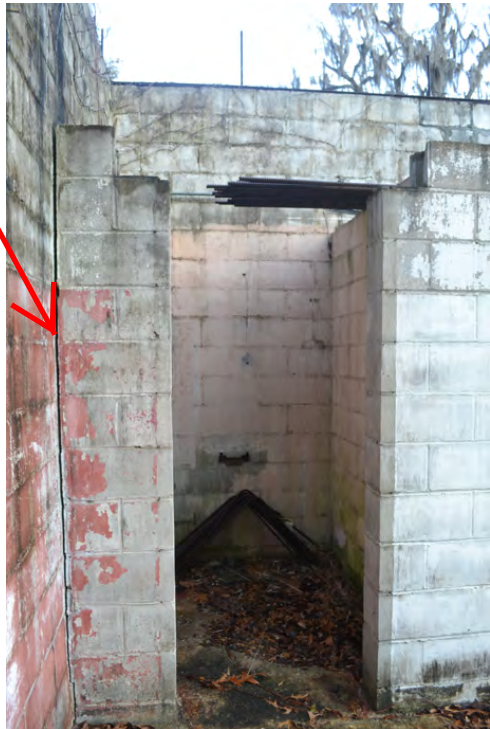
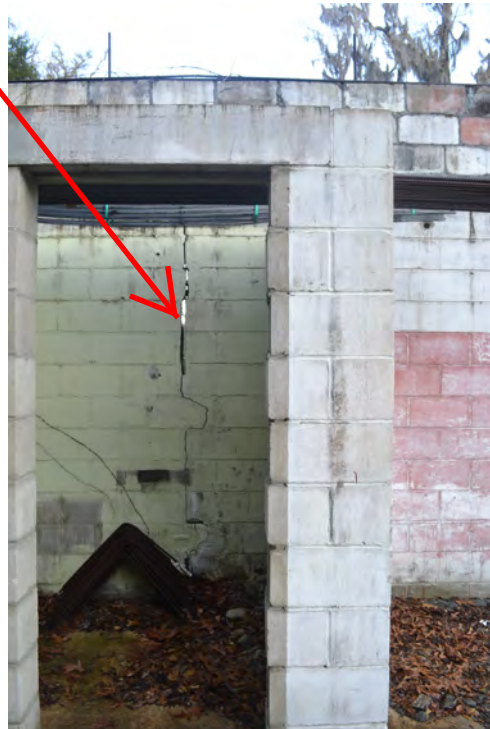
Improper cement repairs at the upper portions of the wall are visibly failing and causing blocks to shift.

Large cracks are visible in both bathrooms and are structurally concerning as they connect to the exterior frame of the building.

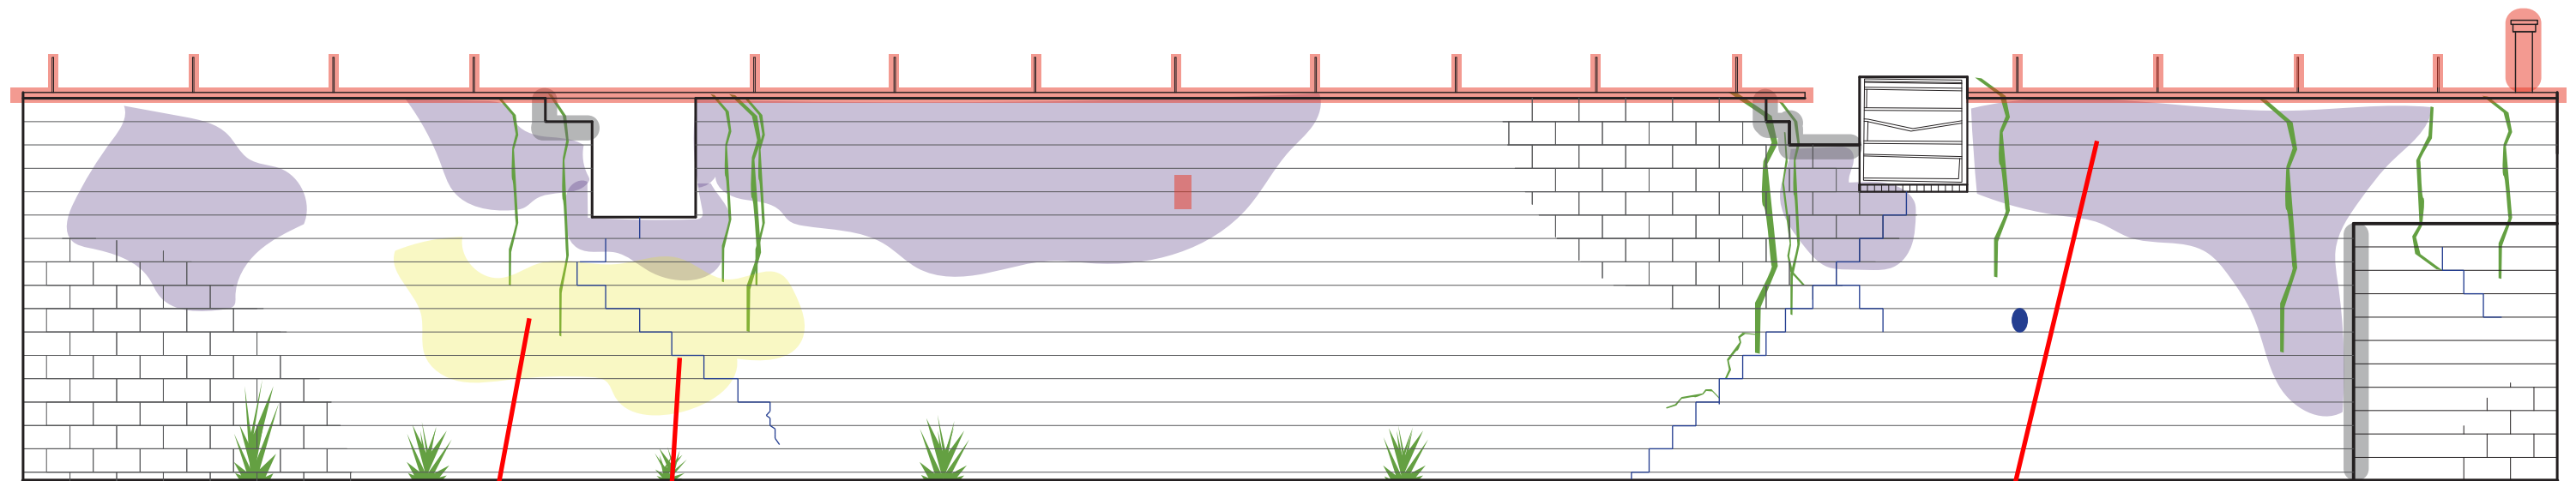
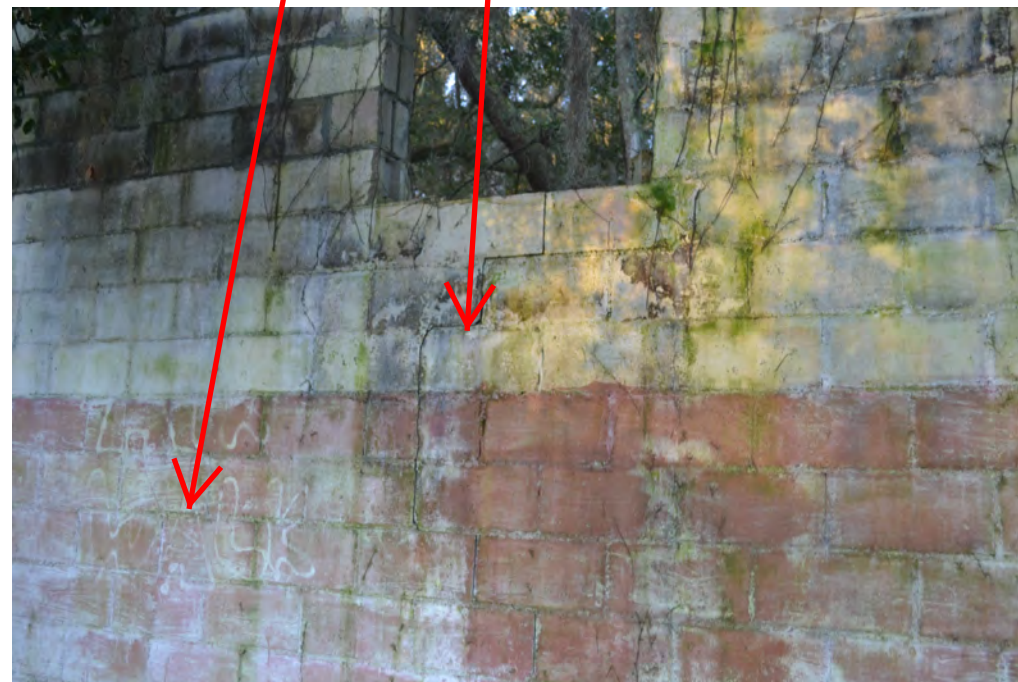
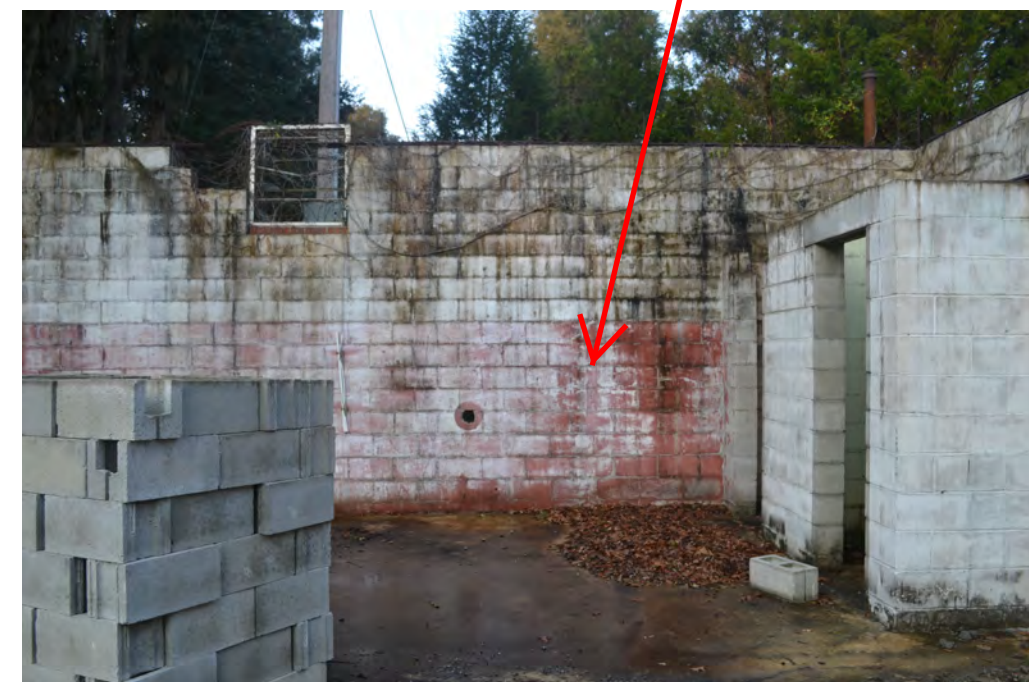
Additionally, structural cracks are seen stair-stepping under the window opening.

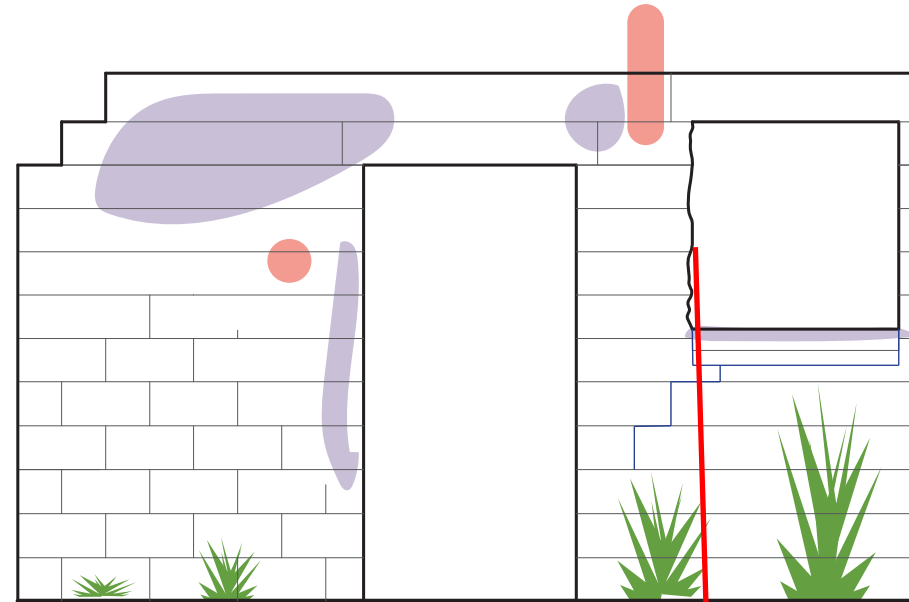
Wall 9

The sun porch has been greatly exposed to biogrowth and plants, which are interrupting the joint where the wall meets the foundation.

Additionally, the window is causing significant issues. The brick sill is loose and there is a large crack forming underneath it. The left portion of the window has been roughly cut diminishing the structural integrity of those CMUs.

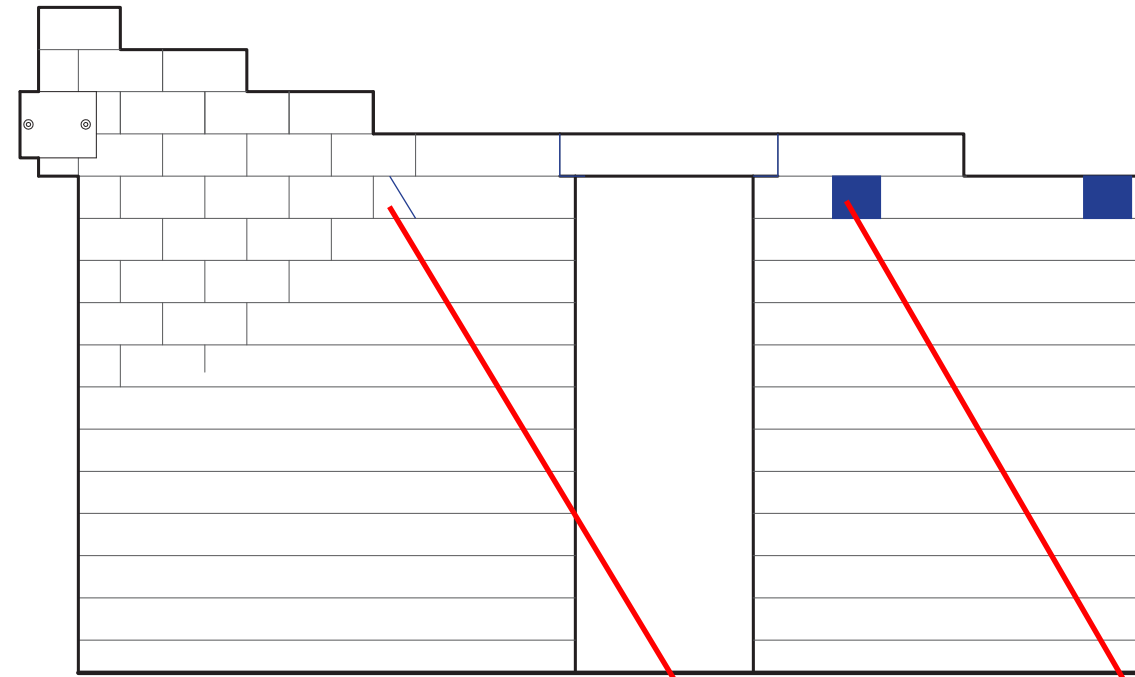
Wall 12

Potentially due to the collapse of its roof, the sun porch is extremely structurally damaged. The corner of the low wall is being overcome with plant growth, causing the CMUs to shift considerably due to the plants' roots.

Missing CMUs and large upper cracks also express concern for a wall collapsing or the door lintel moving in the near future.

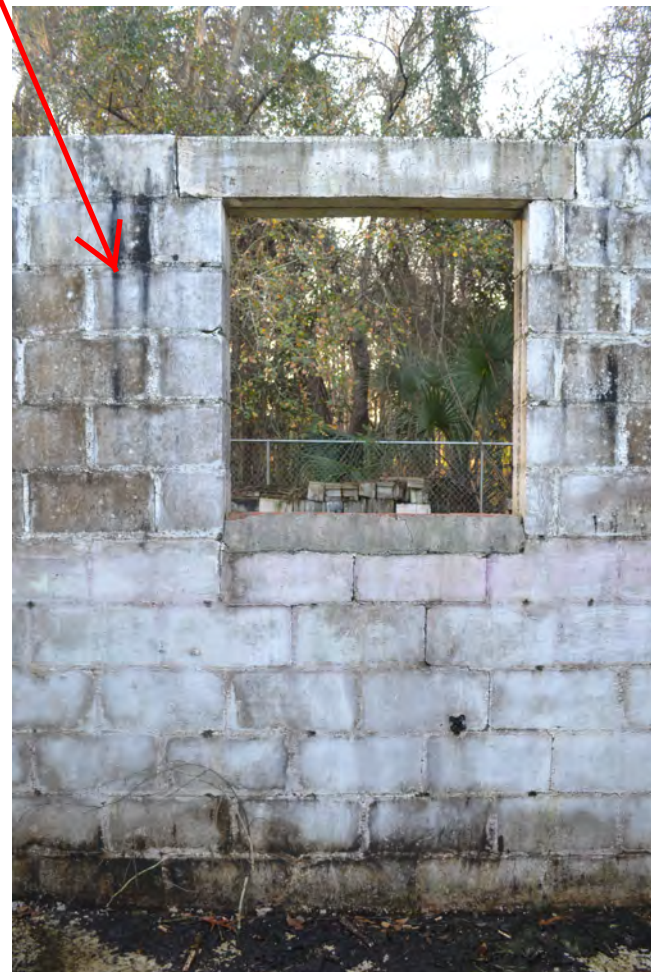
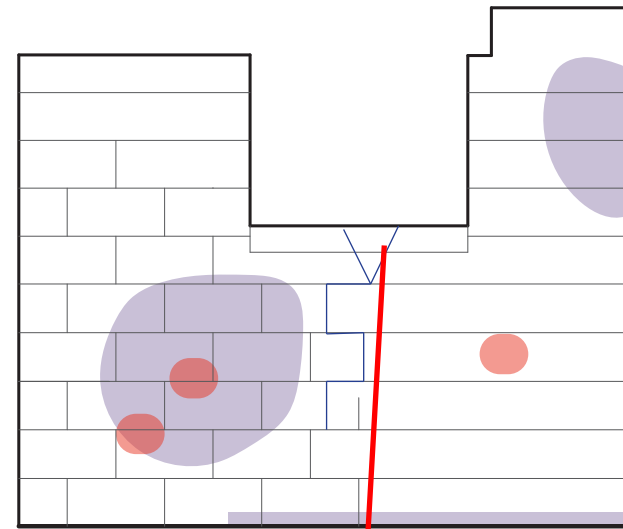
Wall 14

The loss of a lintel has caused CMUs to be exposed consequently allowing more to fall off the top of the wall. The brick sill on the window is sloped outwardly and down at an angle not originally intended. This stress is causing a crack beneath the window opening which will potentially develop further.

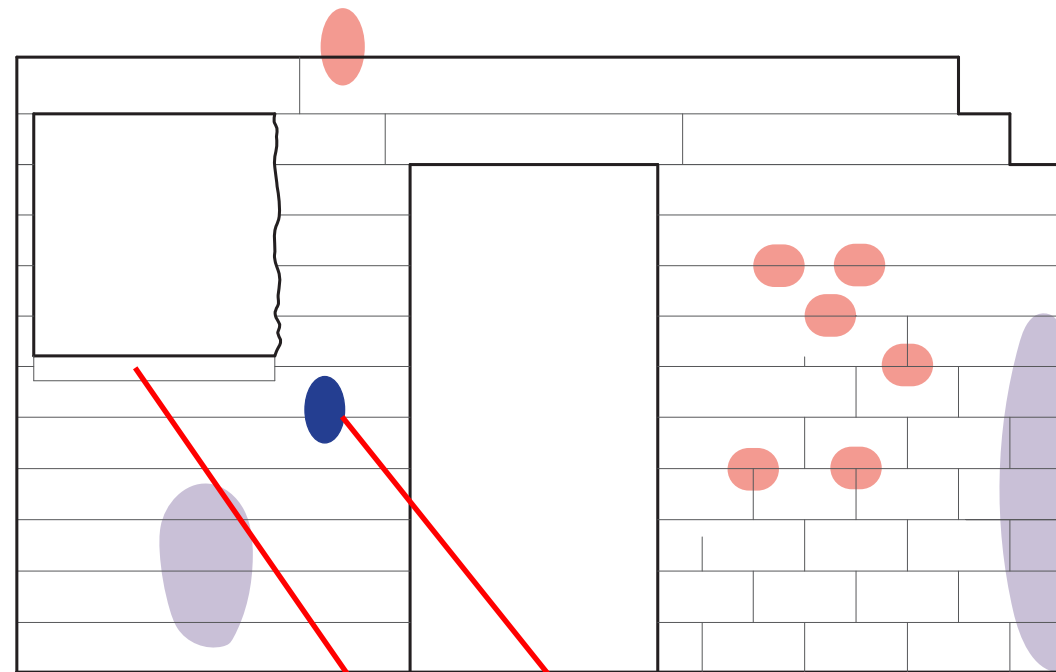
Wall 15

Throughout the dormitories and bathrooms in the back of the structure, metal lintels have been placed at the doorways. They are severely rusted and corroded, posing potential failures. Some iron staining is also detected at the sides of the doorways.

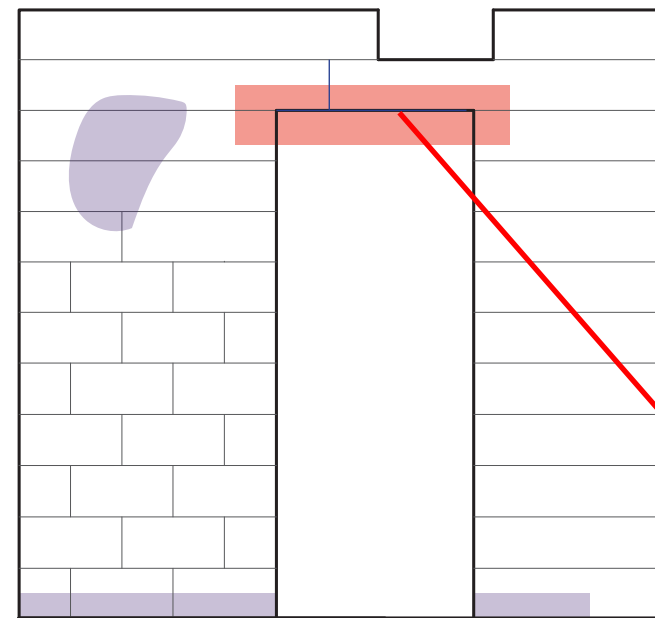
Wall 16

The structural integrity of the CMUs has be compromised by rough cutting the window opening, as well as the large hole near the door. Rust staining from previous iron intrusions are detected across the wall.

The rough window opening causes future concern for the position of the lintel overhead.

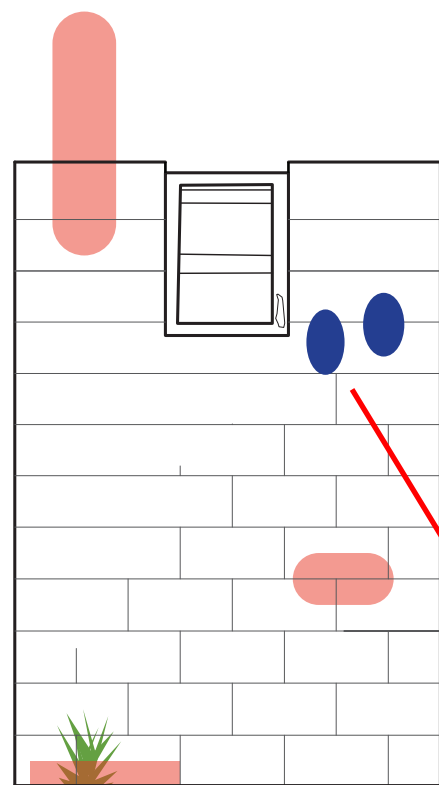
Wall 17

Two holes have been punched through an exterior CMU wall diminishing the structural integrity. The wall has other staining from mold and rust caused by the metal clip.

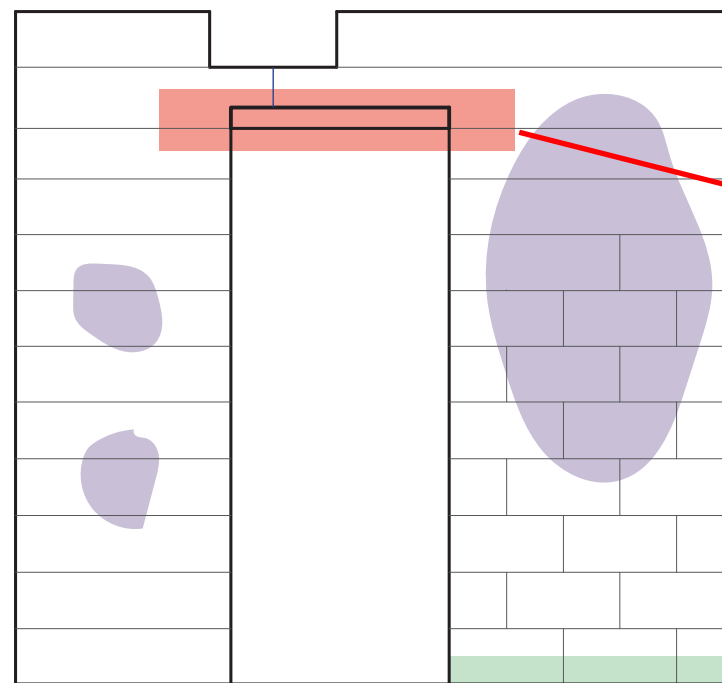
Wall 18

Metal lintel is rusted and the natural expansion of the metal has shifted some CMUs above the doorway out of plumb.

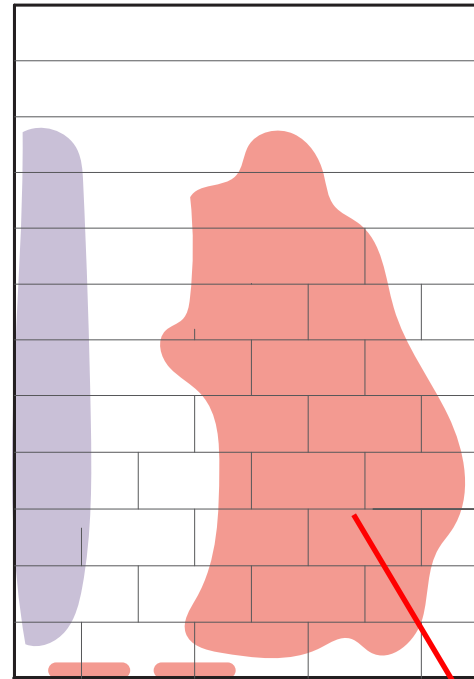
Wall 19

Interior wall is not structurally tied to exterior. Separation where two walls meet is visible. Section of wall is susceptible to imminent collapse.

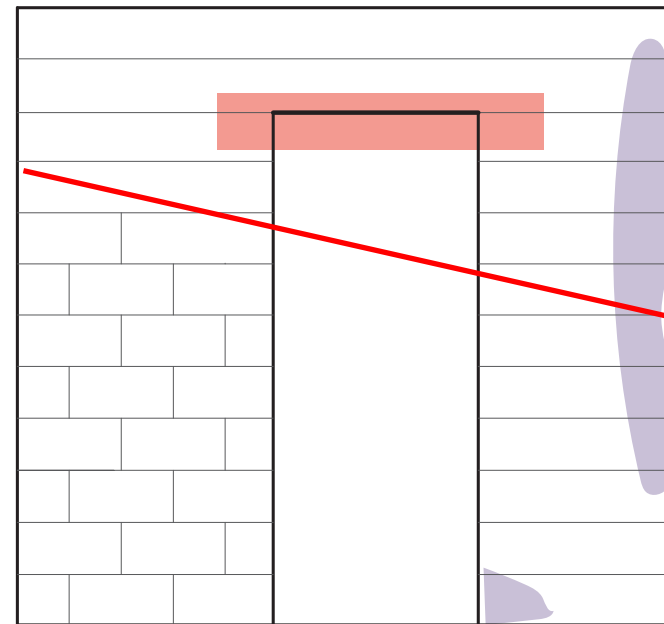
Wall 20

An unknown stain/chemical reaction has occurred on this wall. The stain is raised from the surface of the CMU and has a thick consistency.

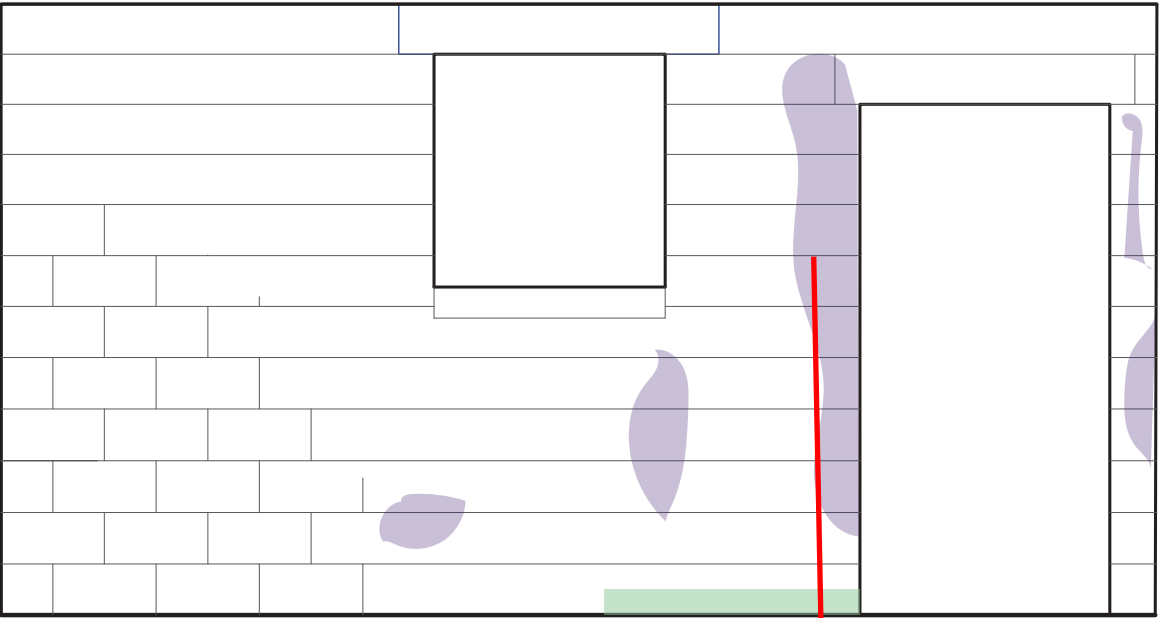
Wall 21

Black mold is prominent in the dormitory spaces. This area receives little sun throughout the day and remains constantly damp.

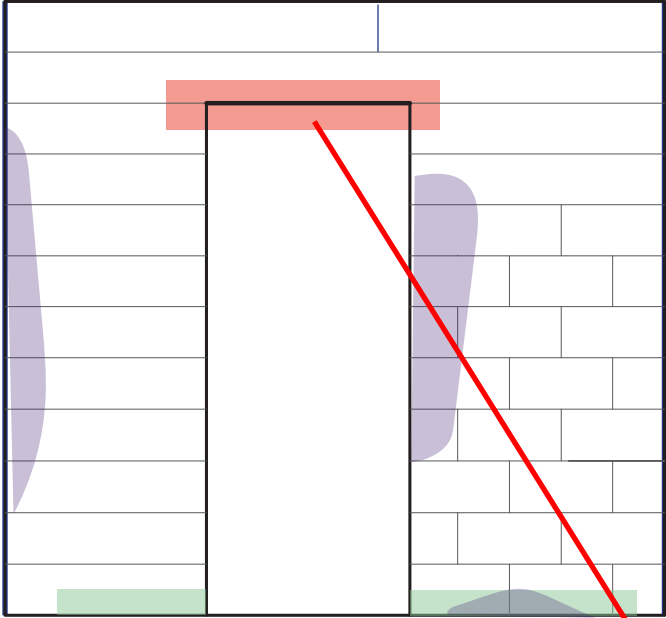
Wall 22

Detail of rusted metal lintel supporting CMU's above doorway. Expansion of metal plate has caused some CMUs to shift out of plumb.

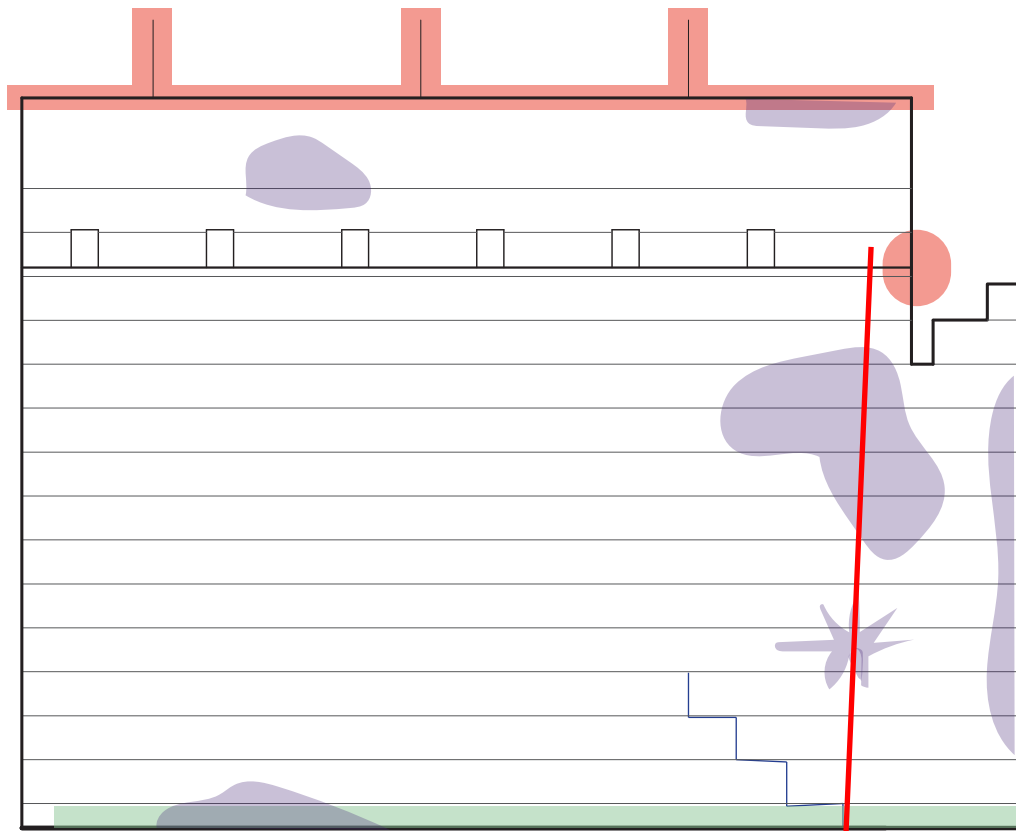
Wall 23

A doorway has been cut through a wall that was not designed with a door. These interior CMU's are half the width of the exterior blocks and were greatly weakened when cut through. The two portions of this wall are structurally unstable and susceptible to imminent collapse.

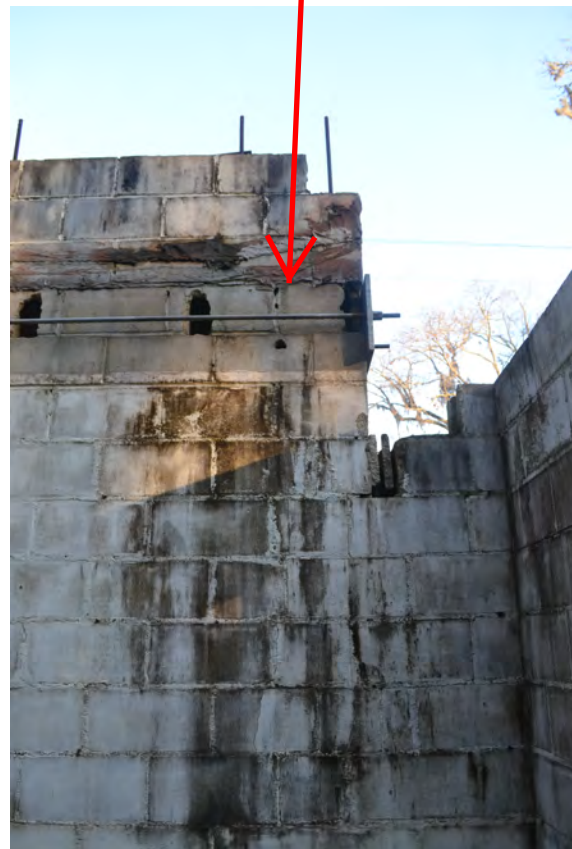
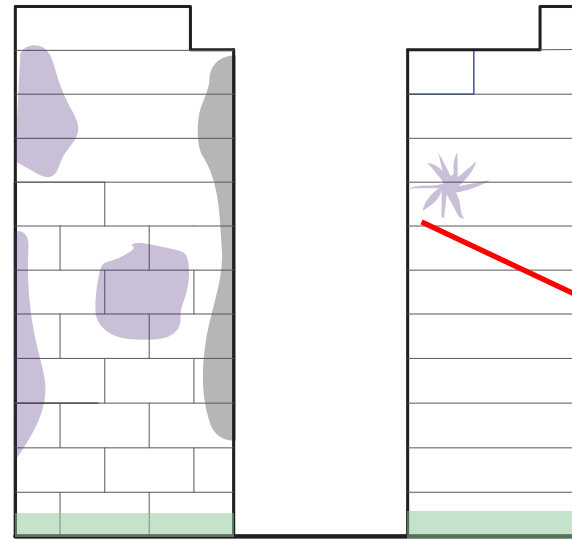
Wall 24

This wall has ghost marks from roofing materials that once covered the dormitory spaces and holes where rafters once sat. The holes greatly diminish the structural integrity of the CMUs. Black mold is also present because this wall is almost completely shaded all day.

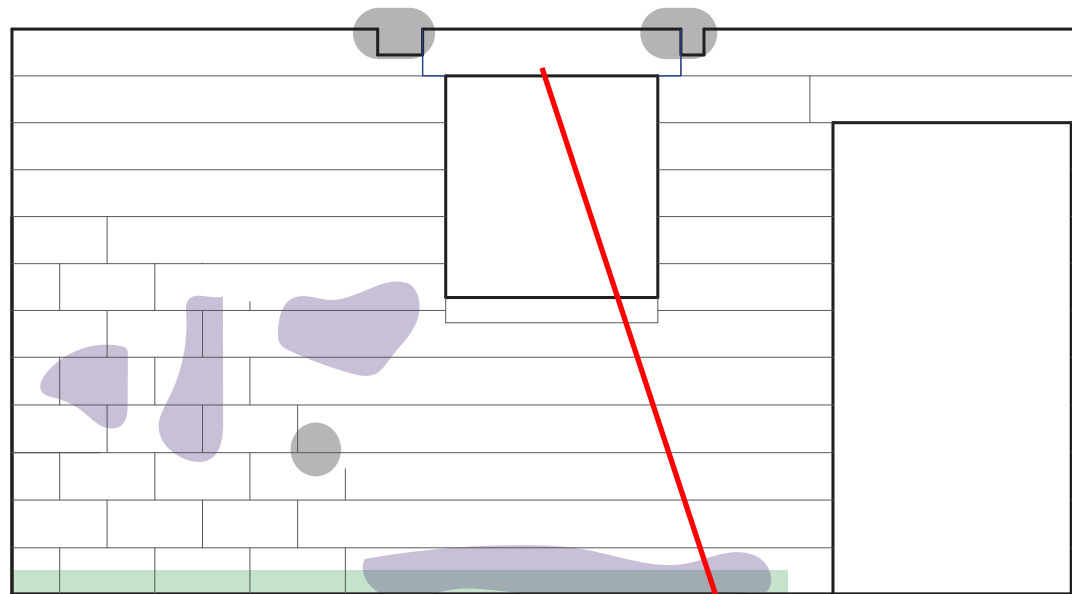
Wall 25

Doorway has been cut through a wall that was designed without a doorway. Blocks are cracked and rough, and both sections of interior wall are structurally unstable.

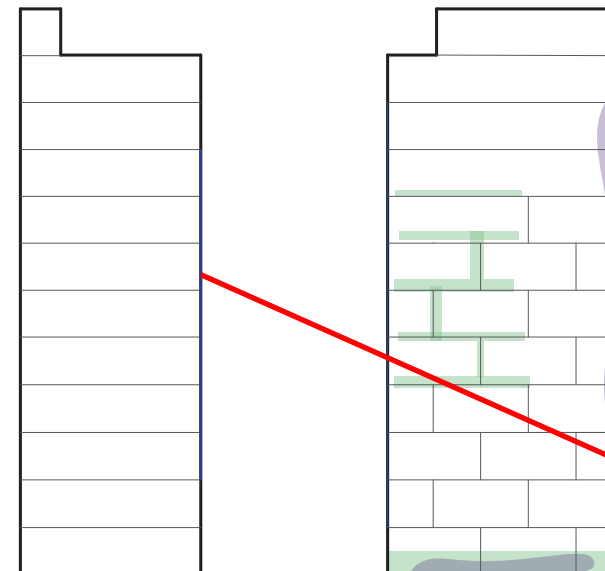
Wall 26

Interior half of lintel is missing, possibly caused by roof of dormitory caving in. Window opening is weakened and adjacent CMUs have also shifted.

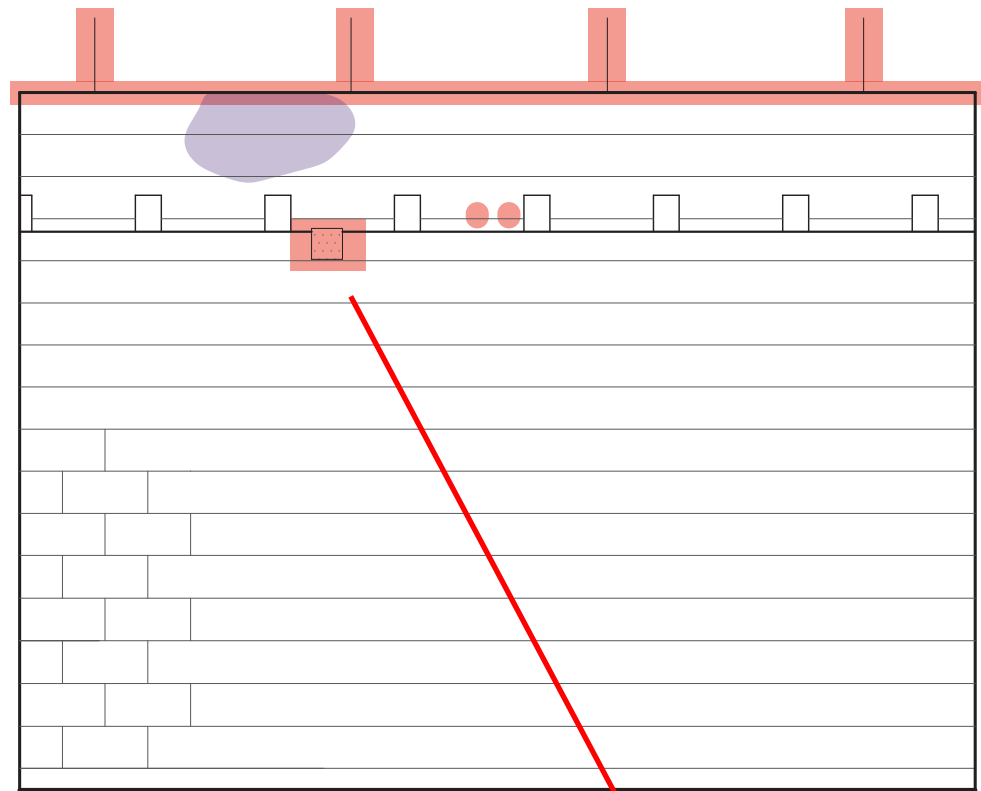
Wall 27

Metal plate supporting CMUs above doorway is rusting. This causes staining and the plate has also expanded, pushing CMUs out of plumb.

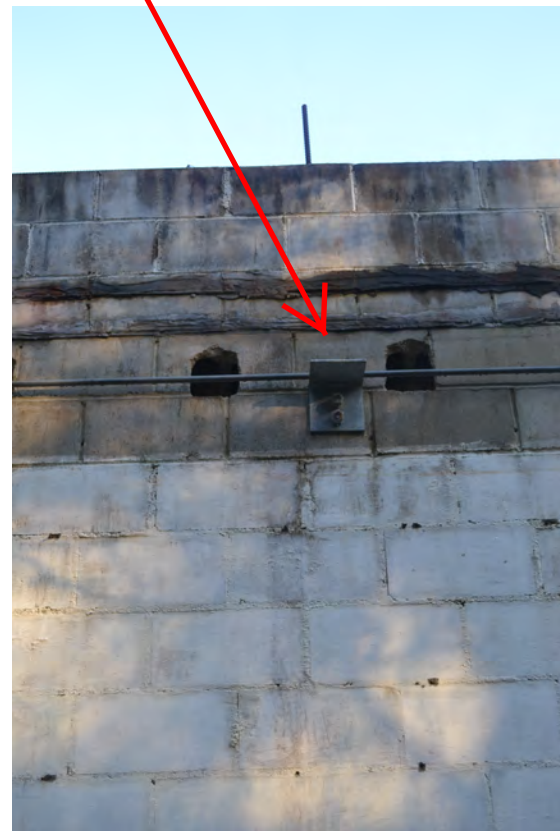
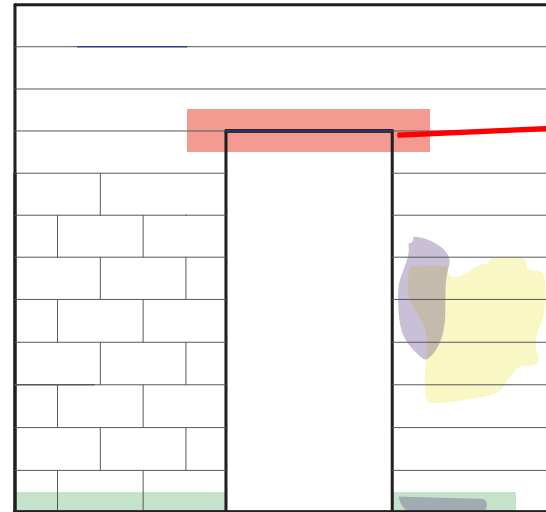
Wall 28

Stainless steel tie rod shows little rust on the plate and cable. However the bolts on the plate and joints between sections of the rod are rusting causing staining on the CMUs.

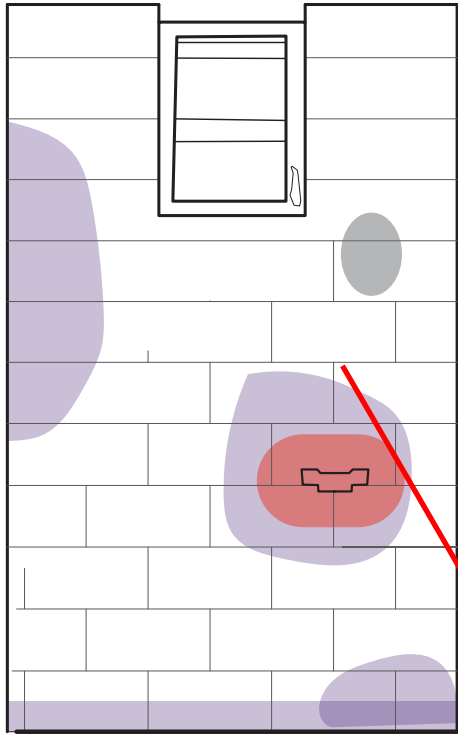
Wall 29

Wall is not tied to exterior walls and a crack spans to the doorway. The top portion of this wall could collapse at any point.
