# The Progressive Club

Johns Island, South Carolina

Preservation  
Studio  
Spring  
Term  
2015

Graduate Program in Historic Preservation

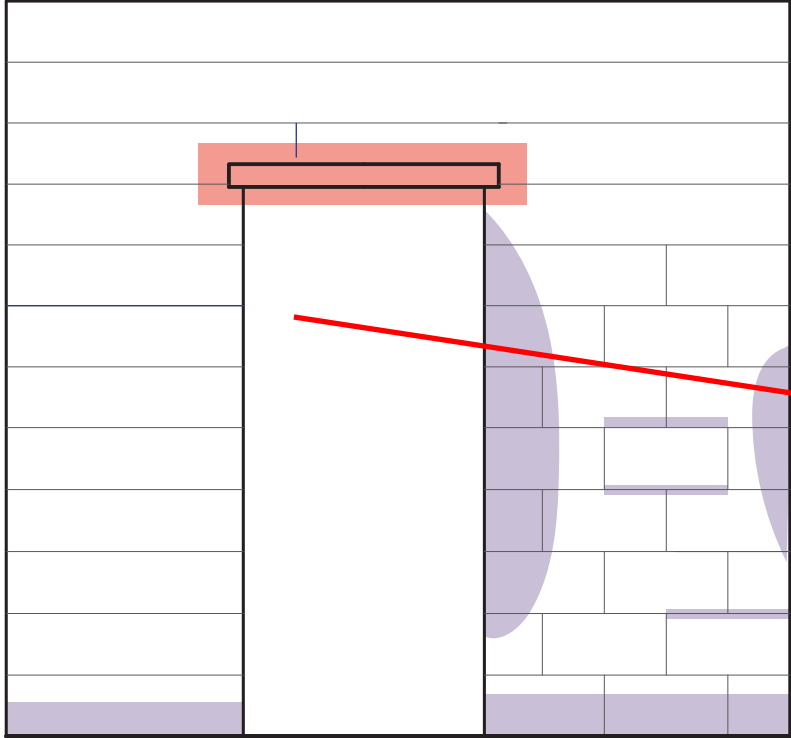
Wall 30

This wall has staining from the window and metal clip. A hole has been punched through one CMU, greatly diminishing the structural integrity of that area of the wall.

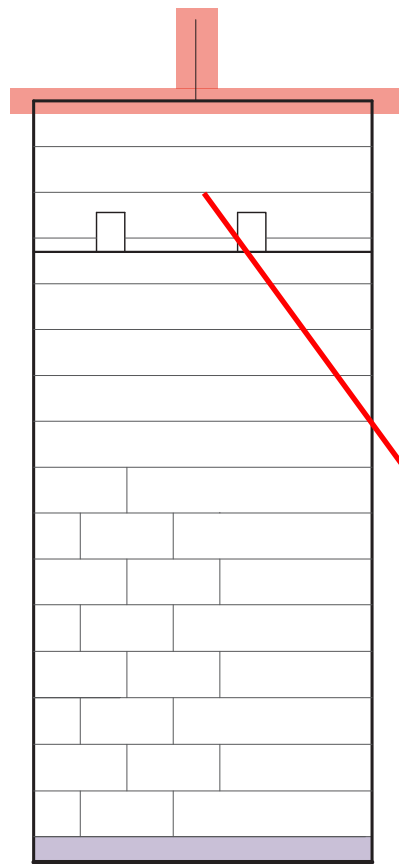
Wall 31

Wall is not tied into exterior walls and CMU's are missing, potentially displaced when the roof caved in.

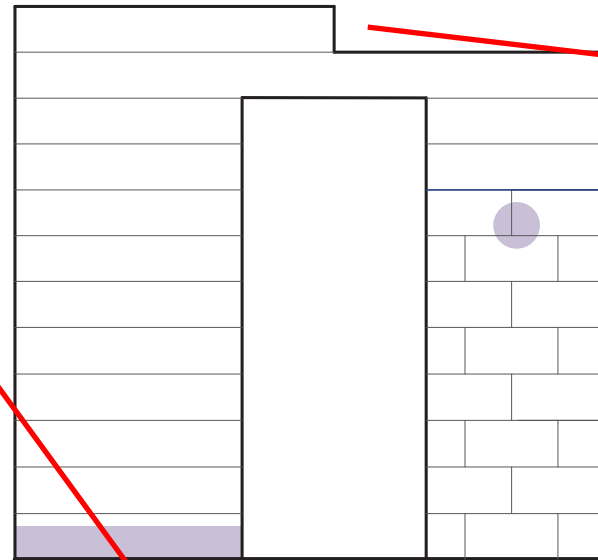
Wall 32

Wall has large holes that are likely rafter pockets from the roof that covered the dormitory space. A ghost mark was left behind by other roofing materials.

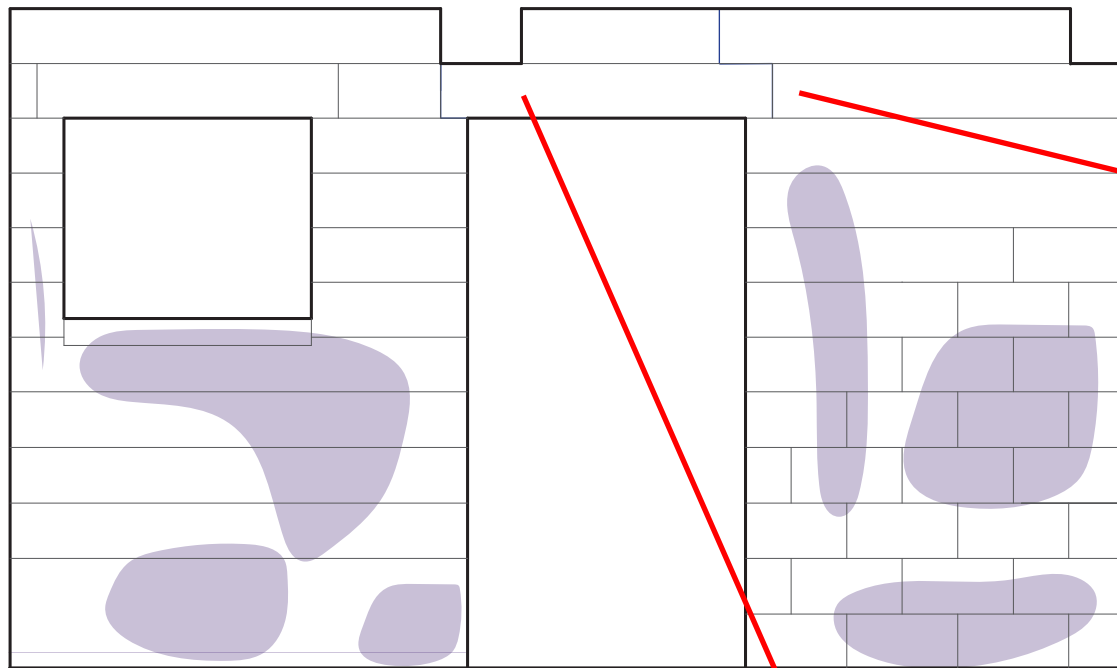
Wall 33

Lintel detail with context of doorway.

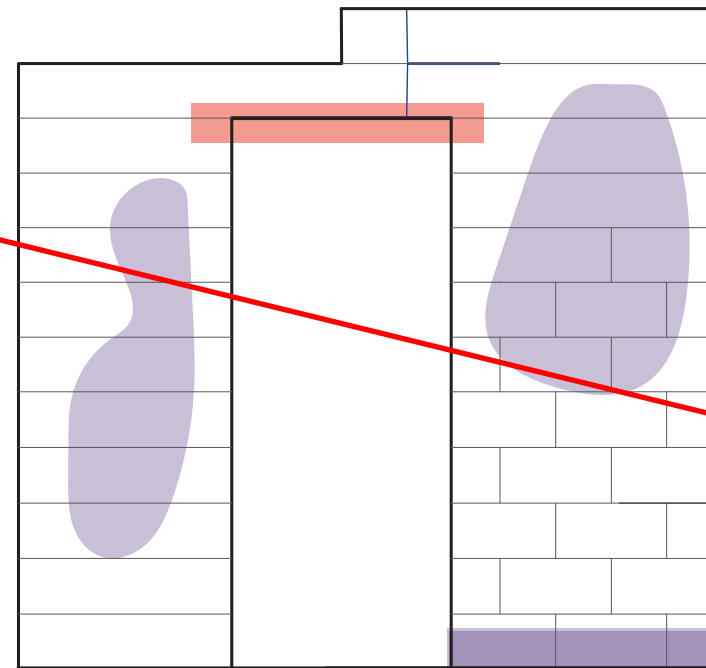
Wall 34

Door frame is missing CMUs and lintel has lost almost all mortar holding it in place. Doorway is a safety hazard due to structural instabilities.

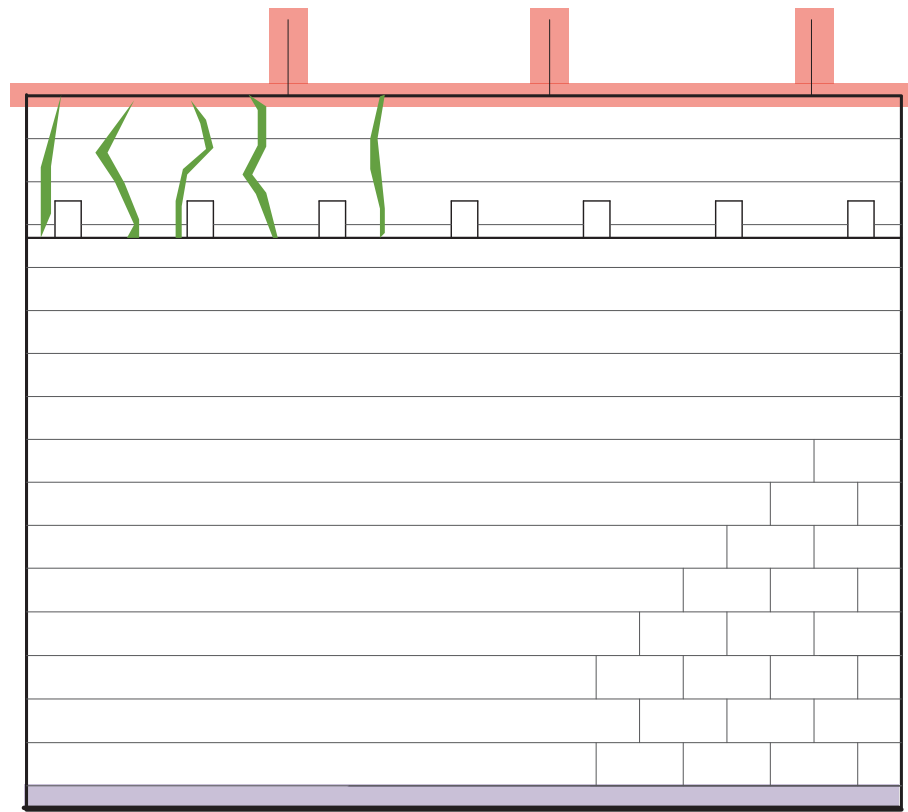
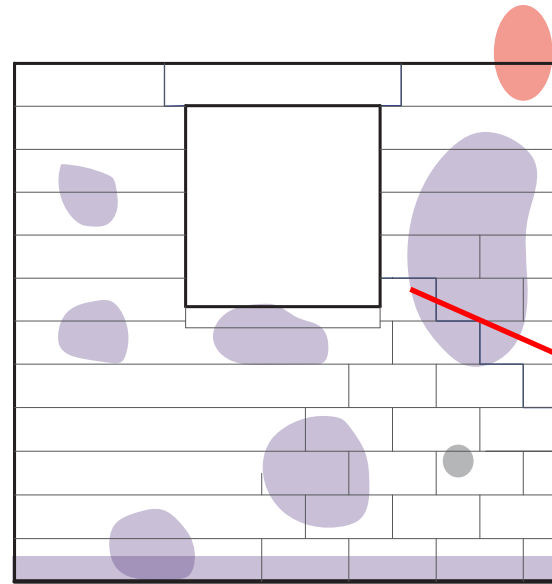
Black mold is present throughout the structure. Large sections of wall receive little to no sun and the surfaces never completely dry out.

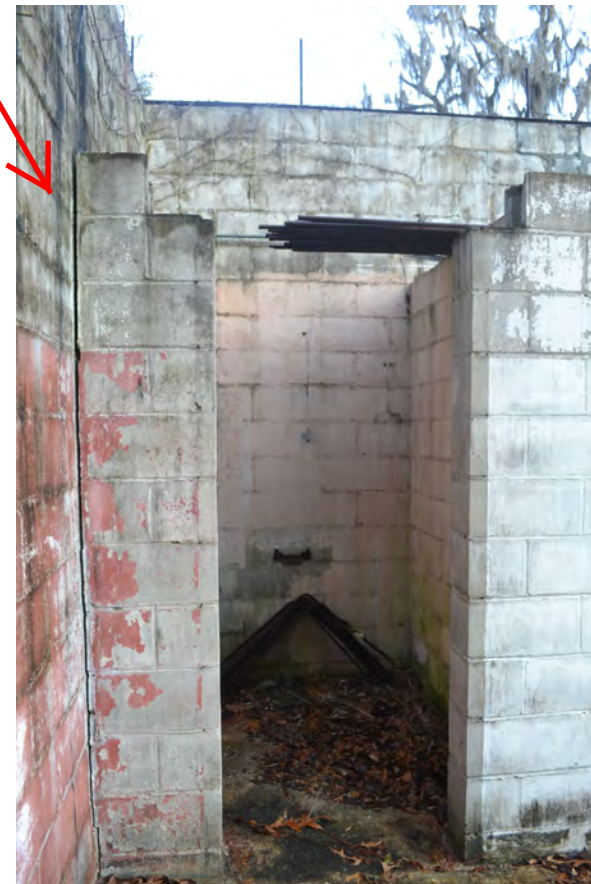
Bathroom wall inside gathering space is pulling away from the exterior wall. This portion of wall is standing alone and has no support or reinforcement.

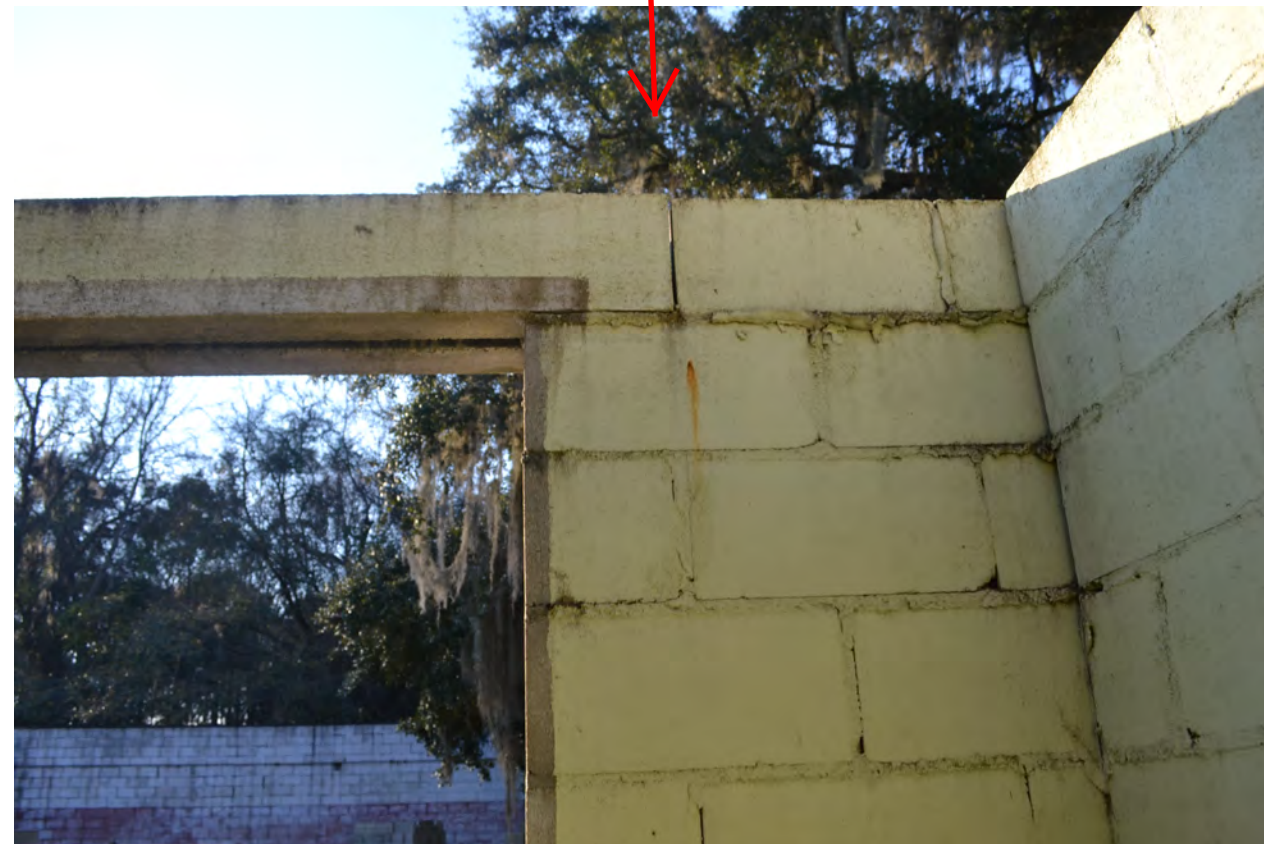
Bathrooms inside gathering space are not tied into structure and lintels and mortar joints are starting to separate.
