Investigation, Documentation, and Conservation of

Pompion Hill Chapel

Berkeley County, S.C.

Clemson University & The College of Charleston
Graduate Program in Historic Preservation
Fall 2014

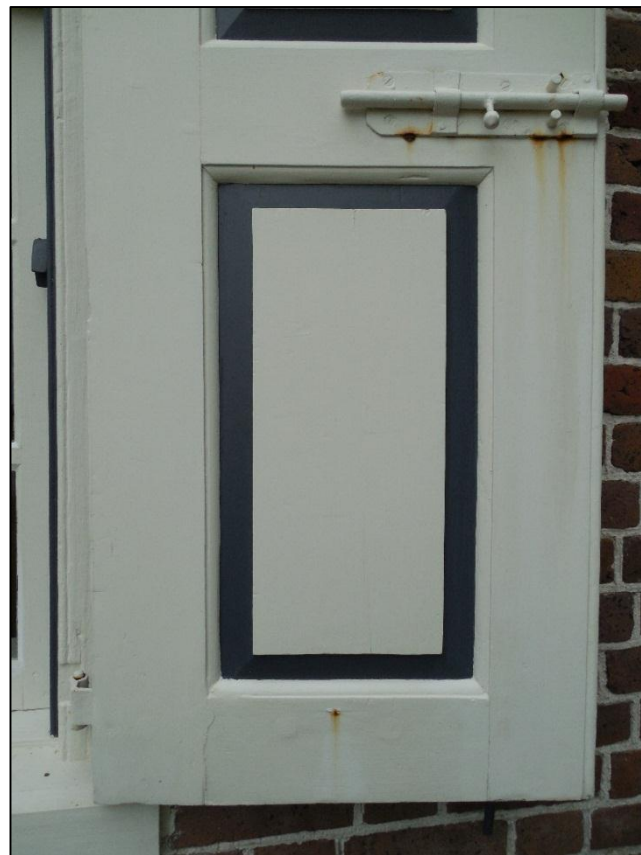
Detail of shutter showing paint scheme and bolt

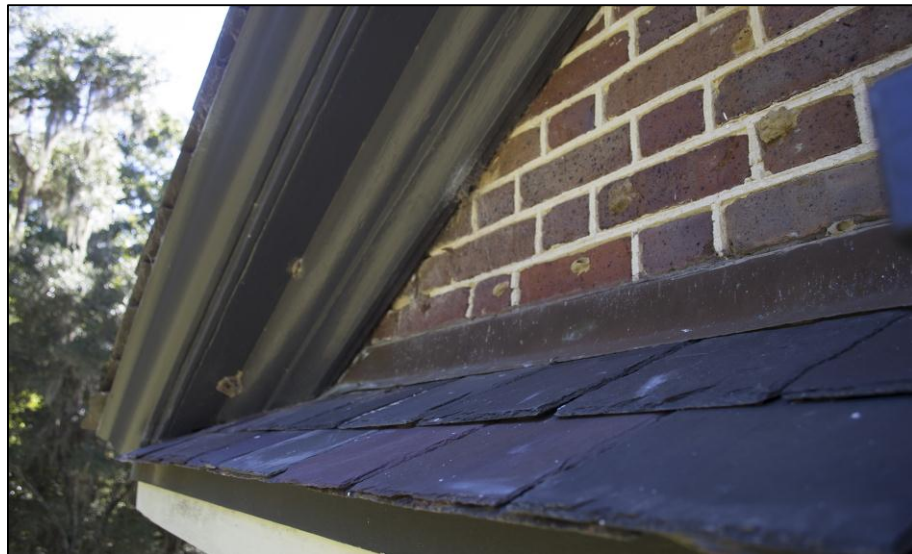
There is both American and Welsh slate on the building.

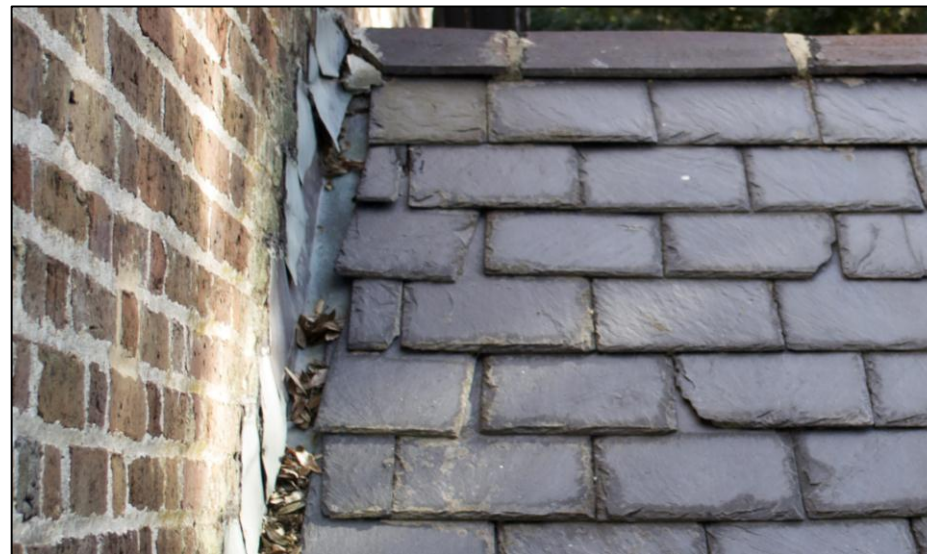
The vestry, is another story. The vestry, due to an improper cold joint, improper maintenance of the flashing, and water intrusion is pulling away from the chapel. This is the most serious condition discovered with the structure. There appears to be significant water intrusion on the interior in the growing gap between the nave and vestry.

The flashing on the building's eastern end is of high quality and does a good job creating a water-tight barrier; its color indicates that it was replaced recently, likely in 2005. The flashing on the vestry end is in worse shape; it appears to be either older or of inferior quality to that on the eastern end. It does a poor job creating a sealed barrier between the nave and the vestry, all a product of the vestry structure pulling away from the nave.

A detail of the flashing on the vestry.

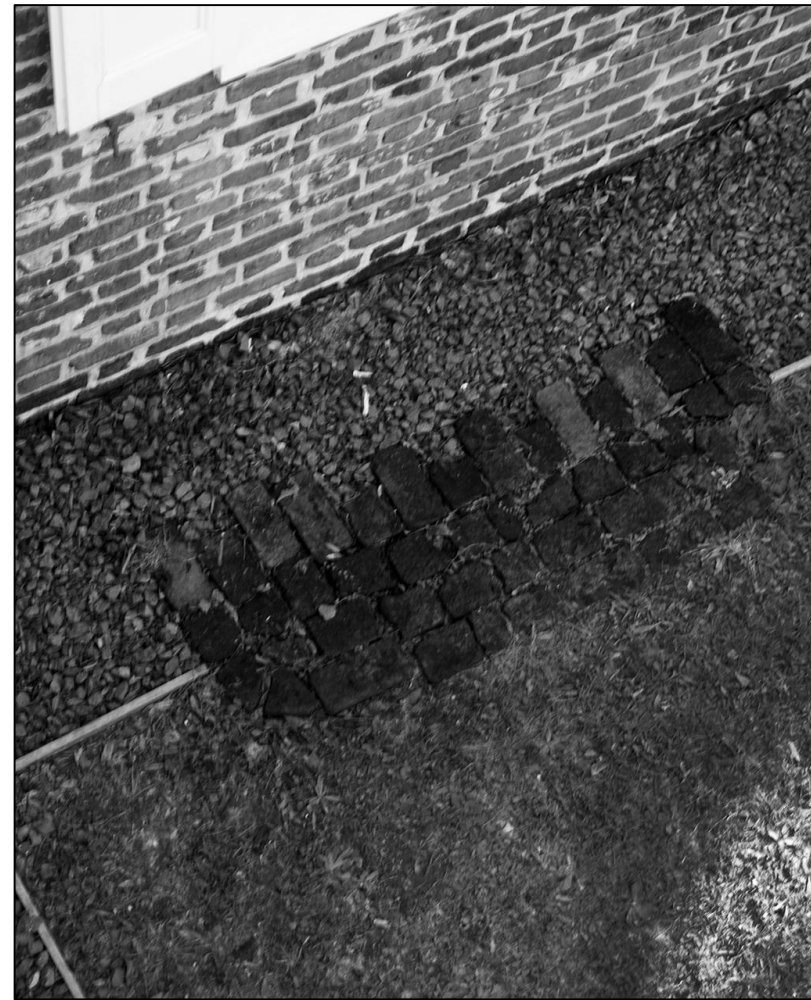
The vestry shows remnants of a walkway in the French Drain.

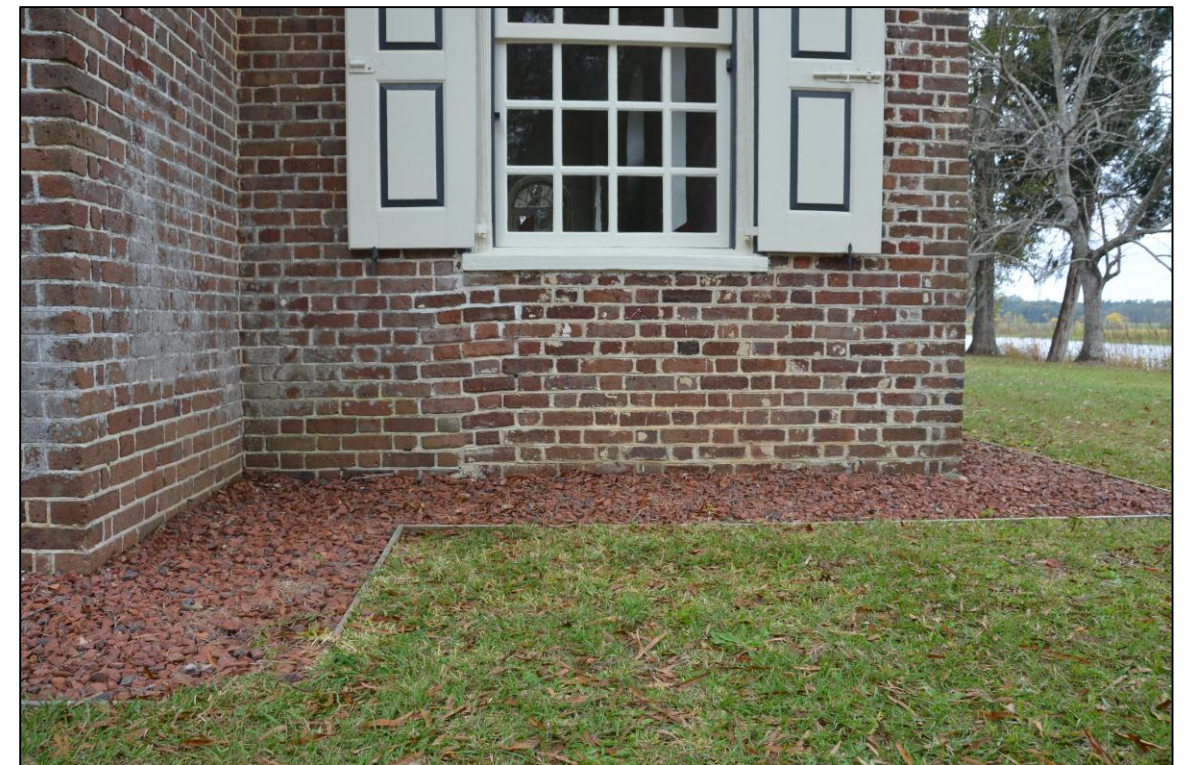
The foundation is in excellent condition, and should continue as such long as both systems are in place and in working order. There is minor bio-growth especially along the southern wall which receives little consistent sunlight. This however is not a major concern.

The NE corner as it is today. The French Drain surrounds the perimeter of the building.

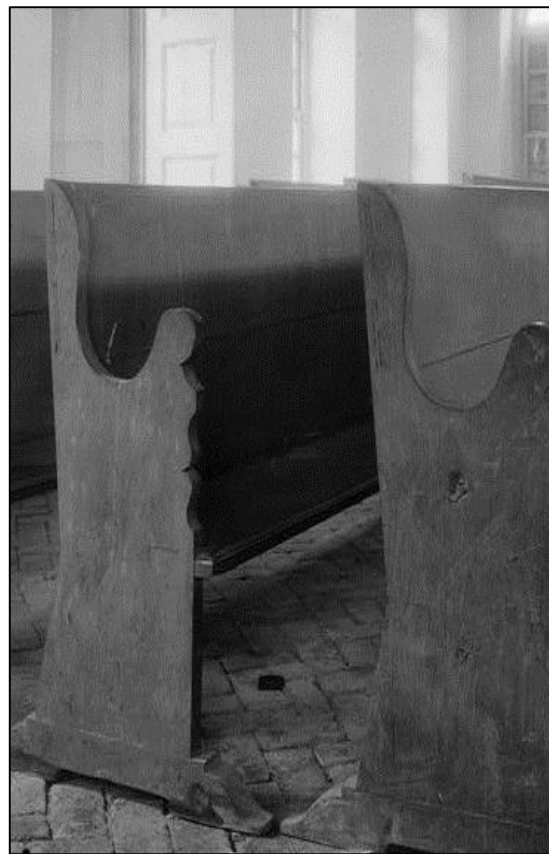
Far Left: This 1930s image shows unpainted pews over the herring bone patterned brick.

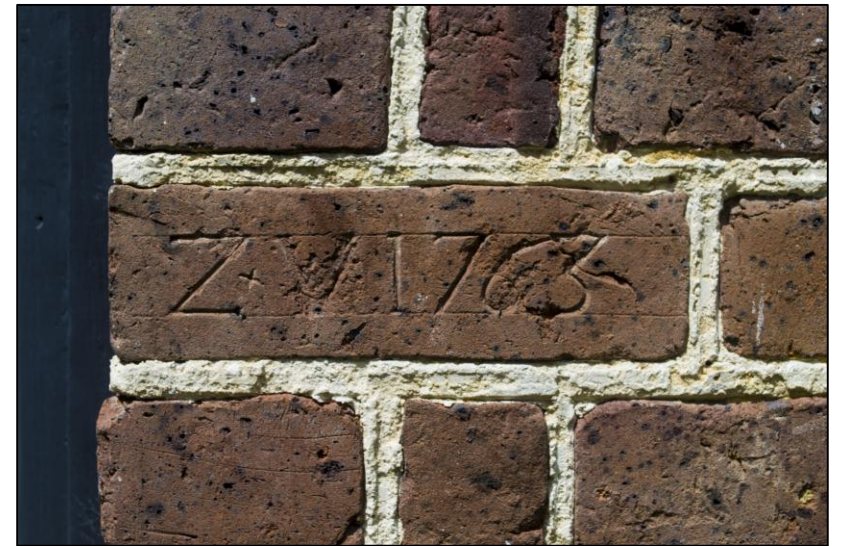
Mason Mark bricks are visible on the building near the doorways. There is also some 'historic graffiti' on the structure, occurring mostly behind shutters.

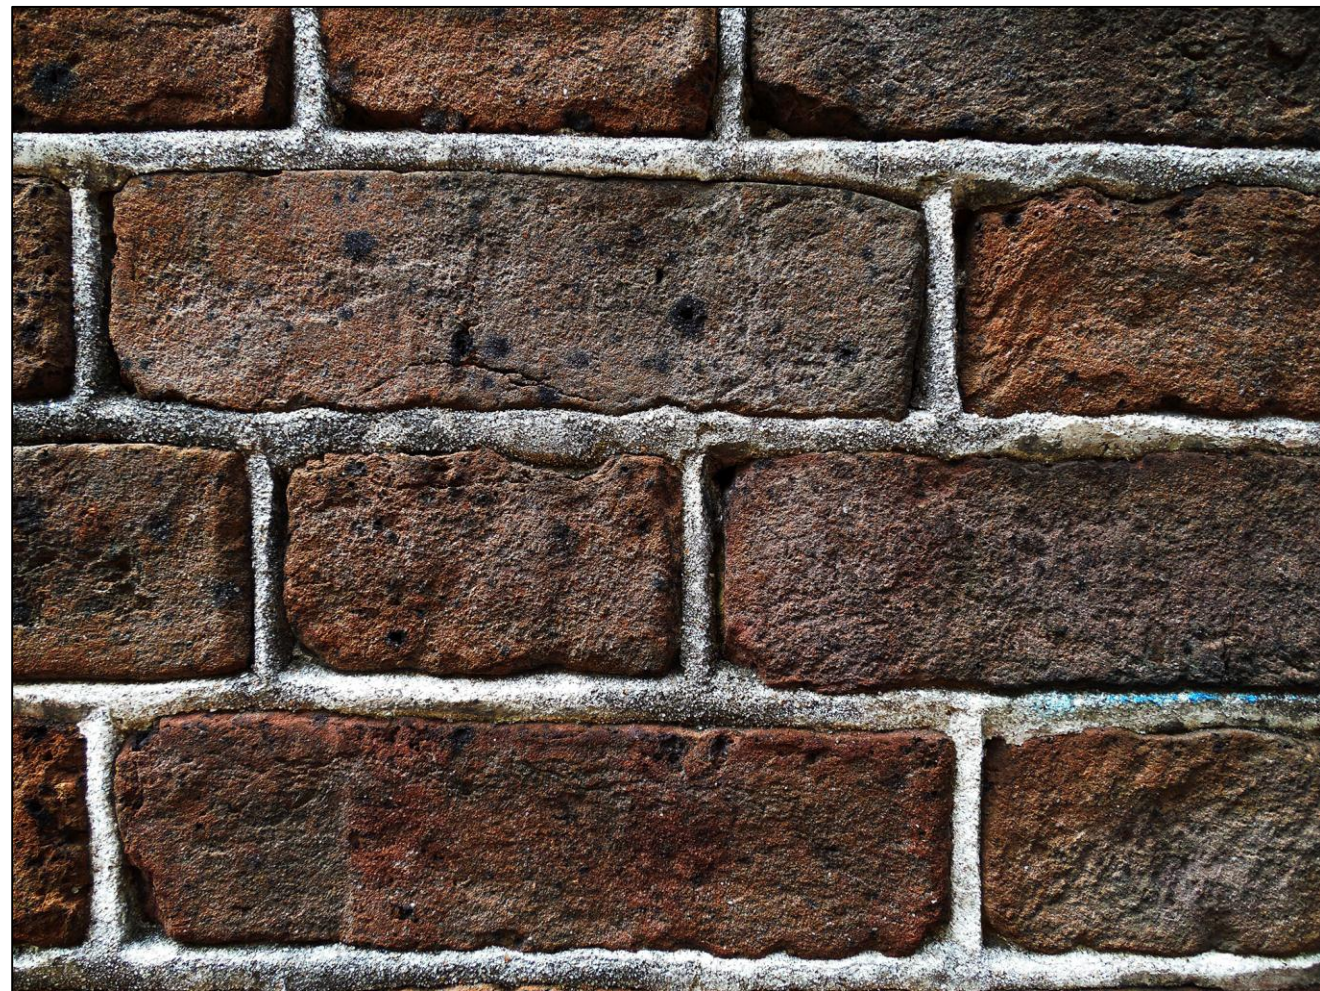
Above is a detail of the bricks. The masonry walls are constructed in a Flemish Bond Pattern with a ribbon joint.

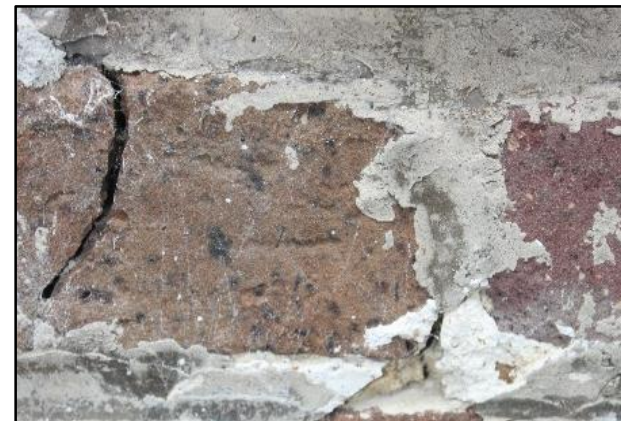
The repointing campaigns consisted of a diverse range of mortar compositions. While most used appropriate mortar, some employed high concentrations of Portland cement. As a result some areas show signs of stress as the Portland expands beyond the mortar beds; cracks have occurred on the affected bricks. These cracks allow water intrusion, which could degrade the wall's structural integrity.

The use of Portland cement has caused bricks to crack.

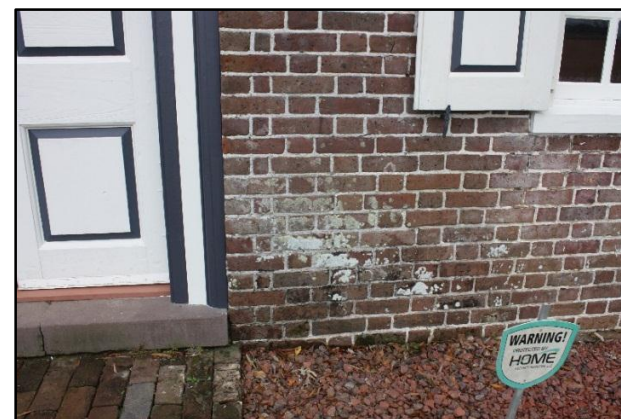
Like the foundation, bio-growth is also present around the exterior. Primarily located near ground level in areas with limited sun exposure, this issue suggests the bricks are holding moisture. Nonetheless, the current bio-growth present is not an imminent hazard.

There is bio-growth present on the perimeter of the building.

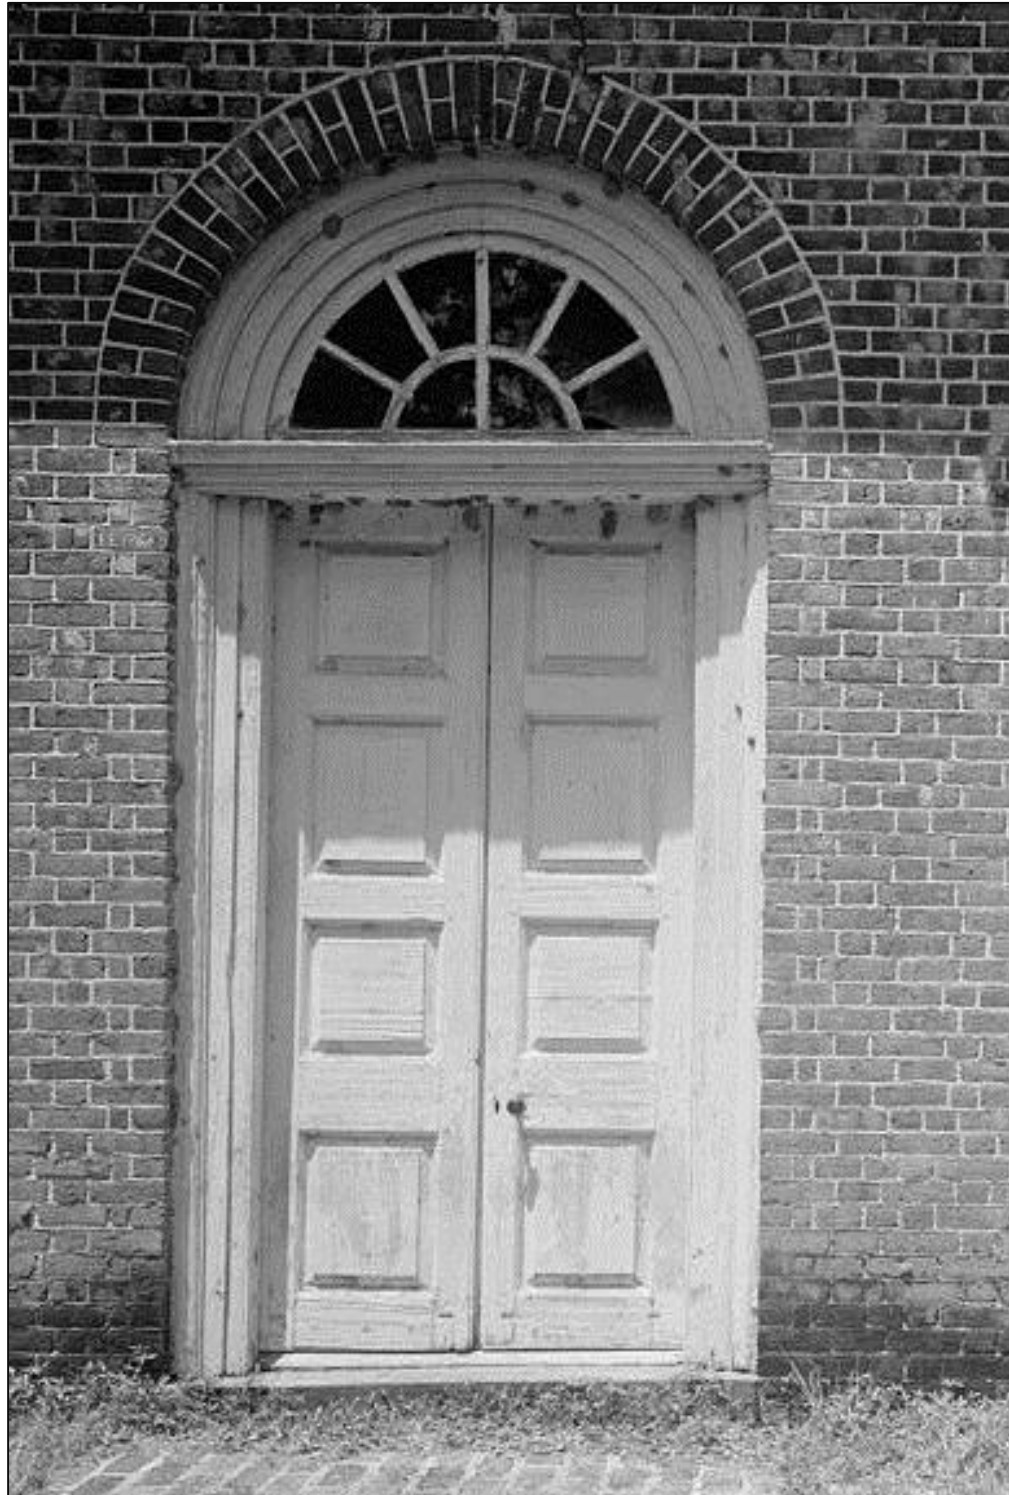
This is a historic images of one of the main entryways prior to renovation.

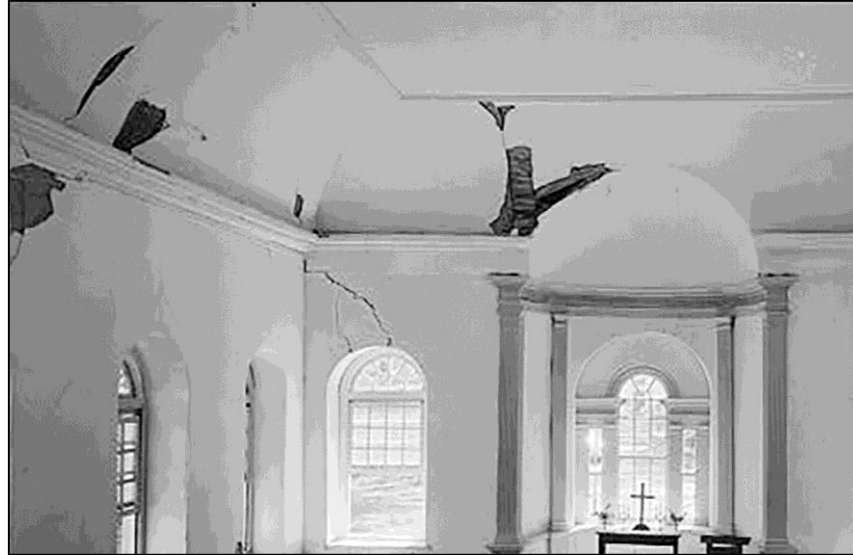
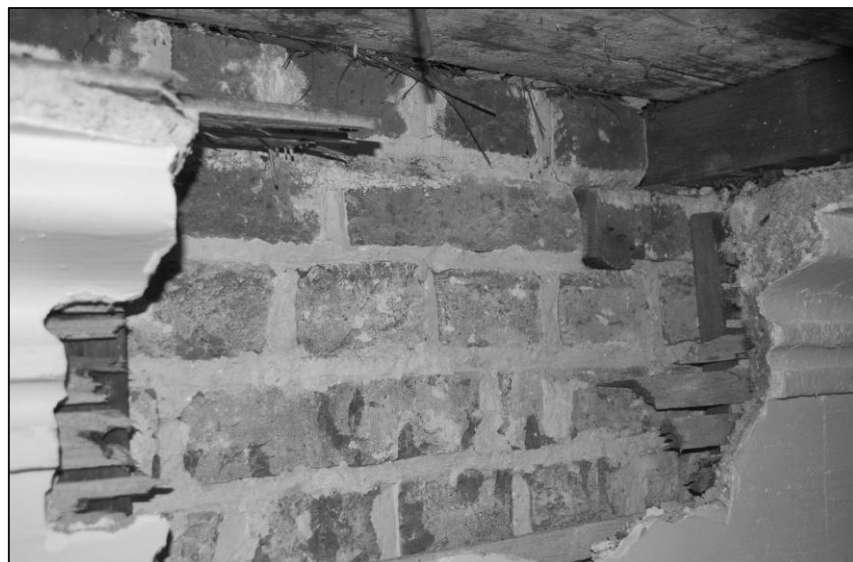
The plaster cove ceiling has been a constant issue, much a result of the consistent pull of gravity. Photographs from the early 20th document its failure along the interior southern wall and around the chancel apse. During the 2005 renovation the entire plaster ceiling was replaced. While access to the roof was not possible, some of the original plaster is perhaps still present between the split lath. The photographs here demonstrate the plaster failures and repairs during the 20th century.

Left: These images show previous plaster failures at Pompion Hill Chapel. The lath and masonry is visible underneath.

Right: The 2007 renovations of the chapel allowed investigative demolition to occur. This provided data to recomplete the original plaster cornice.

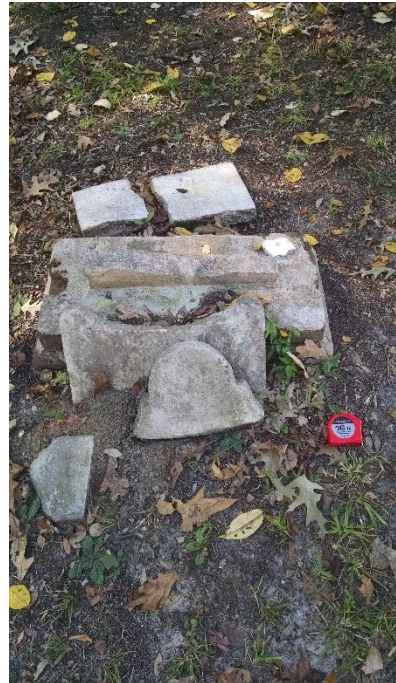
PLOT #19 D.C. EDWARD

The stone as found.

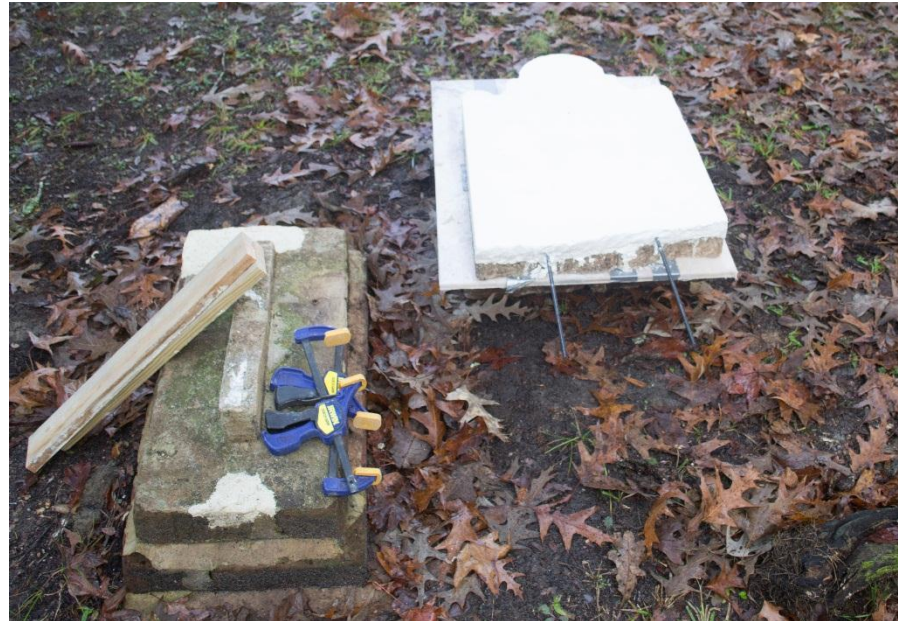
Rods are inserted into the base and epoxy applied between base and tablet

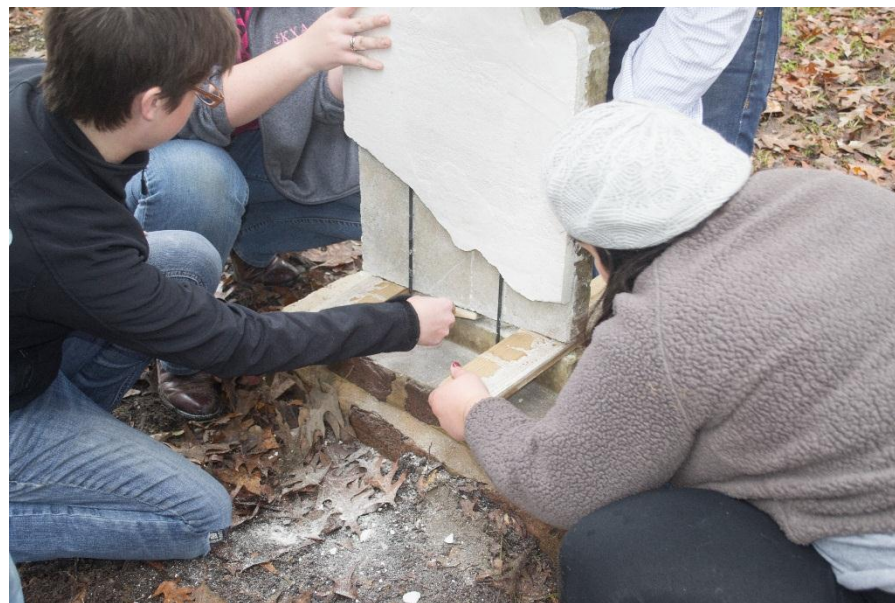
Pieces secured together with epoxy with a NHL lime and sad back.
Carbon fiber rods inserted in bottom.

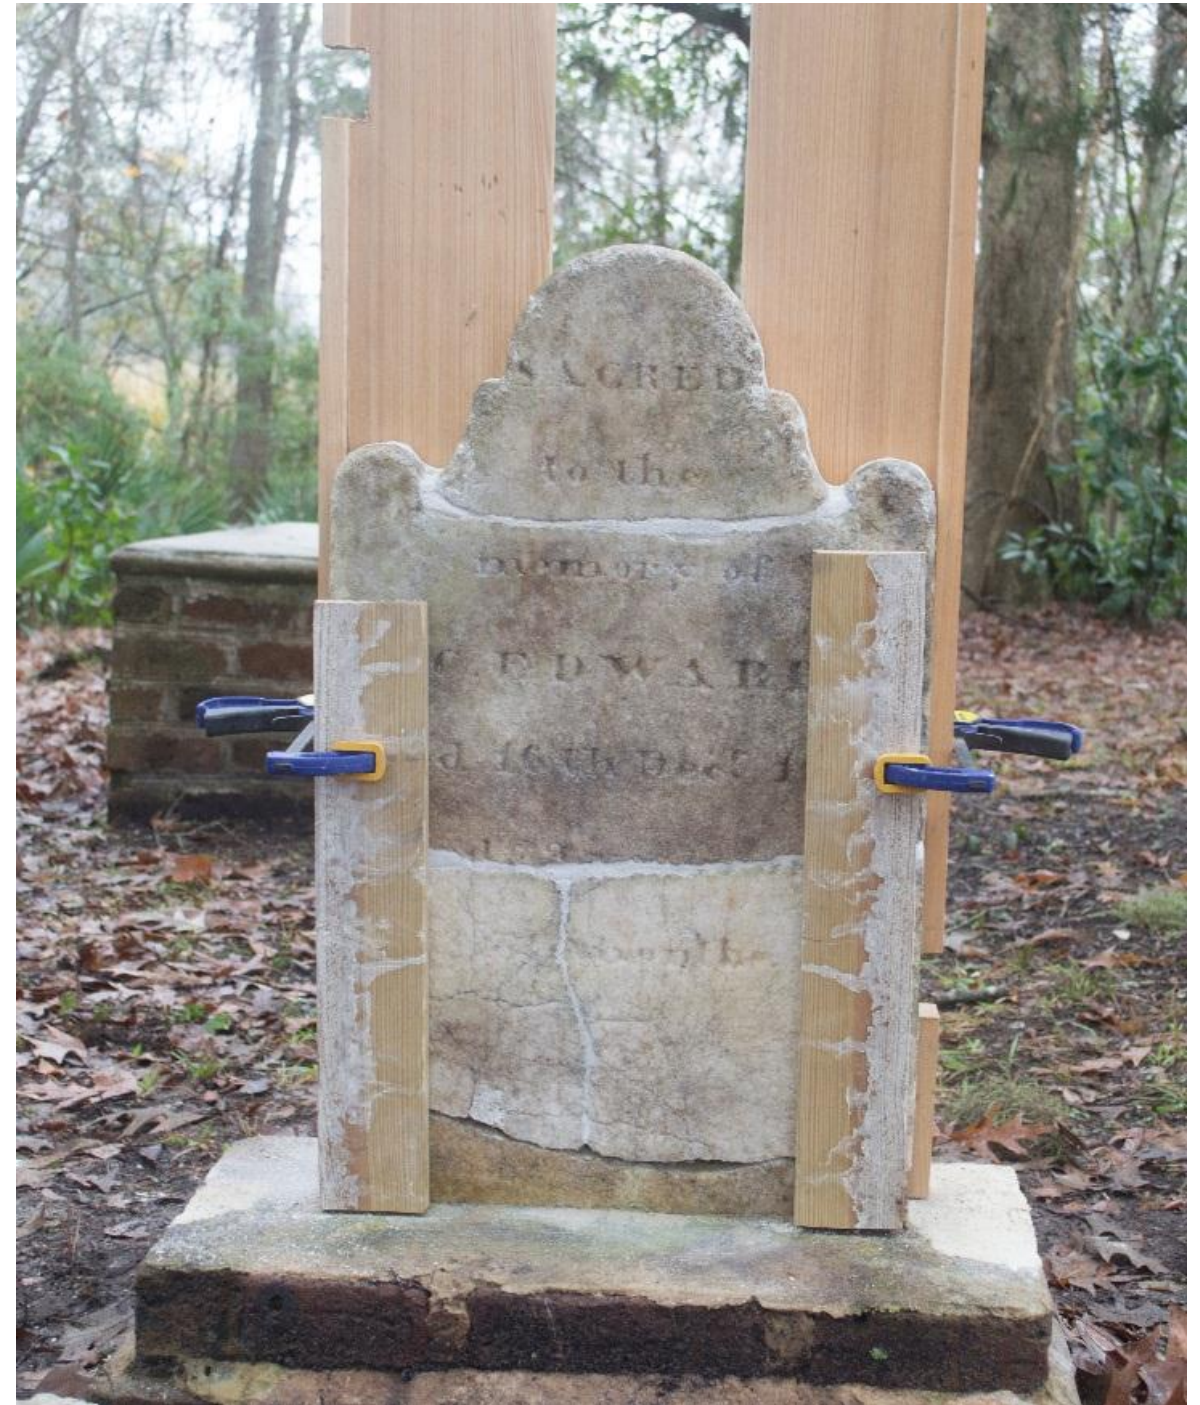
Finished result, boards soon removed once stable.

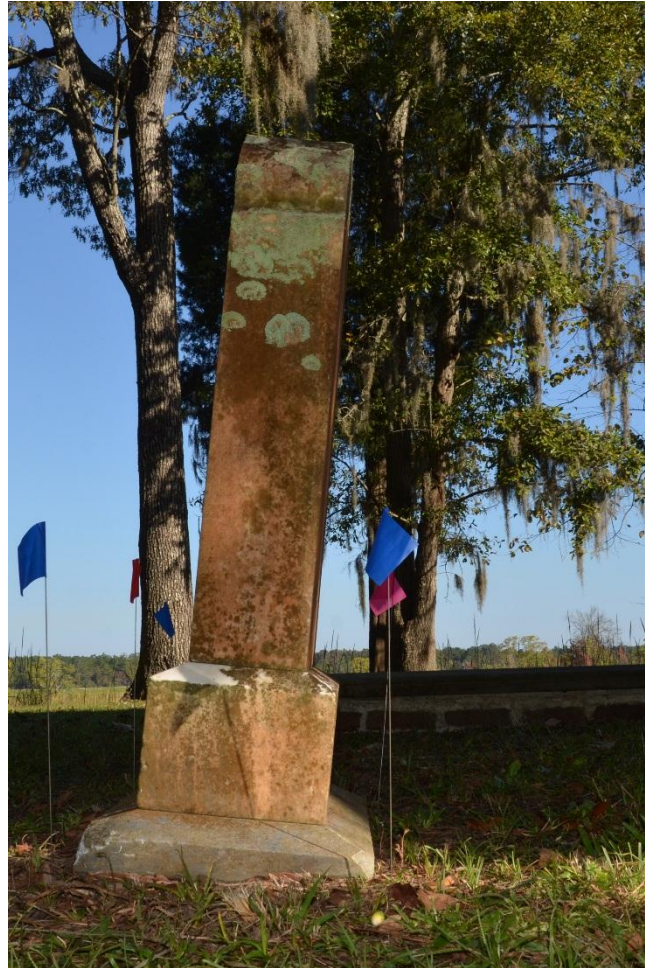
PLOT #8 JOHN HARLESTON

Out Of Plumb

Prior to intervention

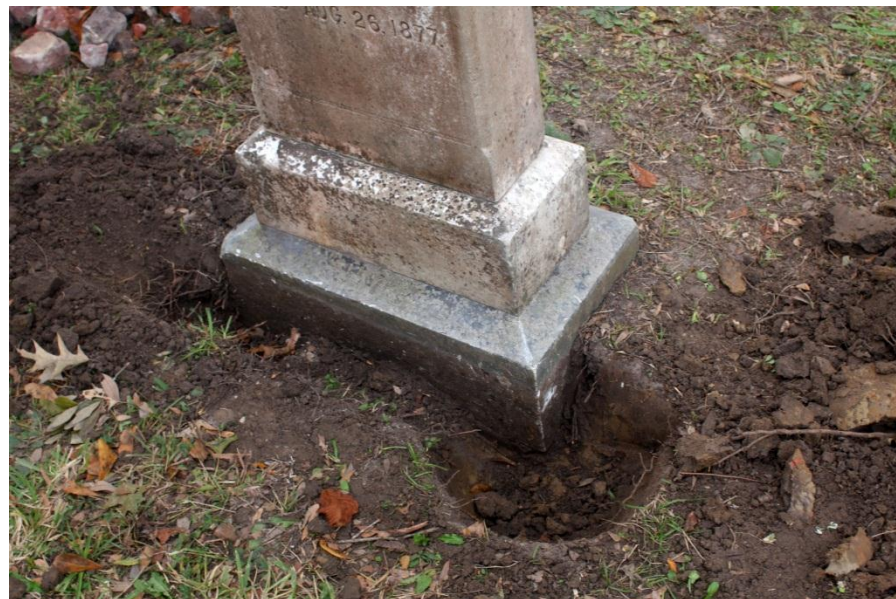
Digging down to bottom of base

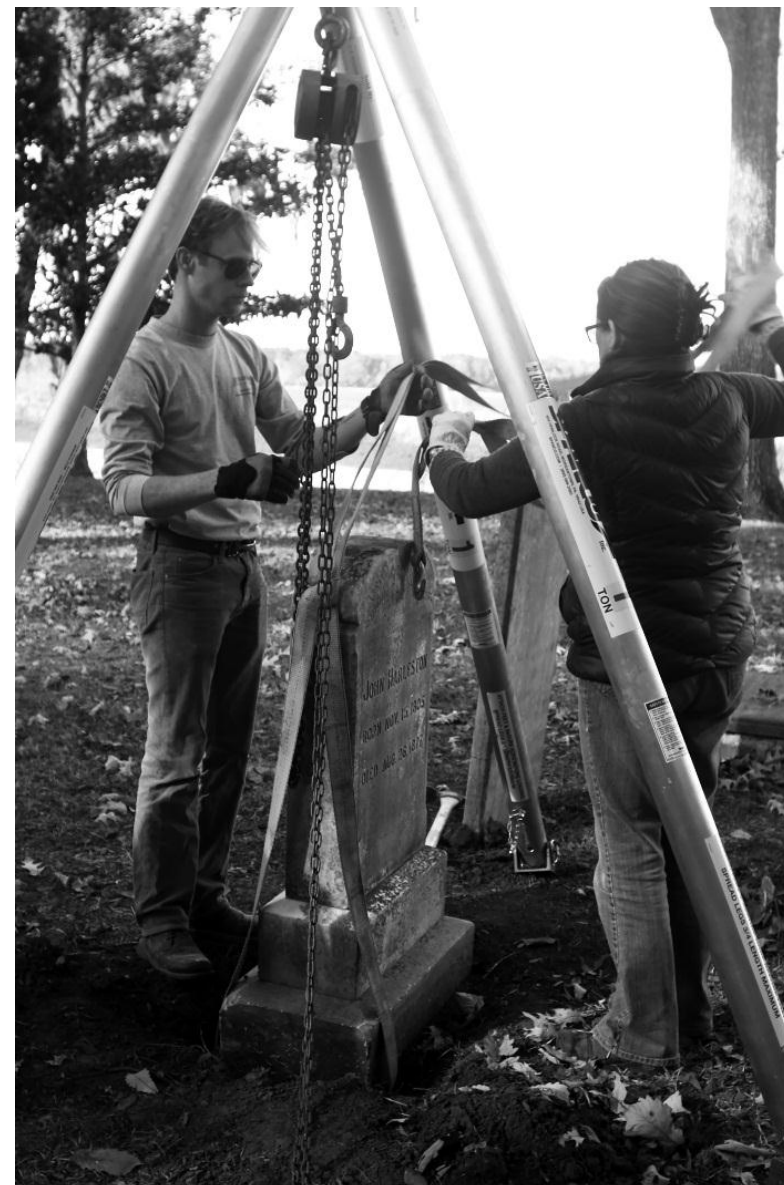
Lifting the Stone with Crane

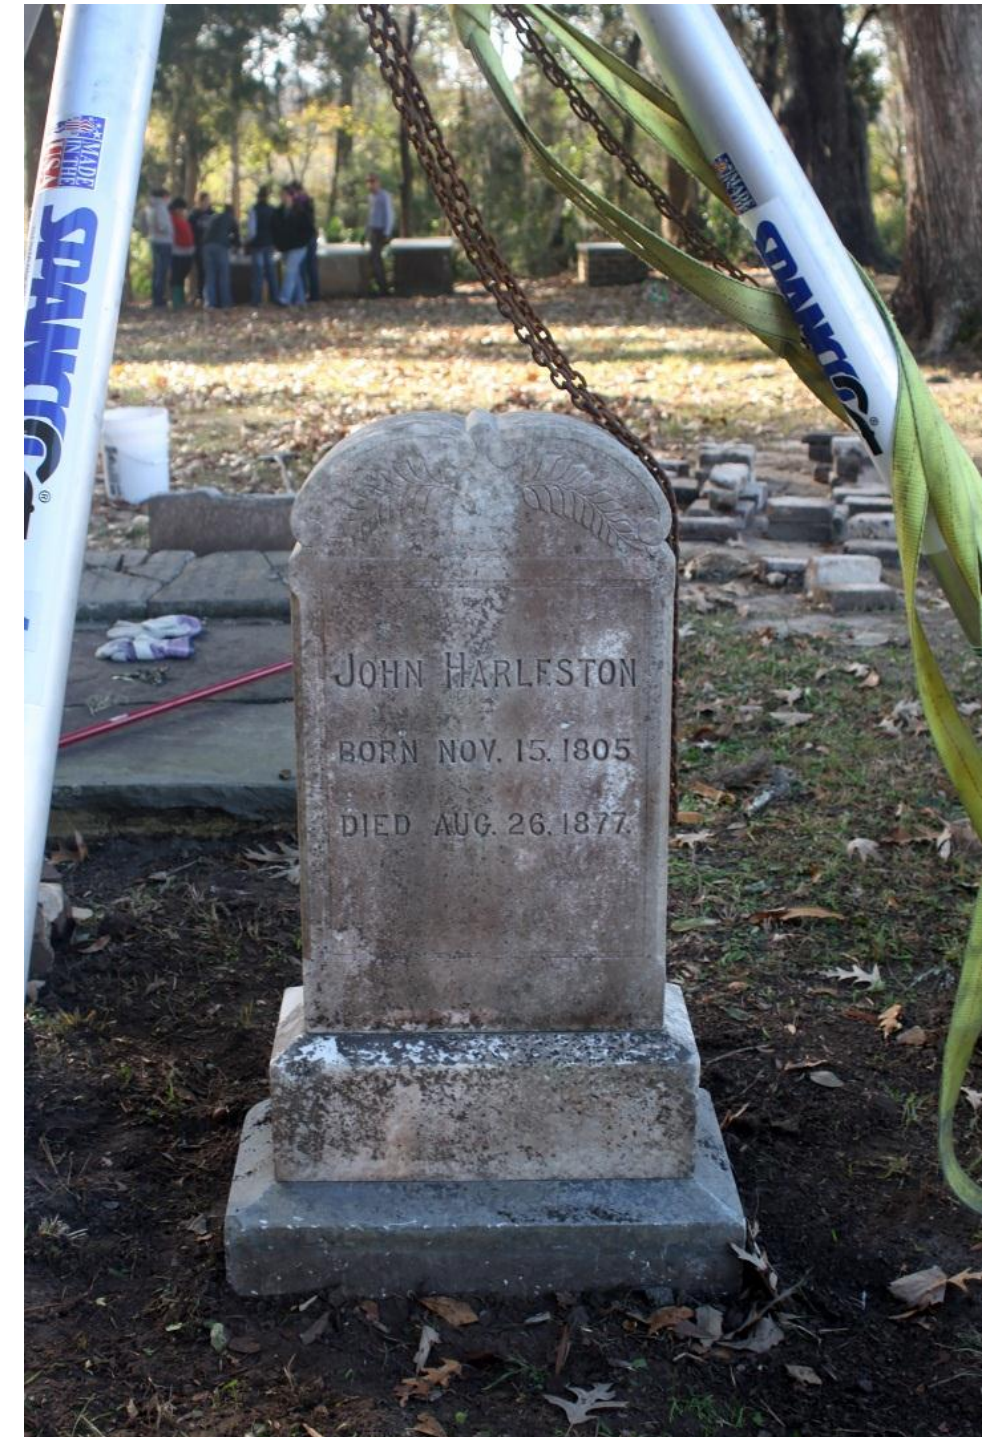
Plumb and level

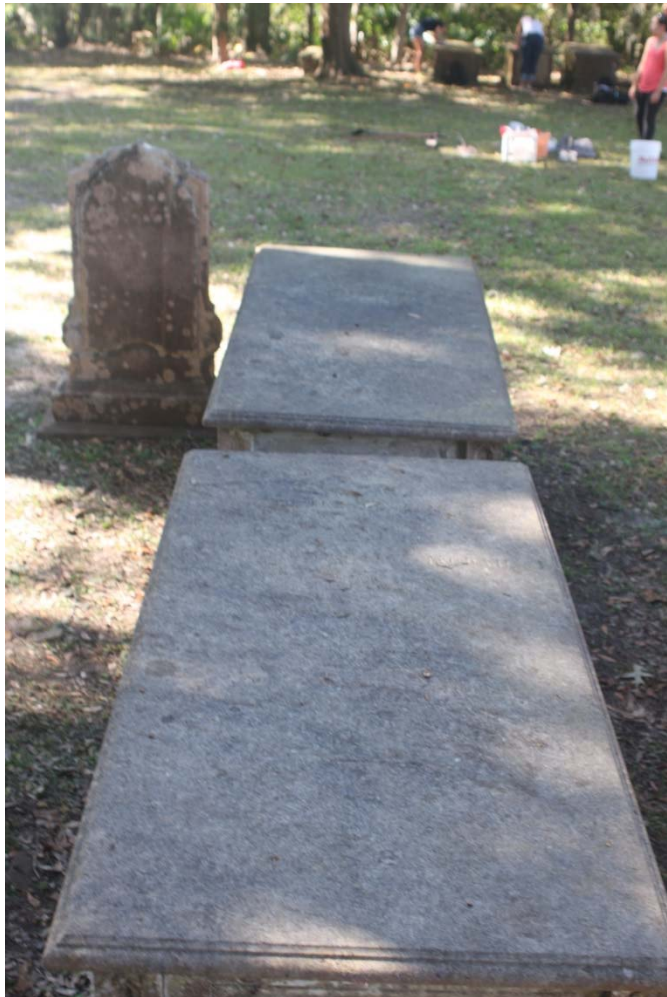
As Found:

Describe any conditions which may require repair: On the ledger there is a small crack that may be filled in to prevent further damage. There is also missing mortar holding the ledger to the base, as well as each side of the base to each other. The foundation is sinking as well. Water prevention may help prevent the pieces of the box tomb from further coming apart.

Recommended treatment: The crack on the ledger should be monitored, as it is a hairline fracture now, but has the possibility of becoming deeper. All of the stone pieces are missing mortar in places. Slight pressure on the base pieces revealed that they are separate from each other—some can be pushed inward. Reapplying mortar to the pieces would prevent them from moving and would also prevent water damage. The box tomb is not drastically out of plumb, but the foundation, which is uneven, should be monitored. Further uneven sinking would require righting the foundation.

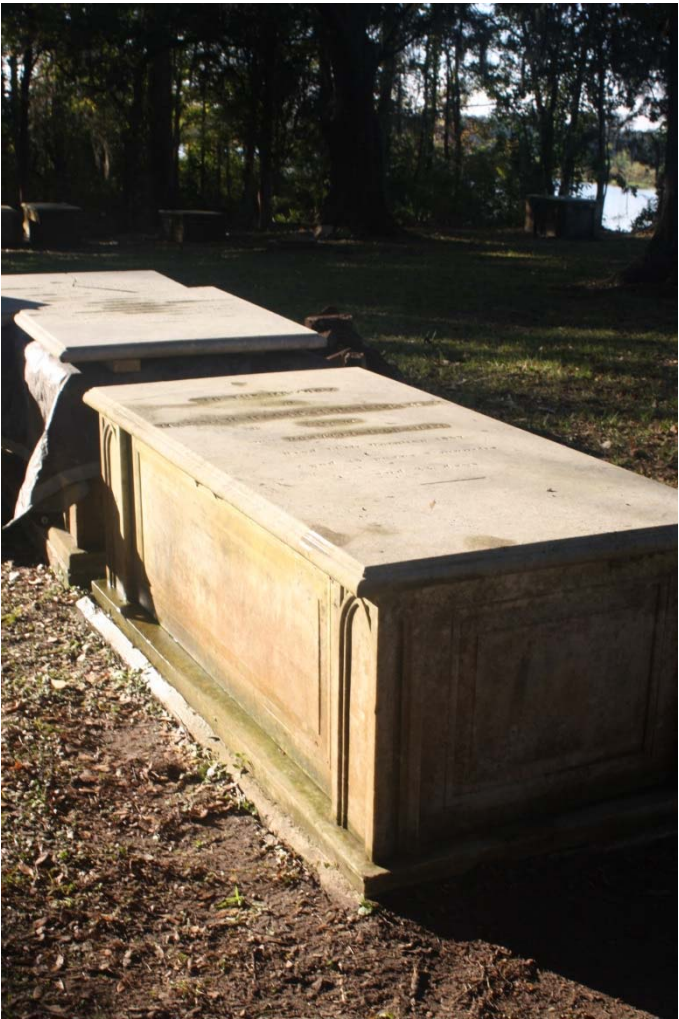
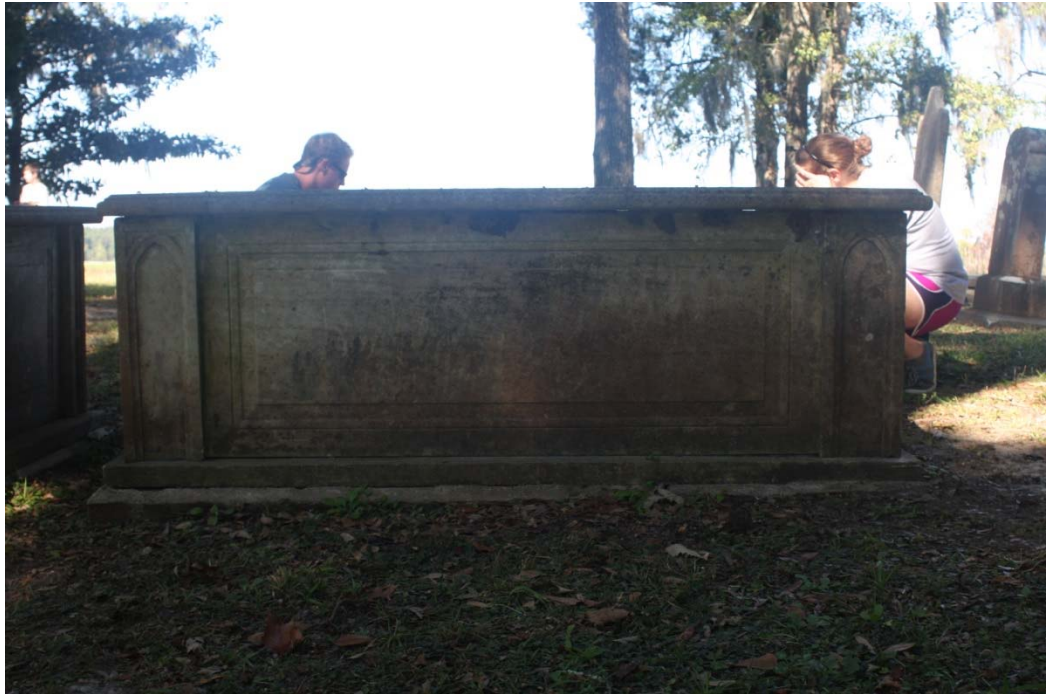
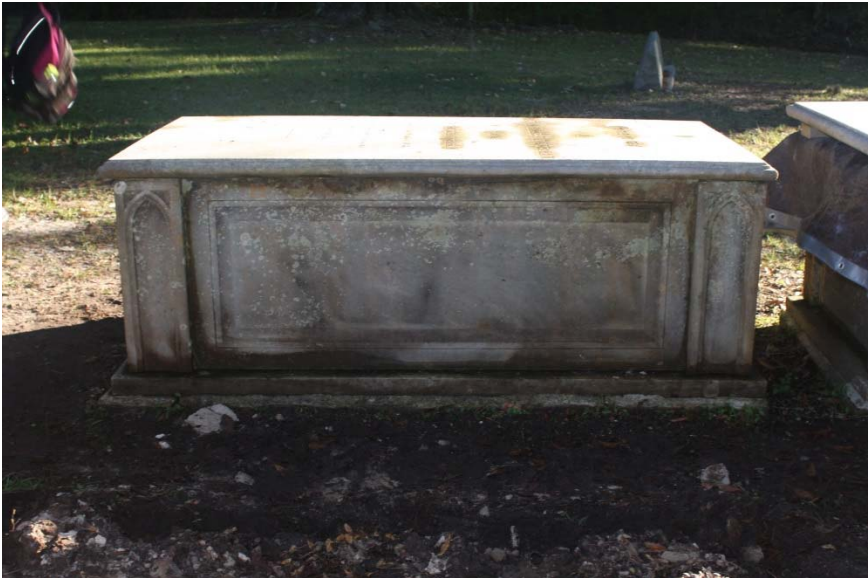
After Cleaning:

Intervention: The box tomb was cleaned with Photo-Flo and water to remove dirt, grime, and insects.

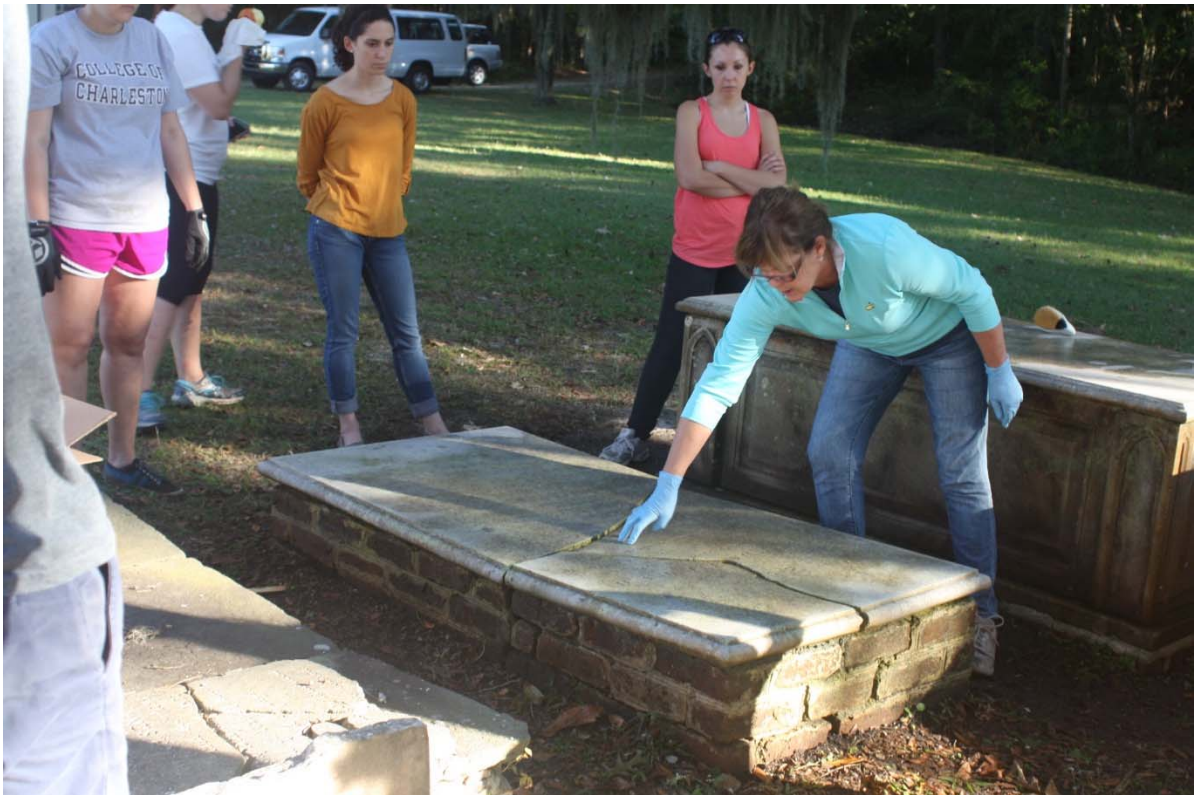
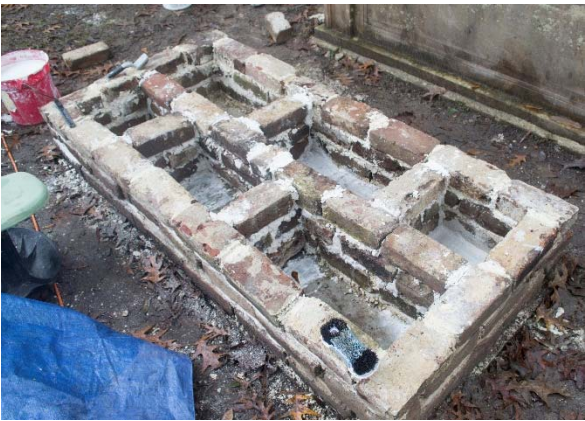
As Found:

The top marble ledger stone is broken into 3 pieces and the brick base is missing mortar in large areas.

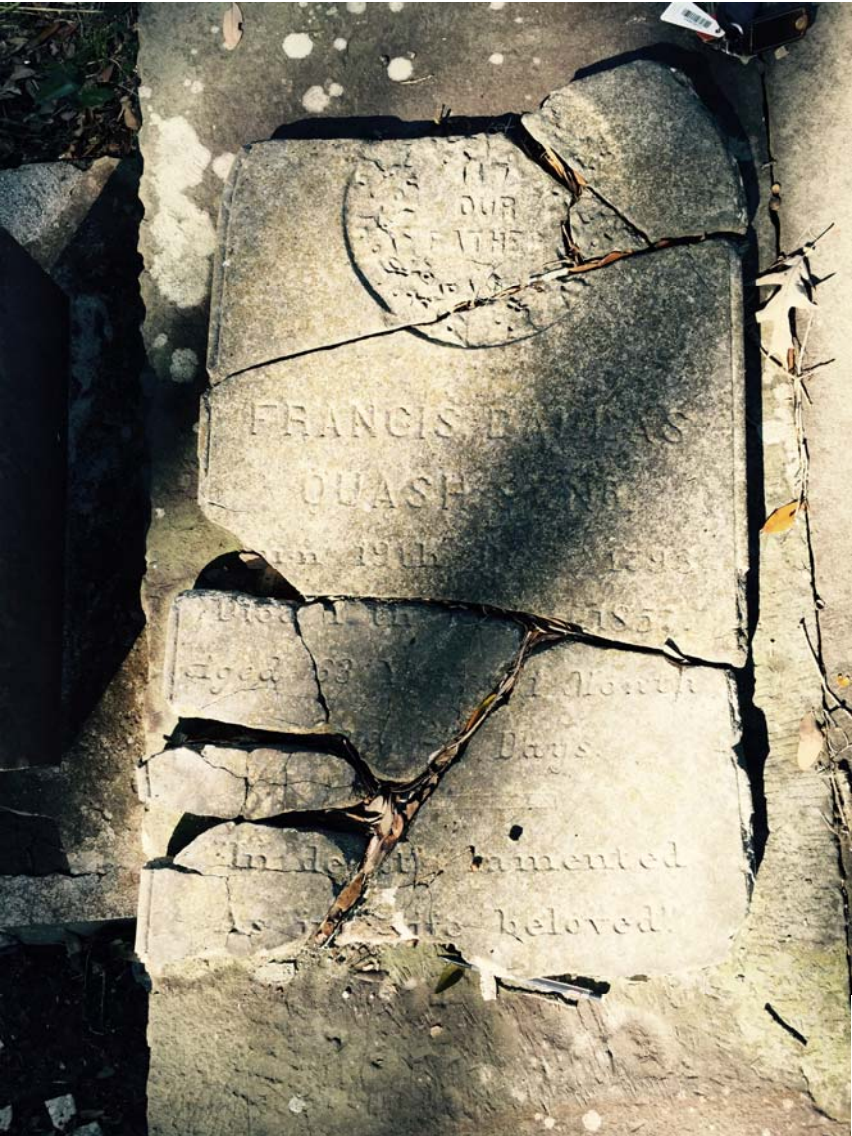
As Found:

Past repairs:
Cement-Adhesive-iron pins-iron braces/cramps-stucco-mortar-encased-rebuilt-coatings
Other: Tablet replaced with (3) slate tabelts, each approximately 2’ veritically and 4’ horizontally covering box tomb.
Headstone has remnants of adhesive, cement, and a stucco/mortar mix.

Describe any conditions which may require repair: Base is crumbling, and the headstone has detached and is laying on box tomb in multiple pieces.

Recommended treatment: For the headstone: Repair with steel braces and piece back together as best as possible. Because of stone width, not able to drill or use rods. For the base, chisel the crumbling stucco away, leaving brick base exposed.

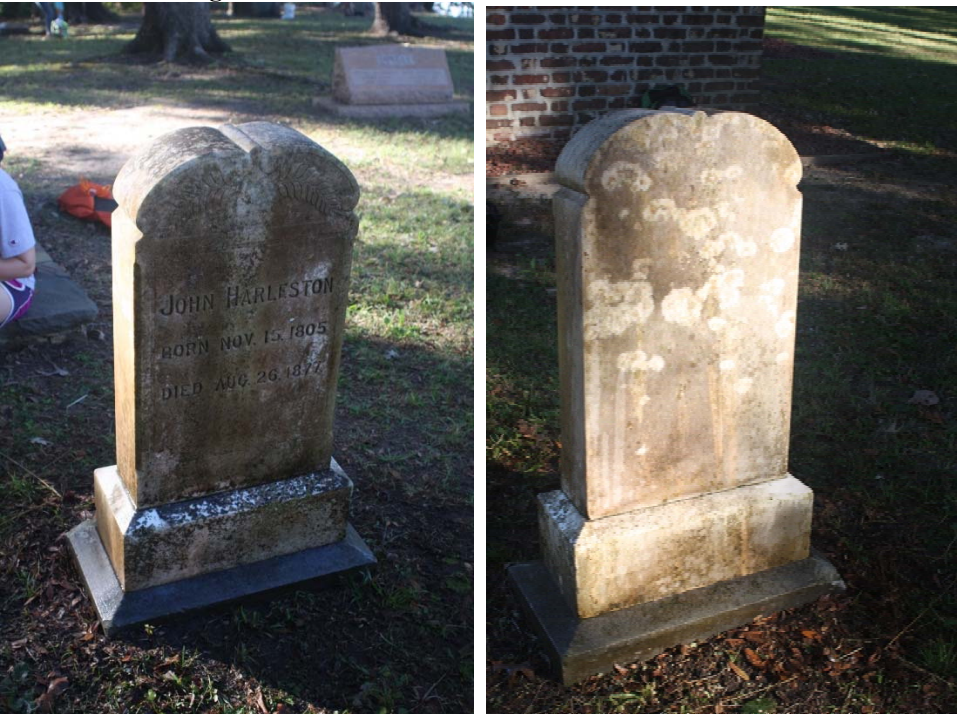
After basic cleaning-

The first day on site was dedicated to cleaning. Wooden tongue depressors and popsicle sticks were used on the wetted stones to gently coax off the lichen that had grown on the surface. This growth was concentrated on the rear and sides of the stone. The stones were then washed with pure water and gently scrubbed with a nylon brush. This was followed by a cleaning with Photo Flo, a gentle product that is not absorbed into the stone.

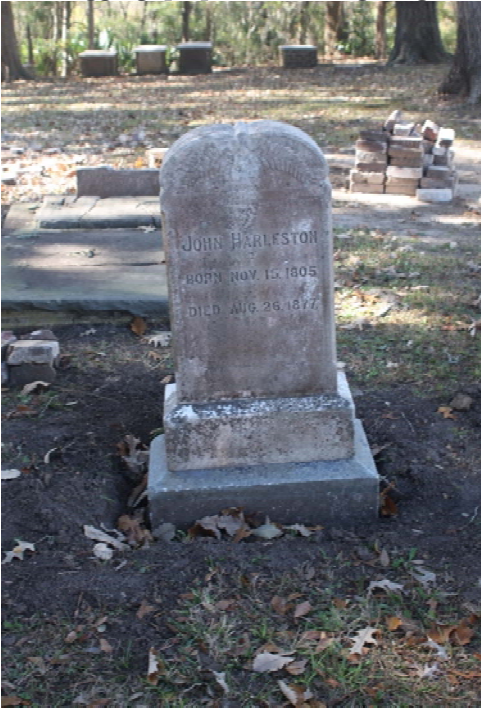
After digging/preparation for righting-

The second site day was given over to preparing for righting the stone. The soil in front of the East elevation was dug down from corner to corner to the bottom of the sub-base. The side opposite had a small amount of soil removed to give the stone space to move. The soil in front of the North elevation was also excavated to the bottom of the sub-base, with some soil removed from the South elevation to allow for movement. After a test where the stone was manually adjusted, a decision was made to wait until the crane was on site to plumb and level the stone.
