Investigation, Documentation, and Conservation of

Pompion Hill Chapel

Berkeley County, S.C.

Clemson University & The College of Charleston
Graduate Program in Historic Preservation
Fall 2014

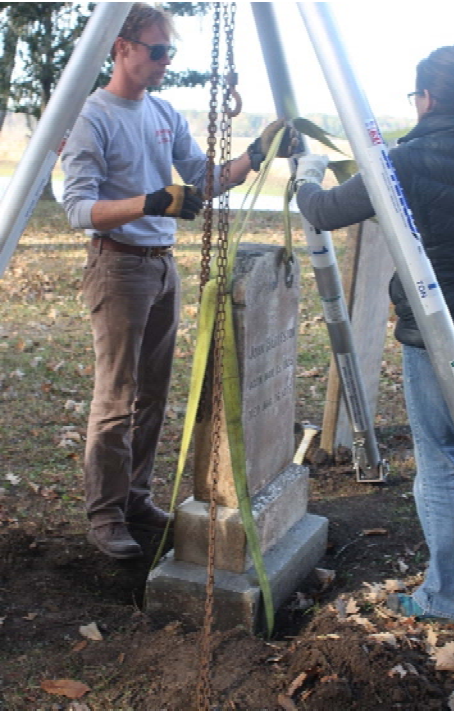
-Crane to lift the stone

On the last day on site, the crane was set up directly over the stone. A nylon strap, connected to the pulley, was coaxed under the sub-base and the stone was lifted. As two persons did the work of lifting the stone, the stone was checked for plumb and level. Once the stone was determined to be in proper position, dry mortar mix was worked under the sub base, packed in a tightly as possible. The mortar mix will absorb water from the surrounding soil, activating it and hardening in position. After the mortar mix was put in place, the stone was wedged up with a long iron bar so that the nylon strap could be removed. The stone was gently set back down and re-checked for plumb. Once the crane was removed, the surface soil that had been excavated was used to re-fill the area around the sub-base and tamped into place. The stone was then treated with a biocide to help keep biological growth from forming again.

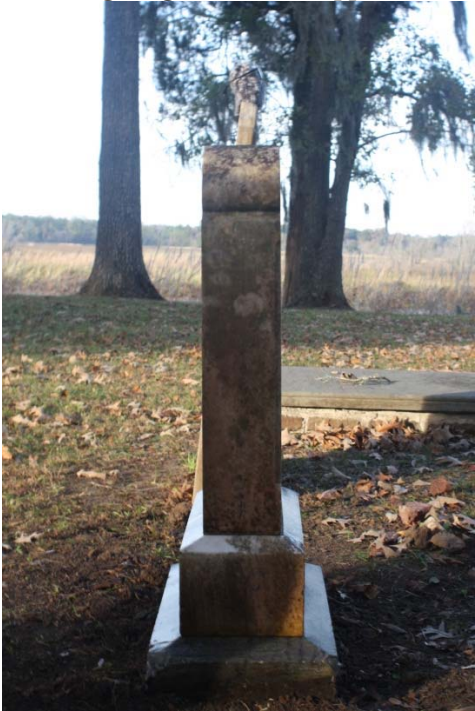
-After righting and biocide application.

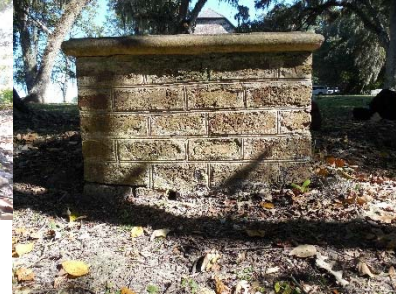
Before:

Past repairs:
Cement-Adhesive-iron pins-iron braces/cramps-stucco-mortar-encased-rebuilt-coatings
Other: The box tomb looks as if it was rebuilt before with new mortar joints and newly repointed

Recommended treatment:
The recommended treatment is cleaning. The ledger stone is still in tact and the box tomb foundation is newly rebuilt with new mortar.

Future Recommendations are to watch the the elevation of the foundation. The foundation might be affected by the close tree roots. Also, to watch the damage overhanging trees might cause the ledger stone. The overhanging trees will most likely cause the stone to be cleaned again.

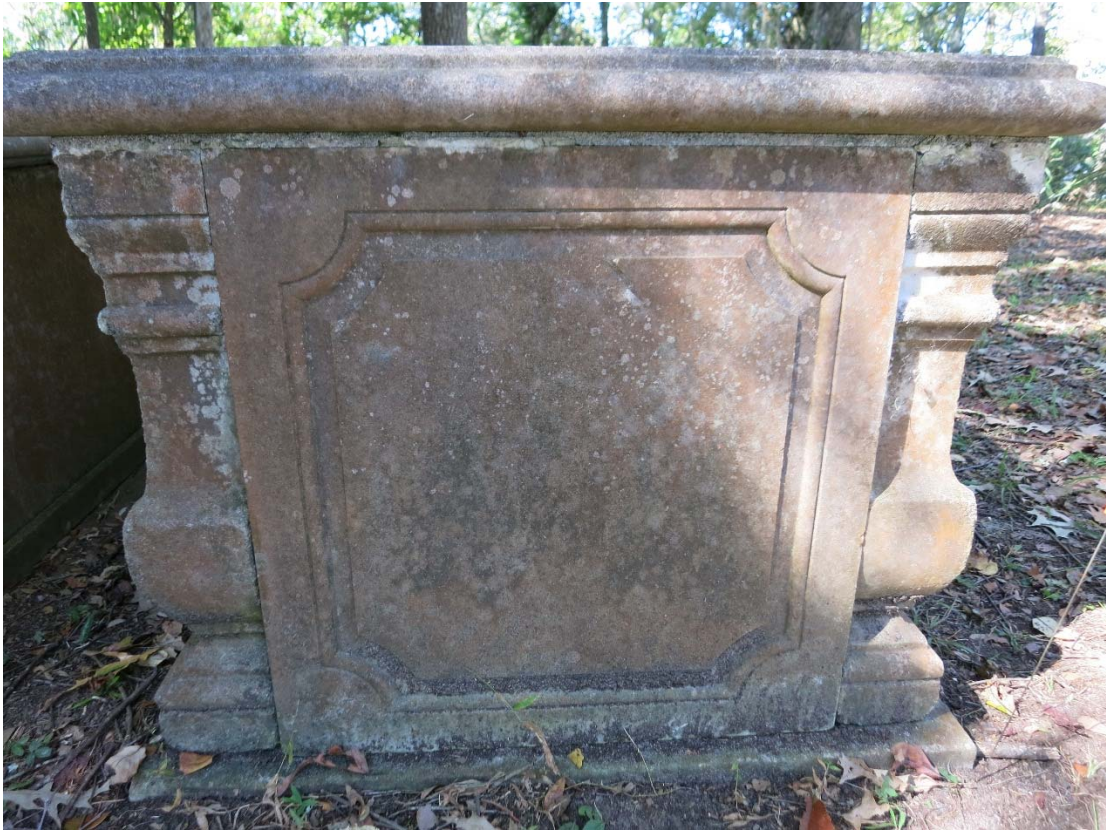
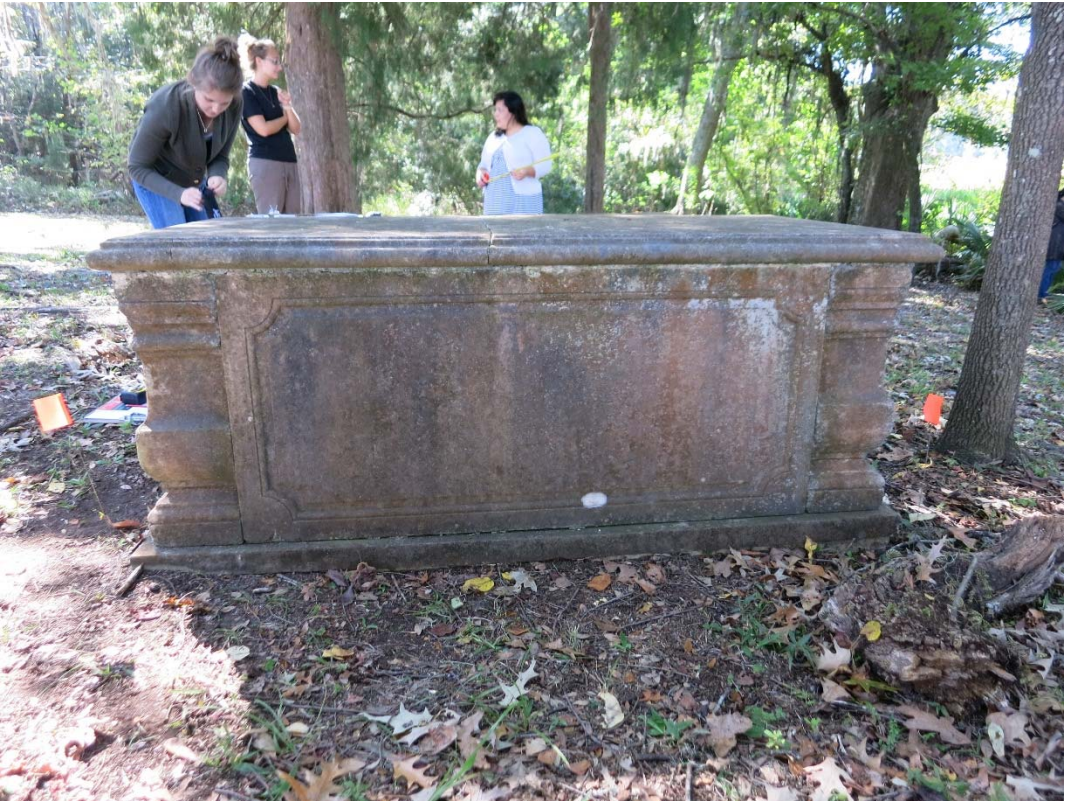
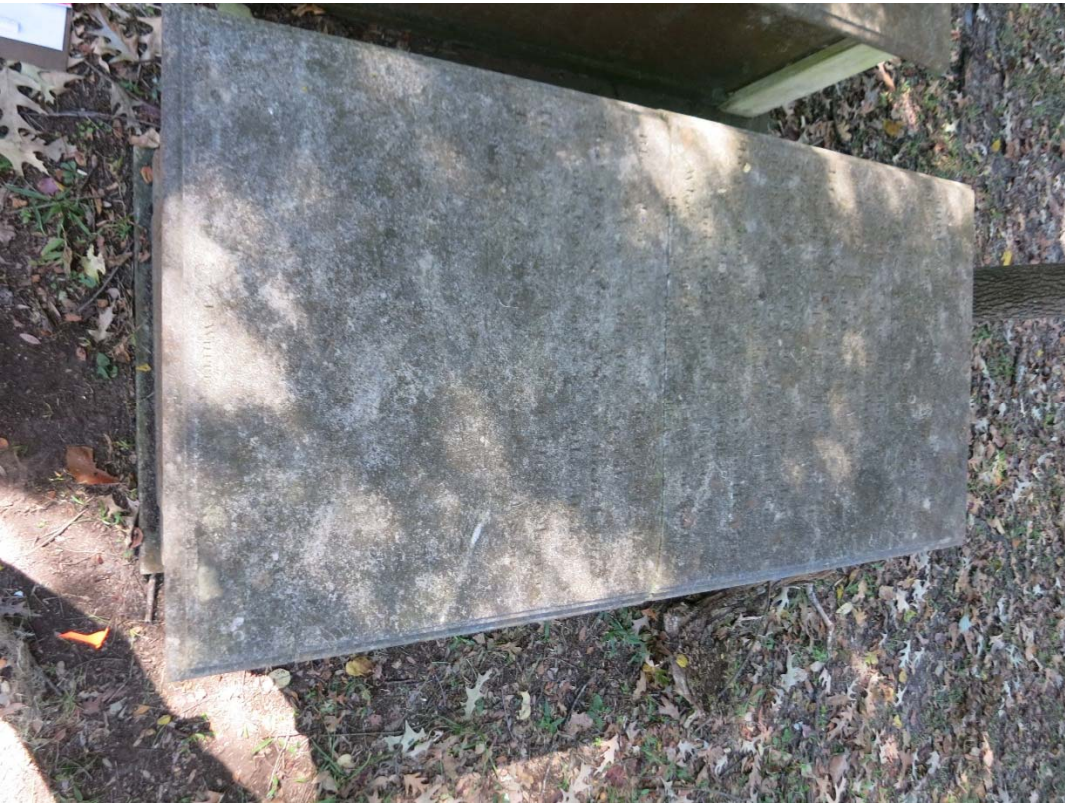
Before:

Deterioration of columns (sugaring)

Cracks allowing water to enter the box

I recommend a good cleaning to the ledger and box as well an application of stone epoxy and clamps to help minimize intake of moisture. Jahn and a brush should also be used to seal the crack across the ledger of the box tomb.

After this initial treatment, I recommend continuing to check on the Jahn application for weak points and a reapplication if necessary. Next, the columns and sides of the box should be cleaned with Photo Flo to remove bio growth and other materials from aging. If there is a sealant for sugaring, this needs to be applied to the columns as well.

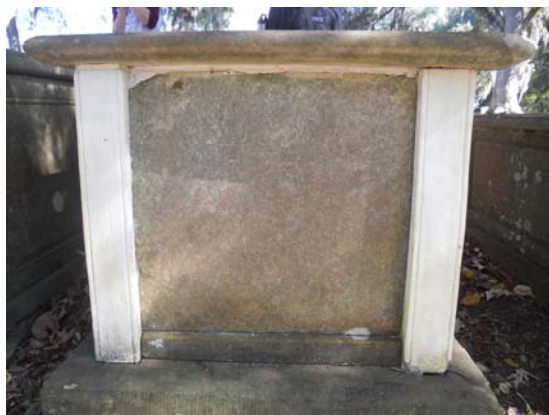
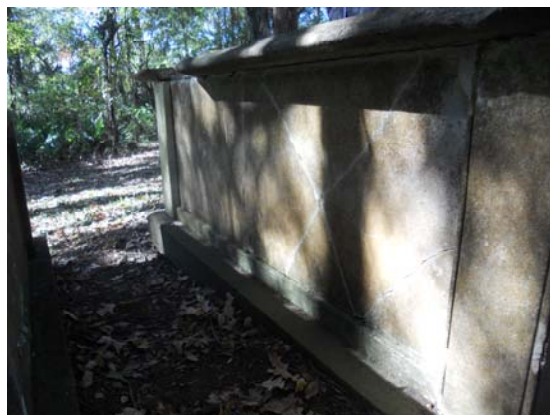
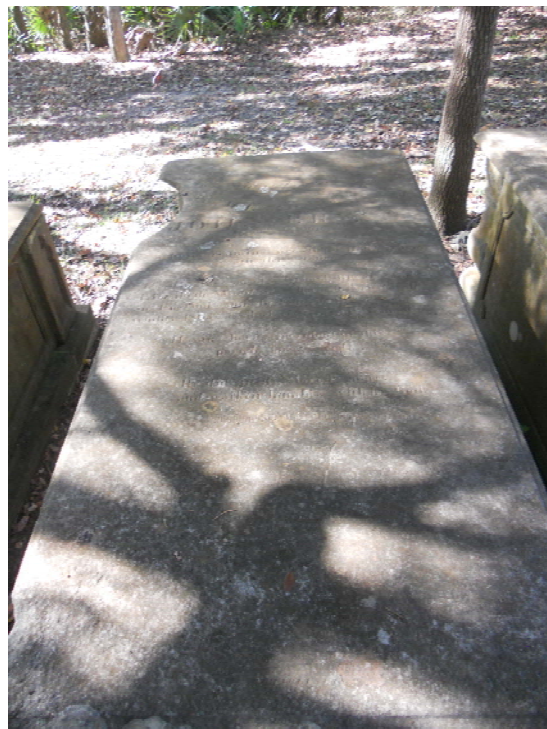
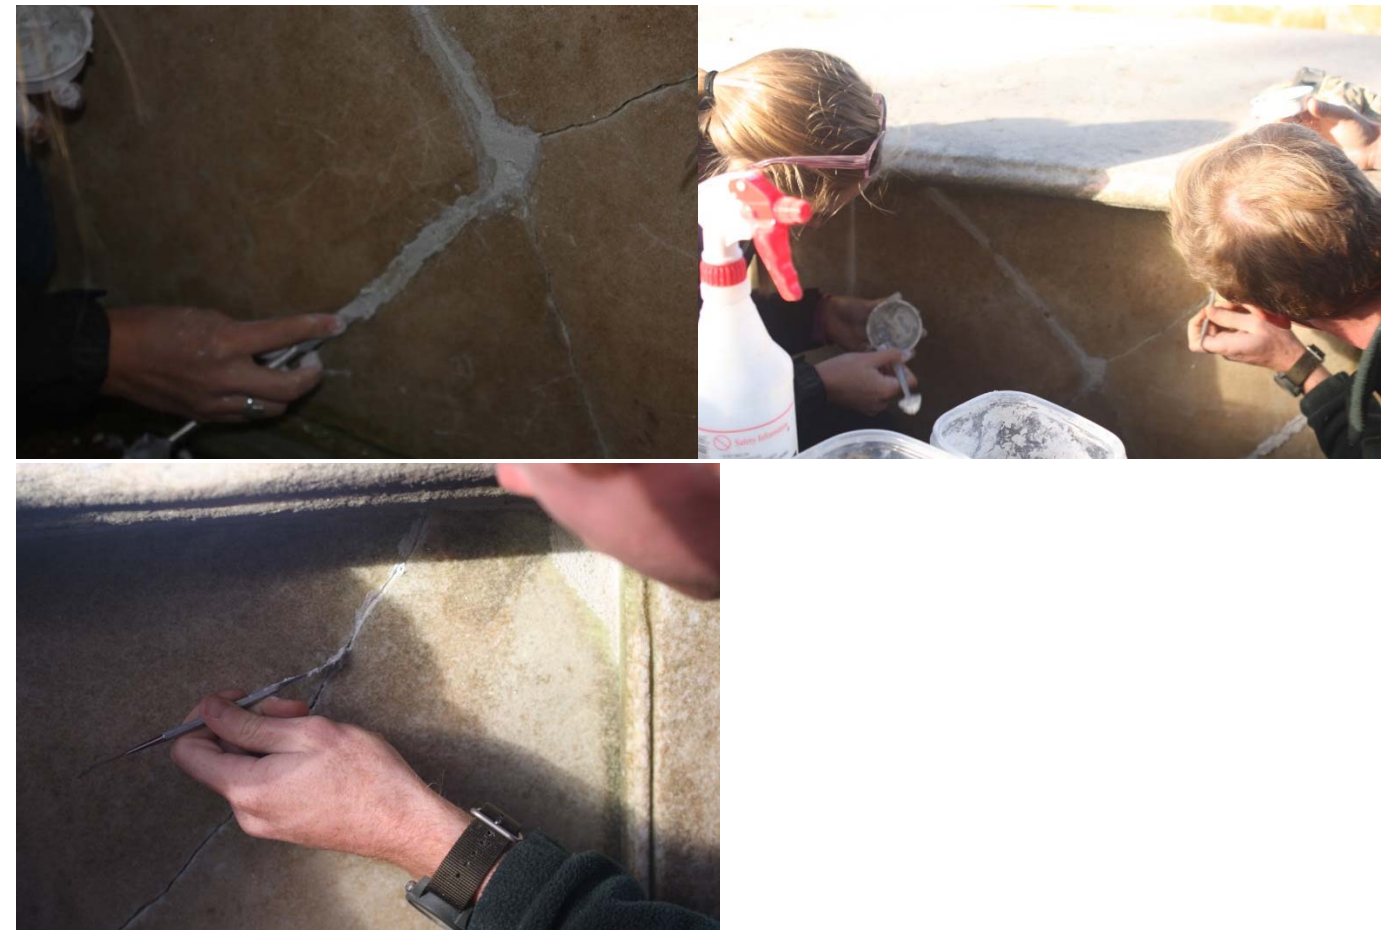
-portions of cracked area on south wall had previously been filled with epoxy

Describe any conditions which may require repair:
-x shape and 2 vertical cracks running height of south facade
-2 hairline cracks through length of ledger
-a semicircular portion of the ledger is missing near the SW corner, roughly 7 inches in diameter, the missing piece has not been located.

The ledger stone and marble sides of the tomb should be cleaned using water and a soft bristle brush. Photo flo soap may aid in removing some of the staining caused by bio growth. The cracking on the south side should be filled with jahn to prevent further moisture from getting inside and causing further cracking. There are two hairline cracks running the length of the marble ledger. These cracks are currently fairly thin and do not appear to be causing any structural strain for the tomb. At present, I would recommend that these cracks be left as-is. The stone missing from the ledger has not been located; since the missing piece does not interfere with the text and also does not appear to be a structural issue, it too should be left as-is.

The ledger stone and sides were first cleaned with a soft bristle brush and water. Photo flo soap was used second to remove further staining that had been left by bio growth. Treatment to the ledger stone was completed after the cleaning. The cracking in the south façade was filled with jahn.

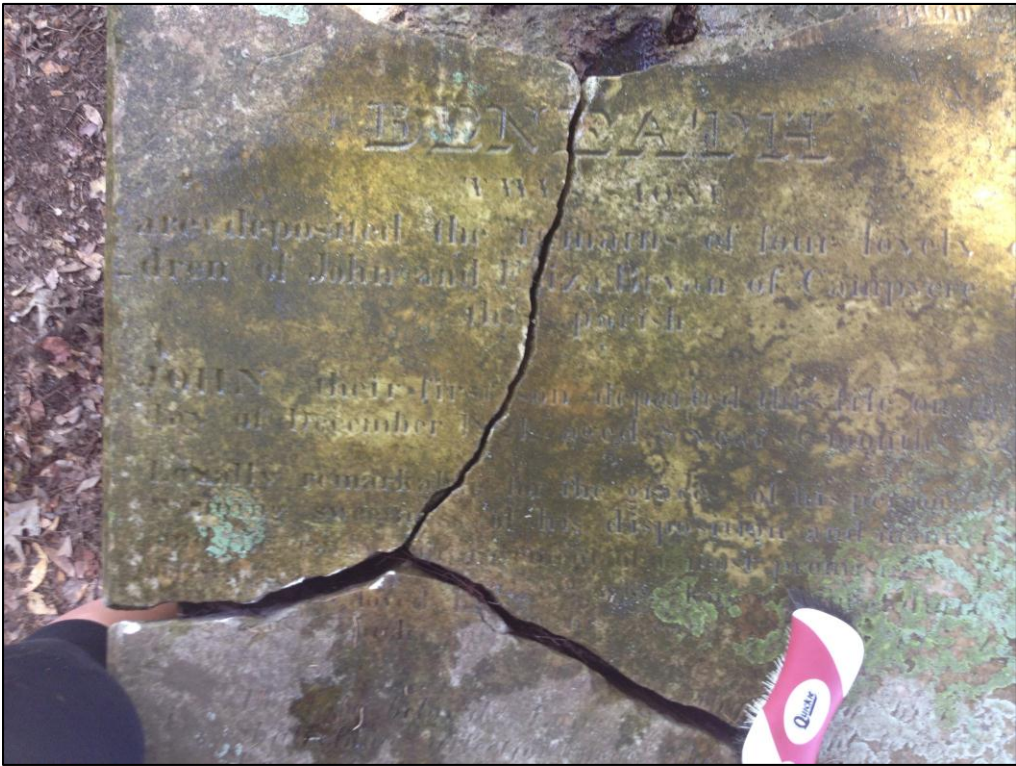
During Initial Surface Cleaning

Ledger is severely cracked through, with large, loose, and or missing pieces. Extent of soiling and bio growth is so advanced as to make the text inscribed essentially illegible. Encroaching tree has been planted too close to tomb as evidenced by roots growing upward from within tomb.

The top surface of ledger was cleaned thoroughly using only brush and water. Bio-growth and soiling were greatly eliminated in this simple process, taking the incised text of the ledger from nearly indecipherable to clear legibility and revealing low-relief carvings of an angel and trumpet near the top corners of the ledger. Next, large, loose portions of the cleansed ledger were carefully set aside to allow brush and water cleaning of the cement base on which the ledger rests. Roots and vines growing upwards from within were then gently pulled and removed where visible. A dry brush and small wire brush were used to clean and prep the edges of the large disarticulated portions of the ledger for a two-part epoxy binding. The epoxy mixture was applied to these edges, reattached, and then clamped to set. Acetone was used to eliminate any evidence of epoxy mistakenly bonded to the surface of the ledger. Once the epoxy mixture had cured, a two-step jahn application was applied to the surface cracks of the ledger, left to dry and then carefully smoothed flush. The surface of the ledger was then wiped clean with water and a soft sponge.

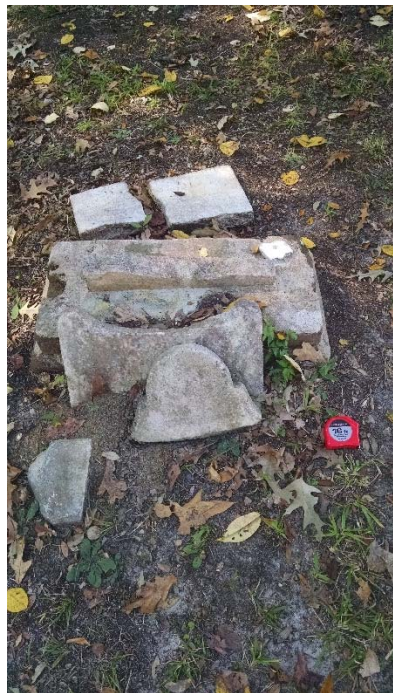
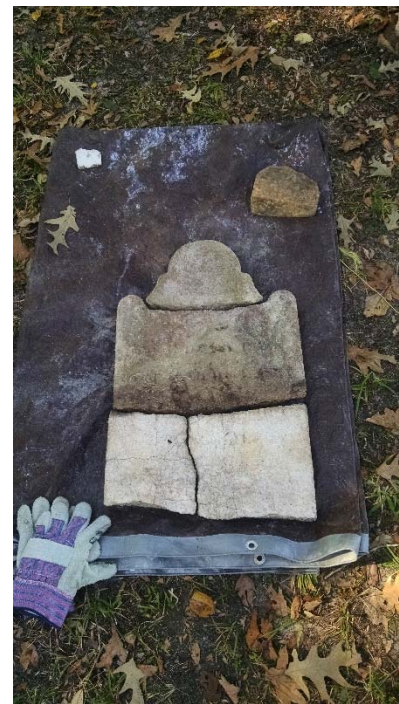
As Found:

Past repairs:
Cement-Adhesive-iron pins-iron braces/cramps-stucco-mortar-encased-rebuilt-coatings
Other: 3 courses of brick in foundation, covered with a soft cement. No other repairs apparent.

The base out of plumb and has an exposed brick foundation. The headstone is in fragments and there is heavy sugaring on areas of the fragments.

Recommended treatment:
It is recommended that the base be re-leveled, and the brick base be repointed and re-covered. Reattach the three fragments to the base and each other using epoxy fiberglass rods, and support with stainless steel channels or a one inch stainless steel encased back to strengthen the stones.
